APPENDIX TO:
**Improving Public and Worker
Safety at Oil Refineries**

Report of the Interagency Working Group on Refinery Safety

CHEVRON RICHMOND REFINERY FIRE

CHEVRON RICHMOND REFINERY

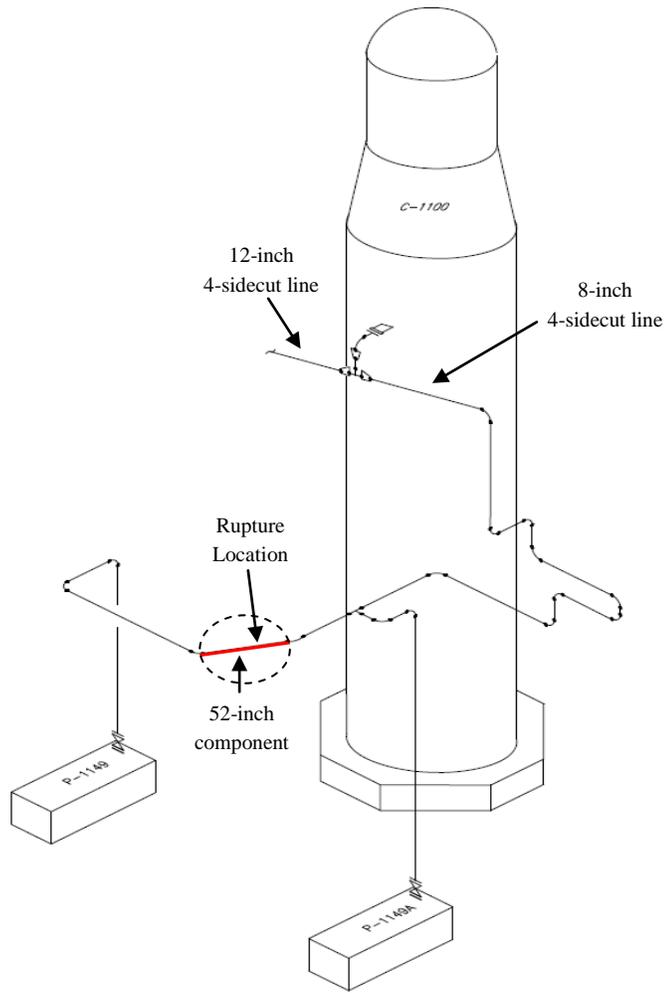
Figure 6. 4-sidecut line configuration and rupture location.

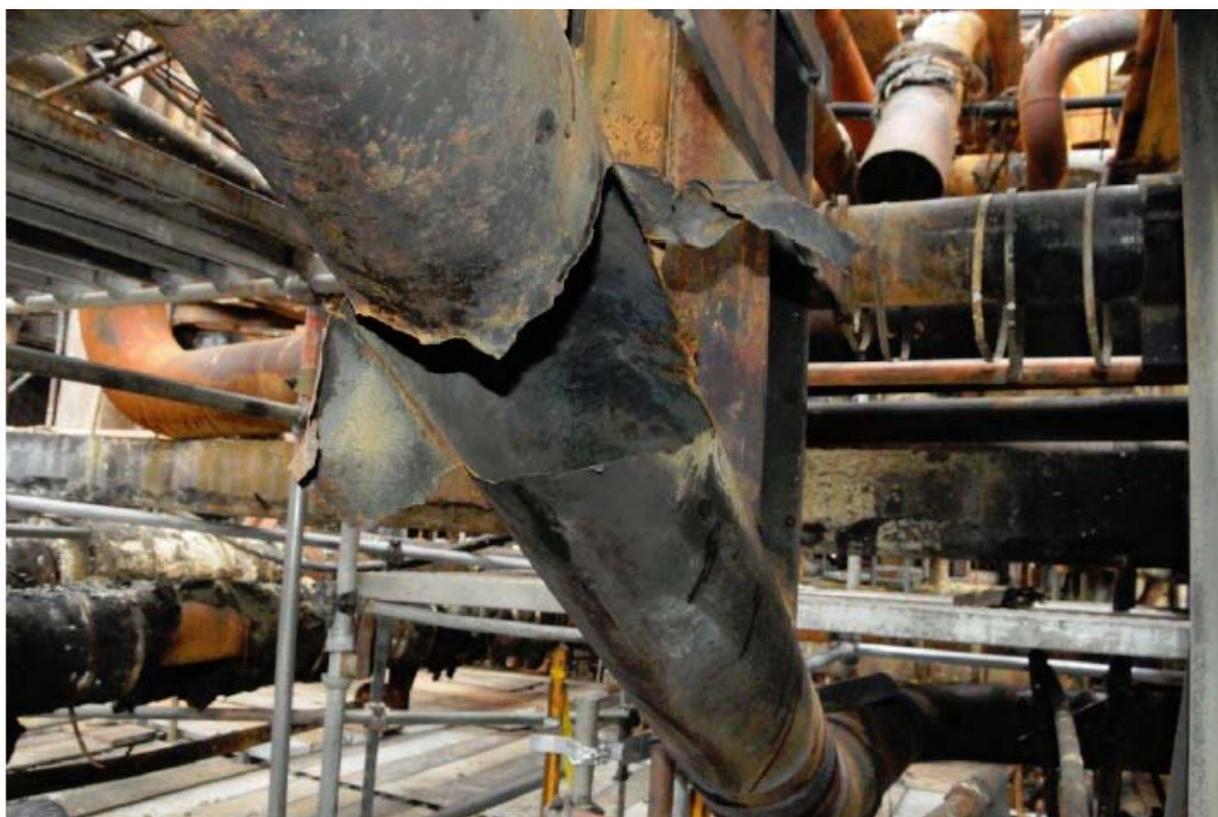
4. The CSB commissioned Anamet, Inc., a materials engineering and laboratory testing company, to conduct testing of the 4-sidecut pipe, including the failed 52-inch component. The testing concluded that the rupture was due to pipe wall thinning caused by sulfidation corrosion,³ which is discussed below.
5. Anamet's metallurgical analysis found that the 52-inch component where the rupture occurred had experienced extreme thinning; the average wall thickness near the rupture location was approximately 40 percent thinner than a dimeⁱ (the thinnest American coin). Between 1976 and 2012, the 52-inch piping component had lost, on average, 90 percent of its original wall thickness in the area near the rupture. The piping had an initial nominal wall thickness of 0.322-inchⁱⁱ when it was installed in 1976.

Figure 7. Photo of rupture on 4-sidecut 52-inch component.

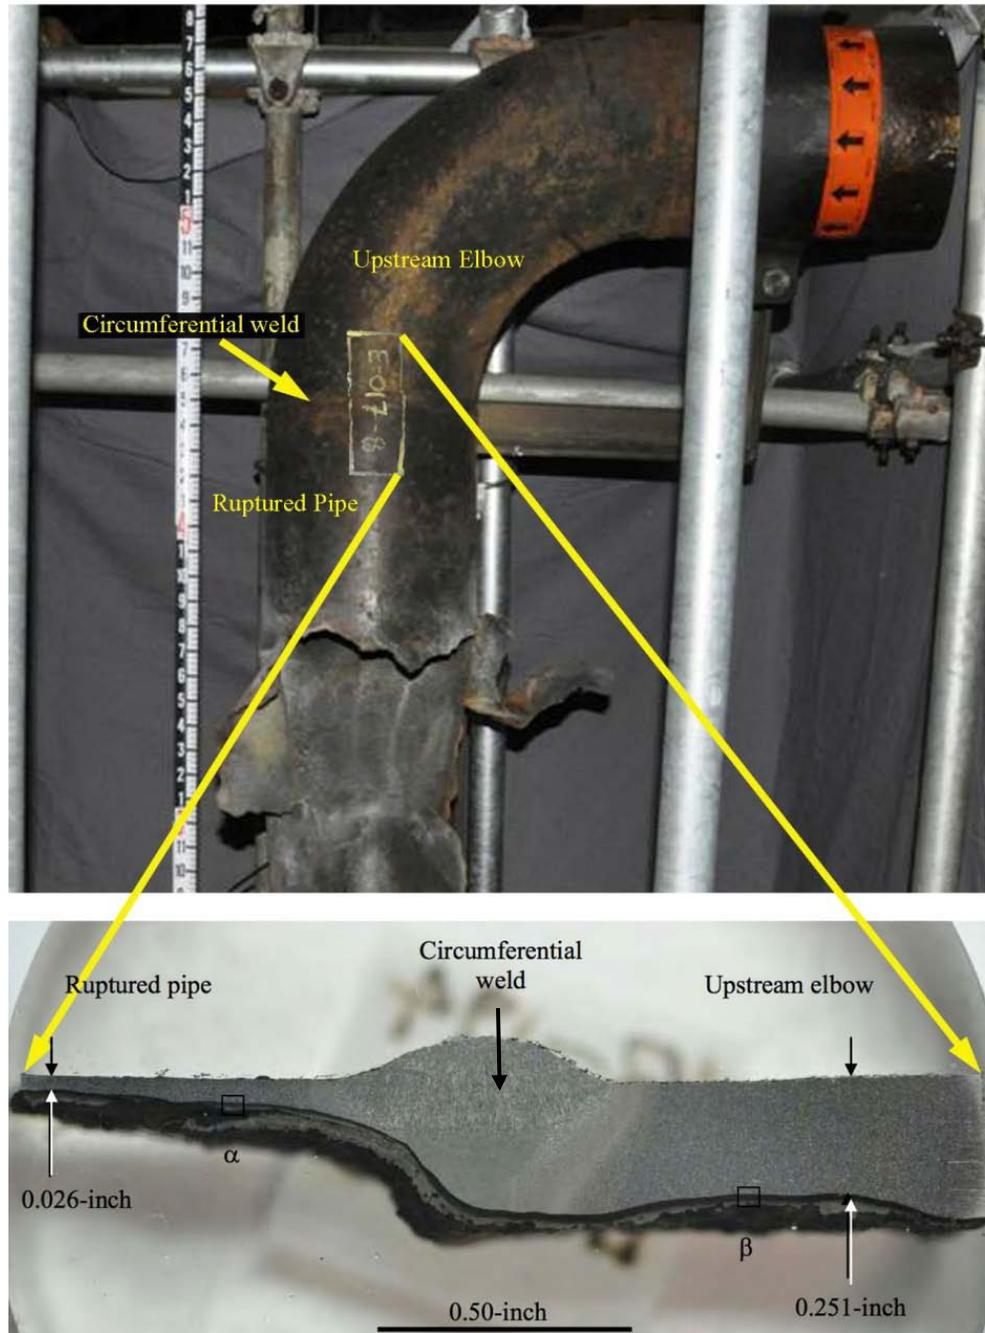
Figure 9. 4-sidecut piping sample (E-017-8) analyzed by Anamet Labs showing the relative thickness of low silicon piping on the left and the high silicon piping on the right. The ruptured pipe component (left) contained 0.01 % silicon and the upstream elbow component (right) contained 0.16 % silicon.¹⁹ The initial nominal thickness of this piping was 0.322-inch.

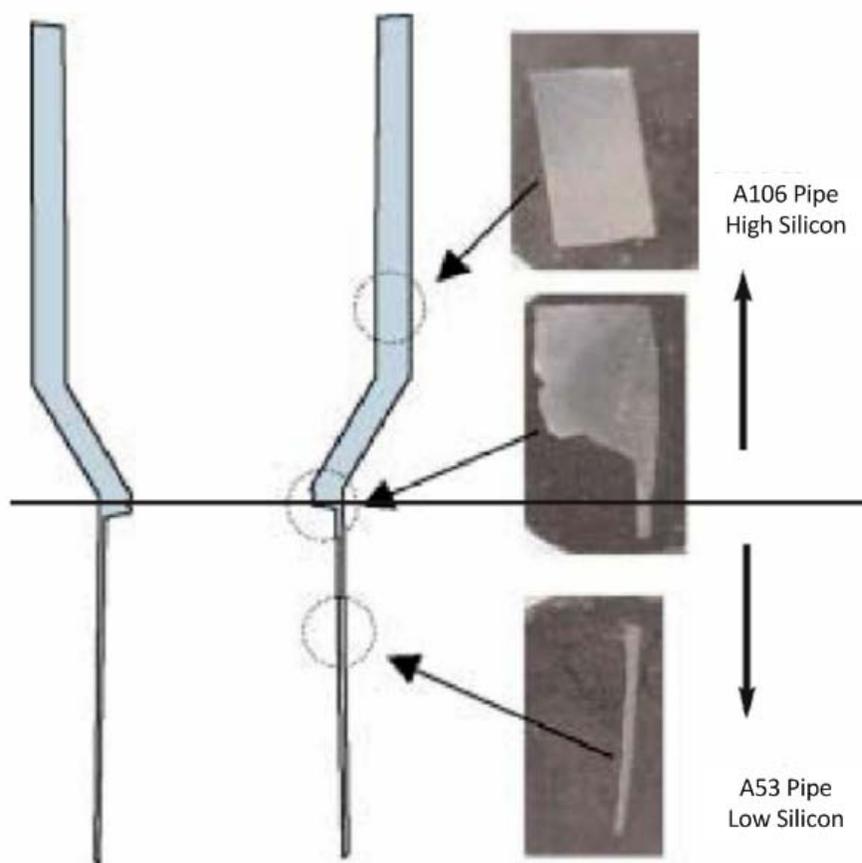
Figure 12. Schematic of failed piping from the Chevron Salt Lake Refinery. Similar to the Chevron Richmond Refinery incident, the failed piping contained low amounts of silicon and corroded significantly faster than adjacent piping components.

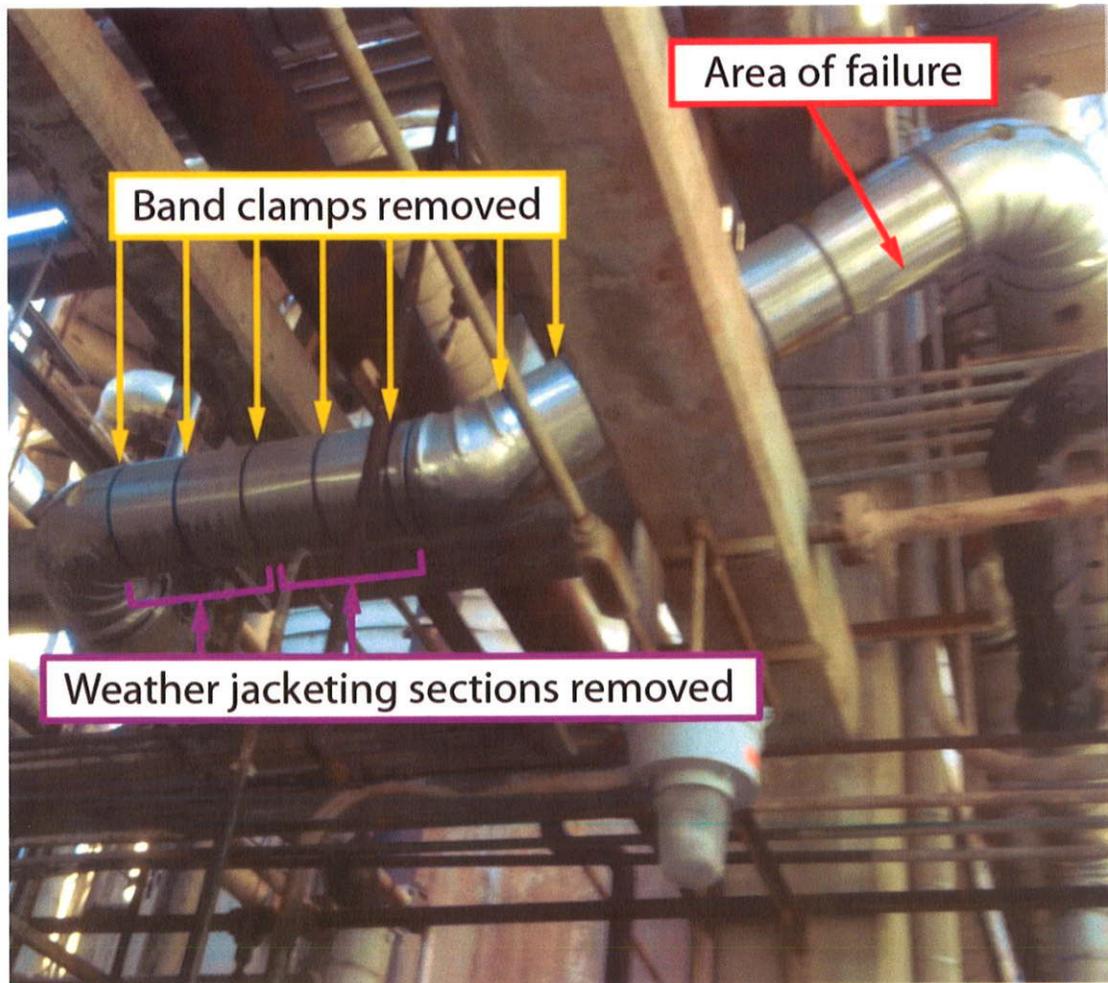
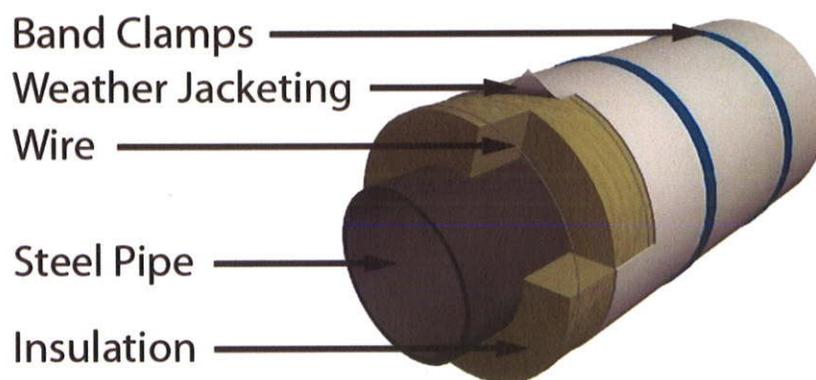
Figure 5. The steel pipe was encapsulated by insulation held in place by wire, which was covered by aluminum weather jacketing held in place with band clamps (bottom). The firefighters cut several band clamps (marked with yellow arrows) with pliers and removed two sections of the weather jacketing from the piping (marked with purple brackets).

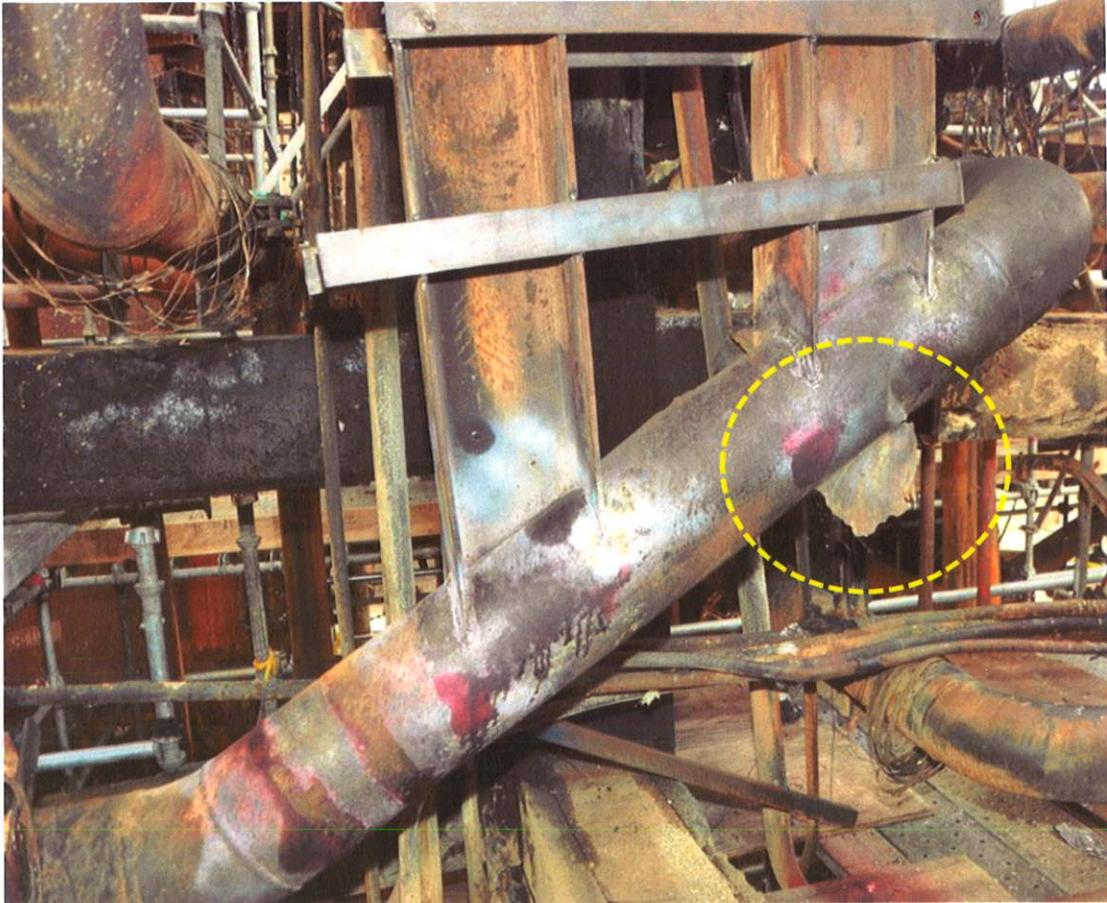
Figure 7. Photograph of the ruptured pipe component during inspection prior to removal. Area of the rupture is circled in yellow. (This photograph shows the same sloped portion of the pipe component shown in Figure 5.)

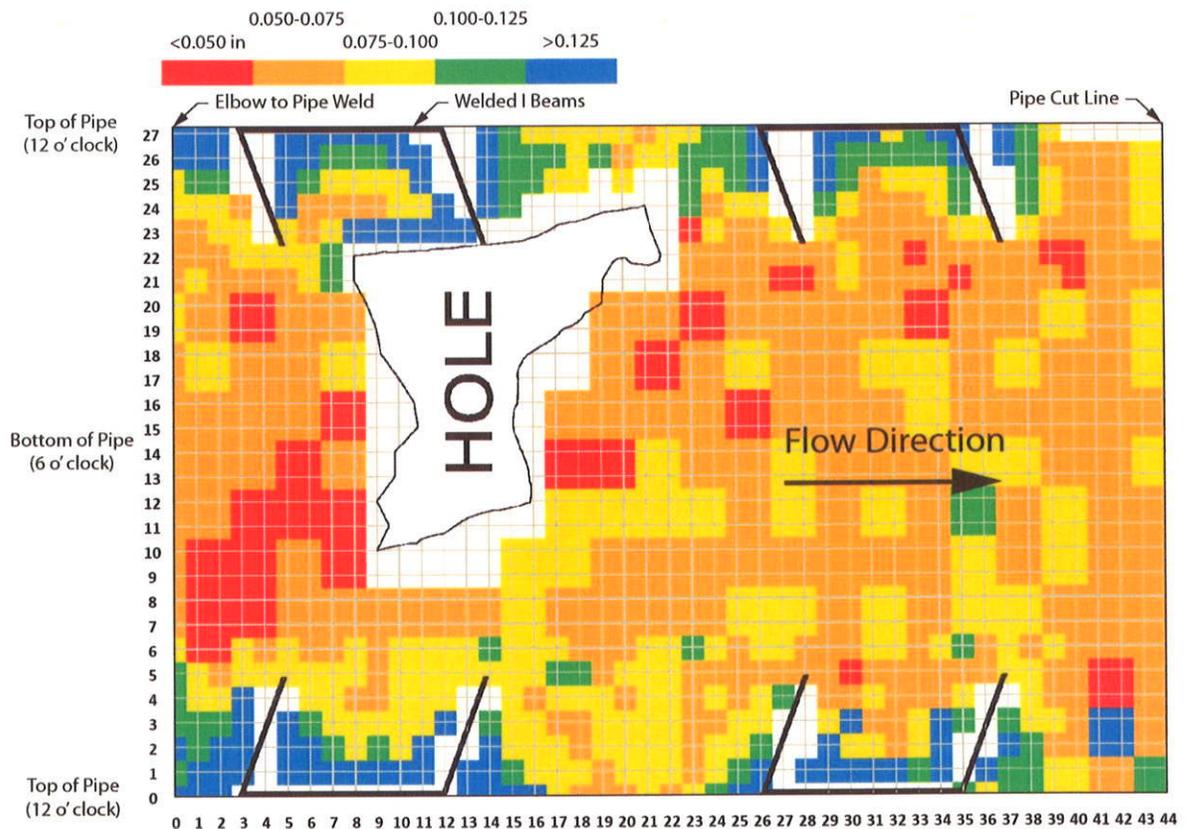
Figure 9. Thickness measurement results from the ruptured pipe component. Virtually the entire 27-inch circumference and 44-inch length of the ruptured pipe component had thinned to less than 0.10 inches, consistent with sulfidation corrosion. The graphic represents the pipe as sliced longitudinally at the top of the pipe (12 o'clock) and rolled out flat. The areas in white could not be measured.

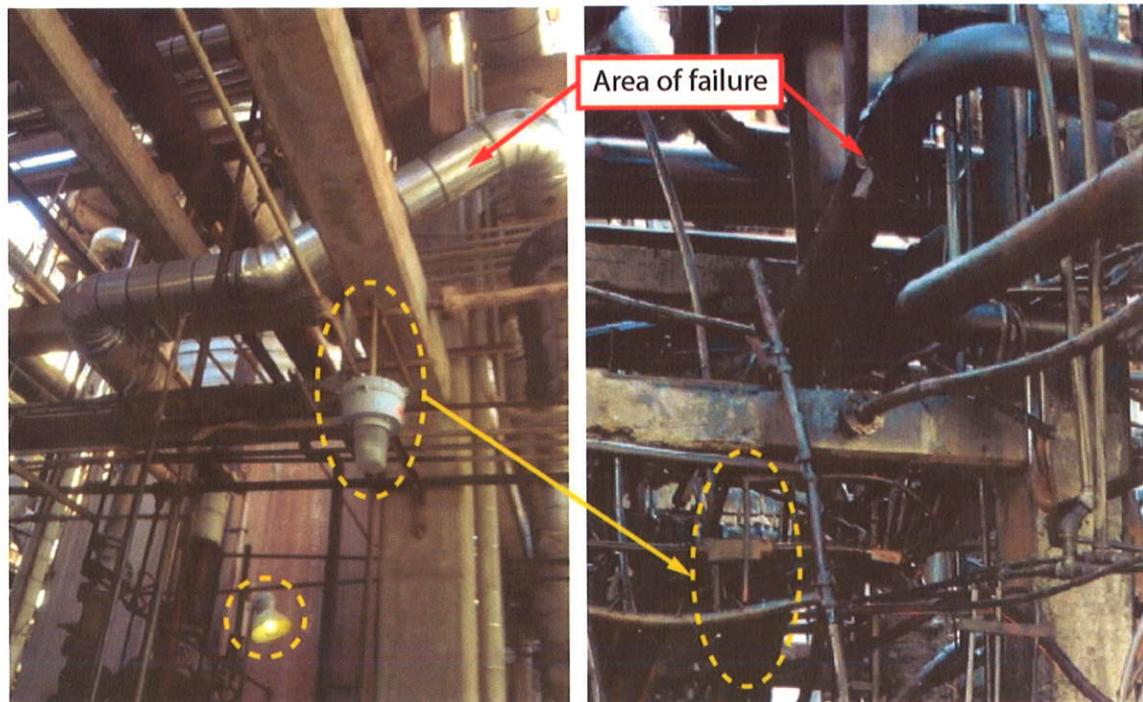
a photocell on the north side of the MCC located approximately 280 feet west of the failed pipe. After the Incident, the light fixture was missing, but the electrical conduit remained, as shown in Figure 15.

Figure 15. Lighting fixtures at the time the leak was discovered (photograph taken during the initial response) (left); and missing light after the Incident (right).
