Improving Public and Worker Safety at Oil Refineries

Draft Report of the Interagency Working Group on Refinery Safety Governor Jerry Brown

July 2013

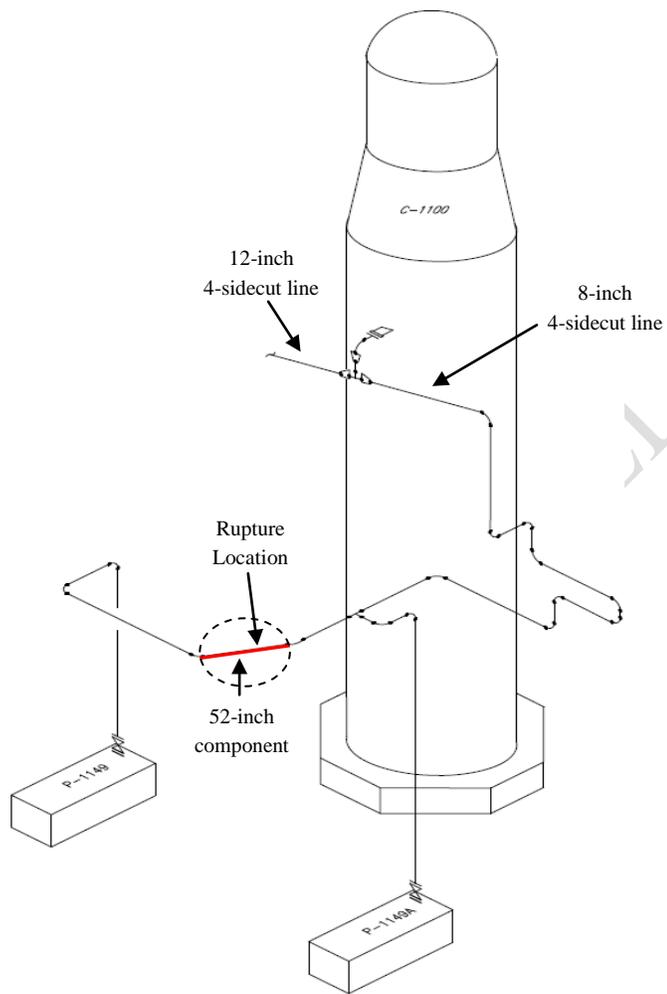
Figure 6. 4-sidecut line configuration and rupture location

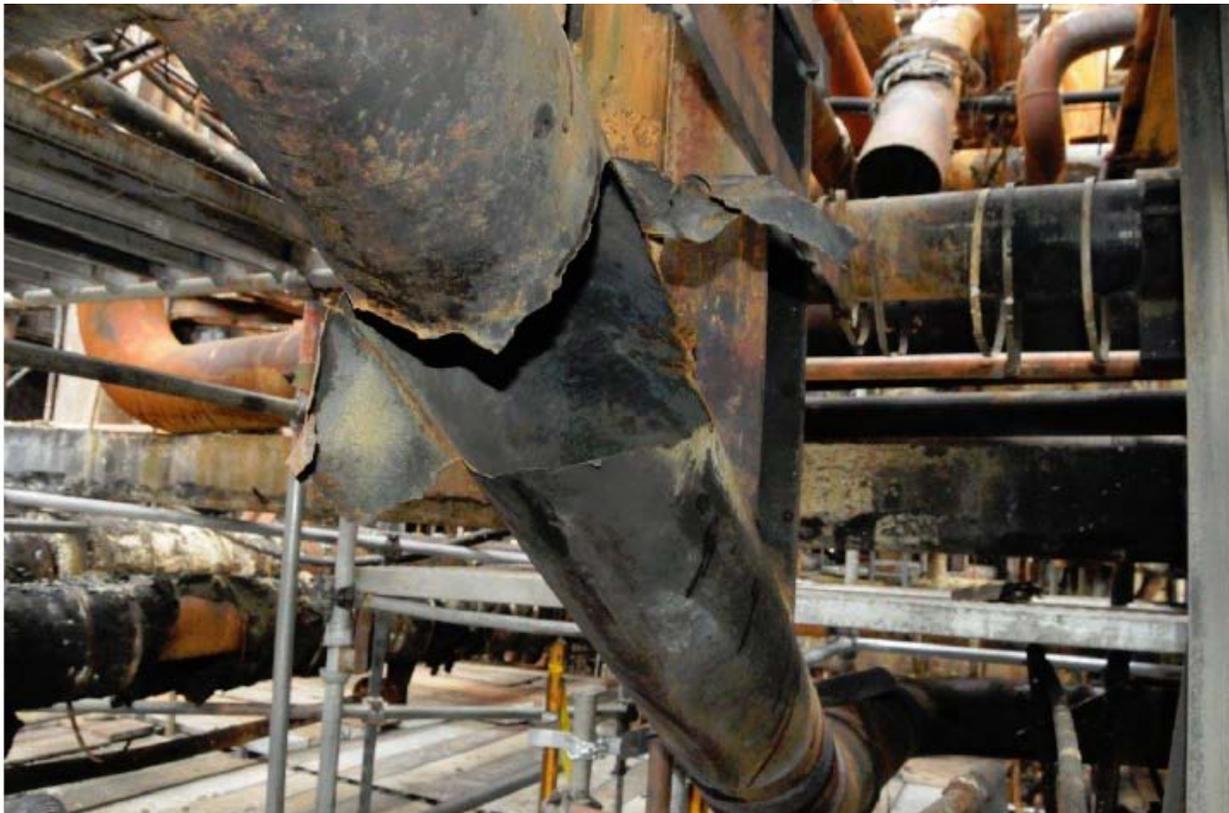
4. The CSB commissioned Anamet, Inc., a materials engineering and laboratory testing company, to conduct testing of the 4-sidecut pipe, including the failed 52-inch component. The testing concluded that the rupture was due to pipe wall thinning caused by sulfidation corrosion,³ which is discussed below.
5. Anamet's metallurgical analysis found that the 52-inch component where the rupture occurred had experienced extreme thinning; the average wall thickness near the rupture location was approximately 40 percent thinner than a dimeⁱ (the thinnest American coin). Between 1976 and 2012, the 52-inch piping component had lost, on average, 90 percent of its original wall thickness in the area near the rupture. The piping had an initial nominal wall thickness of 0.322-inchⁱⁱ when it was installed in 1976.

Figure 7. Photo of rupture on 4-sidecut 52-inch component

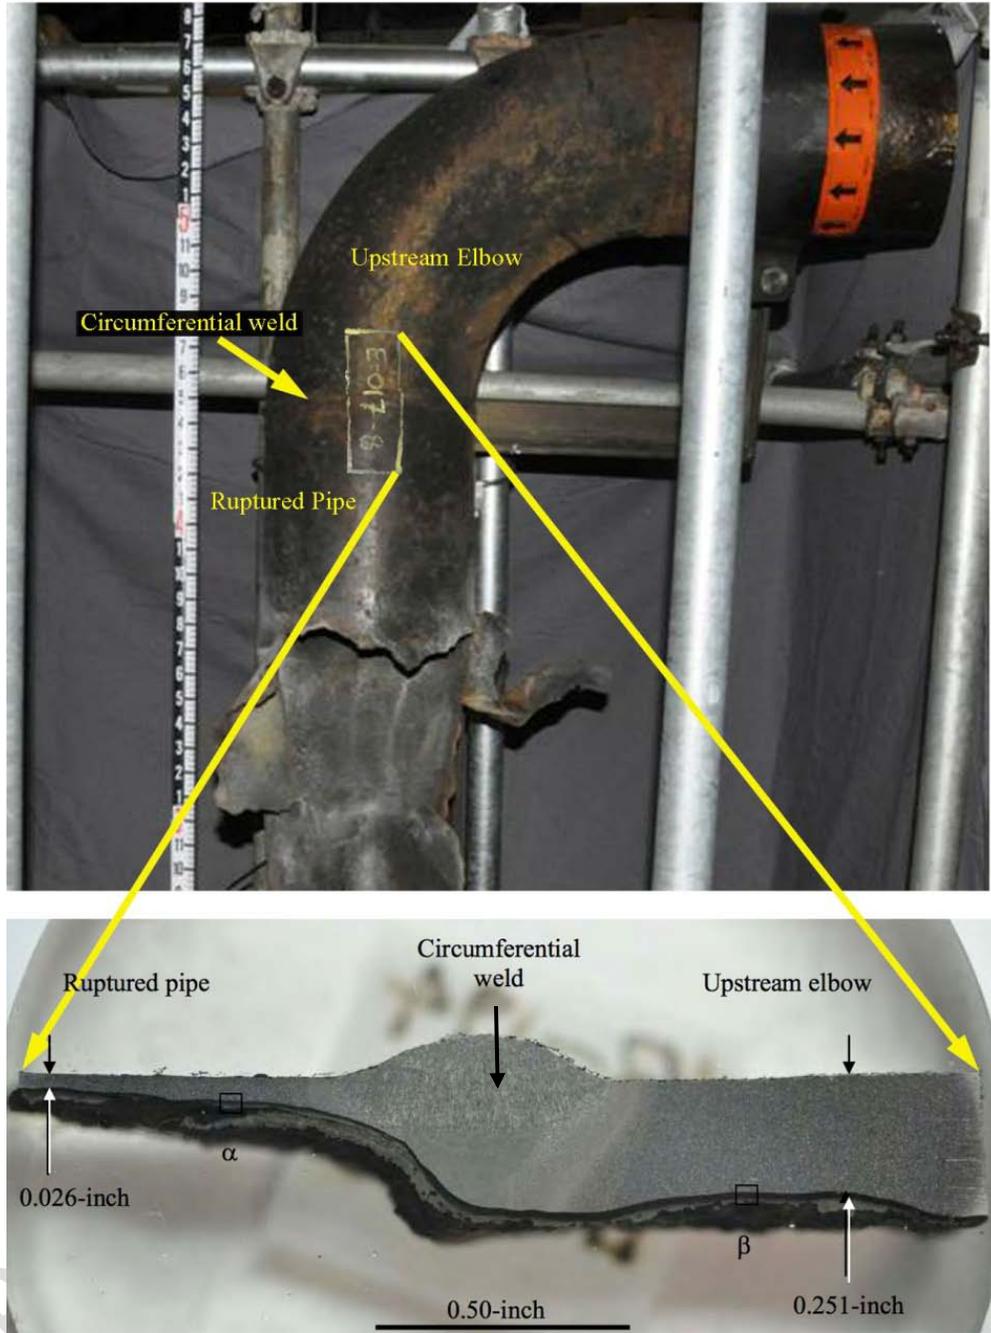
Figure 9. 4-sidecut piping sample (E-017-8) analyzed by Anamet Labs showing the relative thickness of low silicon piping on the left and the high silicon piping on the right. The ruptured pipe component (left) contained 0.01 % silicon and the upstream elbow component (right) contained 0.16 % silicon.¹⁹ The initial nominal thickness of this piping was 0.322-inch.

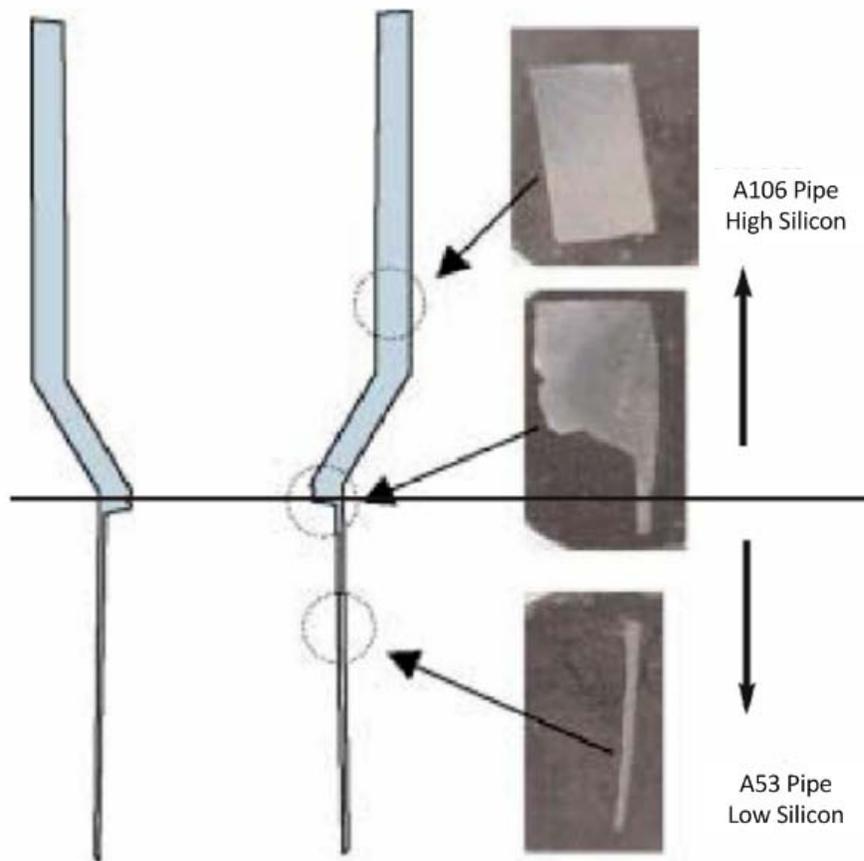
Figure 12. Schematic of failed piping from the Chevron Salt Lake Refinery. Similar to the Chevron Richmond Refinery incident, the failed piping contained low amounts of silicon and corroded significantly faster than adjacent piping components.

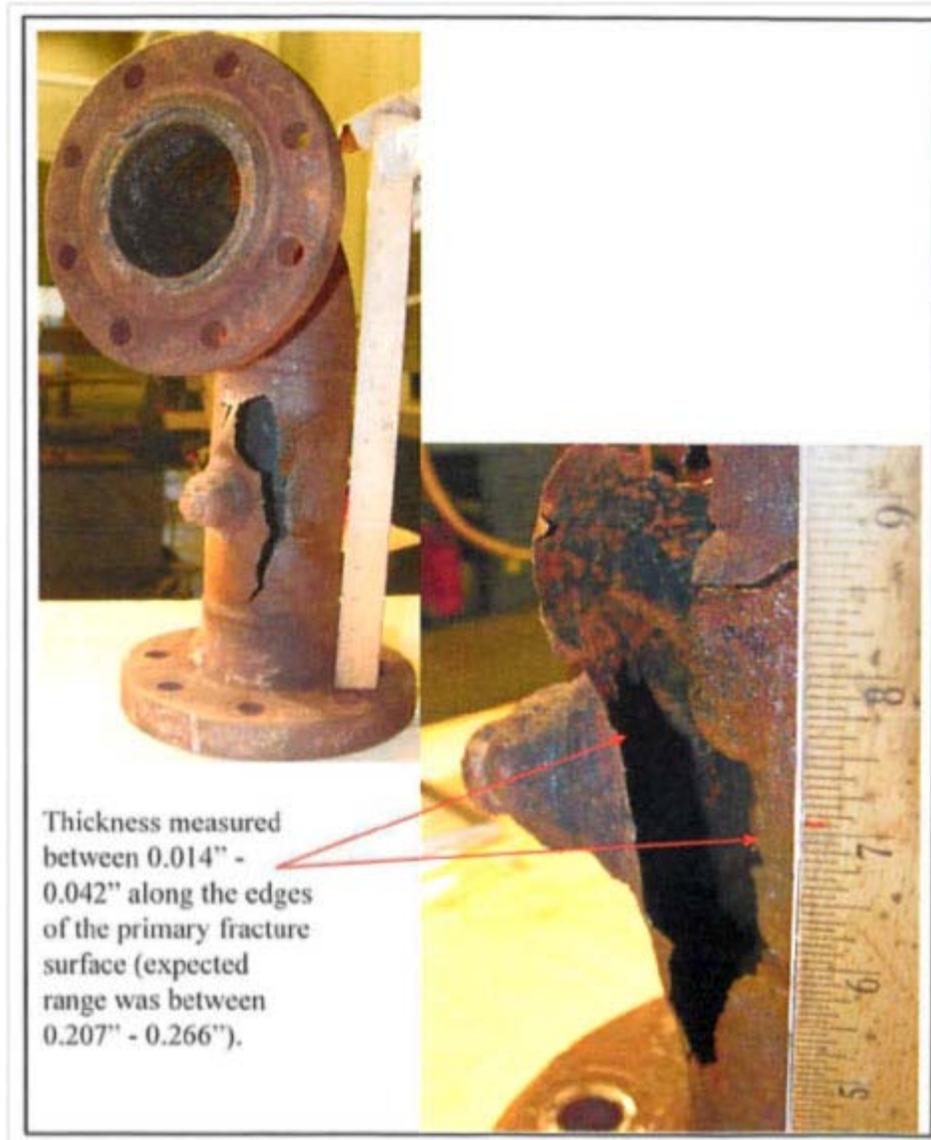
28. In January 2007, a failure due to sulfidation corrosion caused a serious fire in the Chevron Richmond Refinery crude unit resulting in a CWS Level 3 alert, initiating a shelter-in-place for the surrounding community. A carbon steel piping spool¹ failed catastrophically during operation (Figure 13). The carbon steel piping contained a low percentage of silicon (<0.005 wt. %). The process fluid ignited, injuring a nearby worker. Chevron informed Contra Costa County in a letter that the metallurgy had been upgraded following this incident as an inherently safer solution. However, the CSB learned that this upgrade was limited to only the immediate piping spool that failed. The inherently safer, more corrosion resistant metallurgy was not implemented more broadly in crude unit high temperature service as a result of this incident.

Figure 13. Failed piping component that resulted in the 2007 Richmond crude unit fire. This carbon steel piping was found to contain less than 0.005 percent silicon.

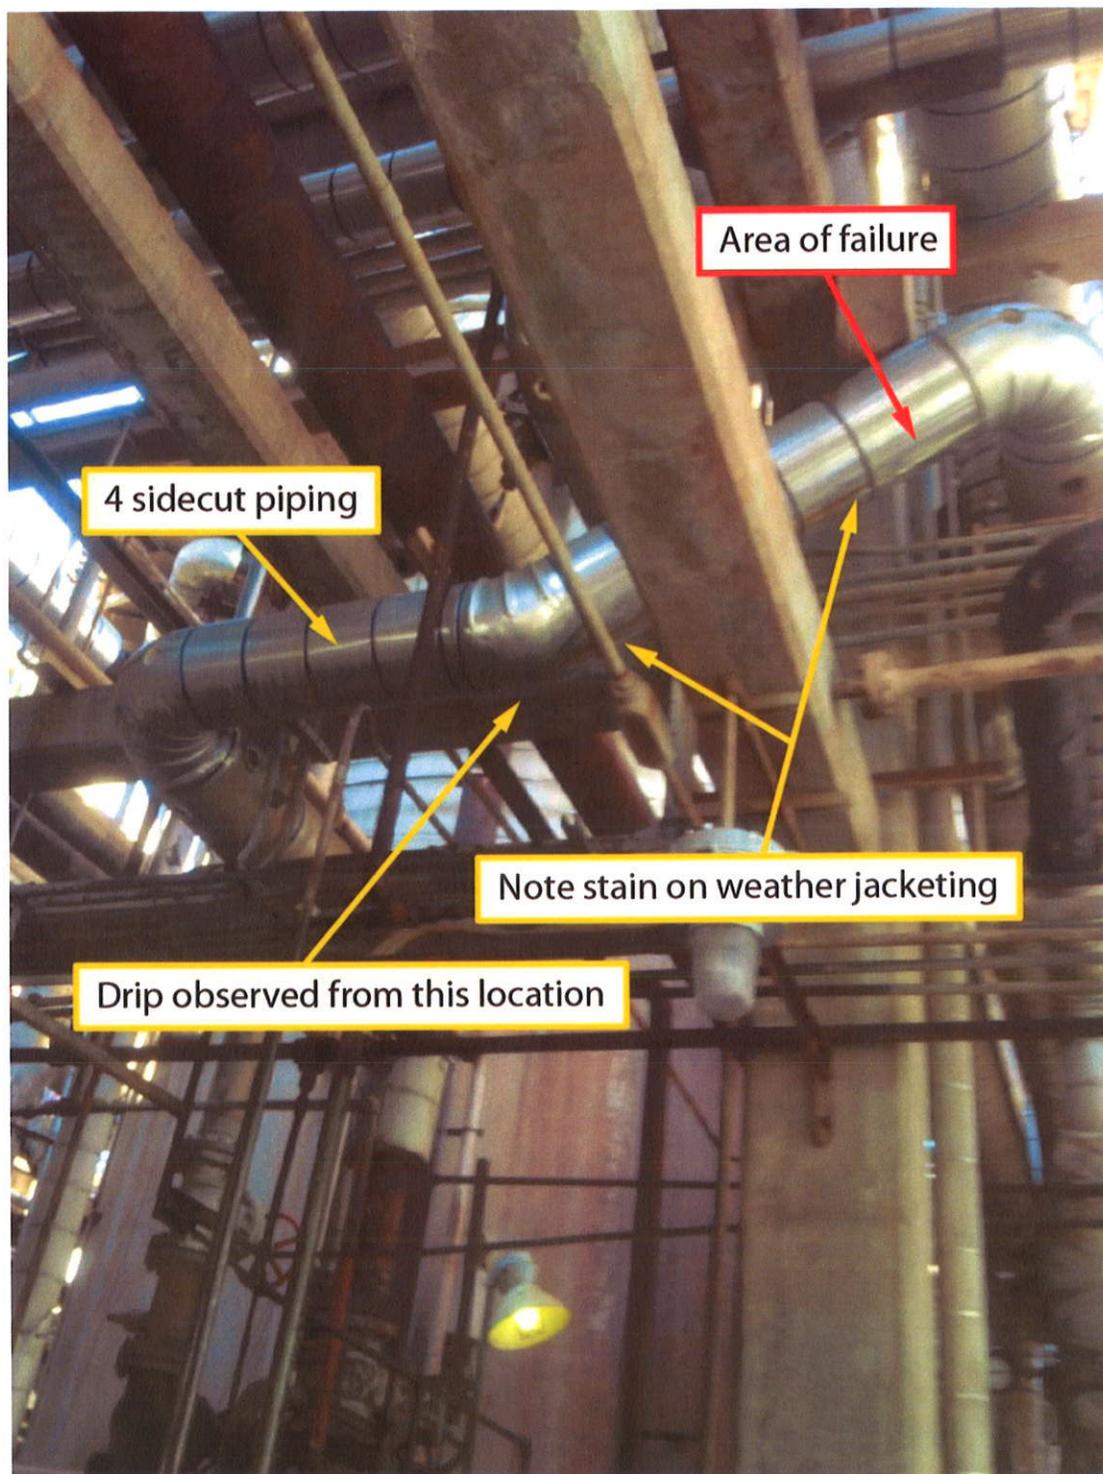
Figure 4. Photograph taken by STL2 during the initial response to the leak, but before the pipe rupture. The area where the rupture subsequently occurred (indicated by a red arrow) is approximately 16 feet from the ground.

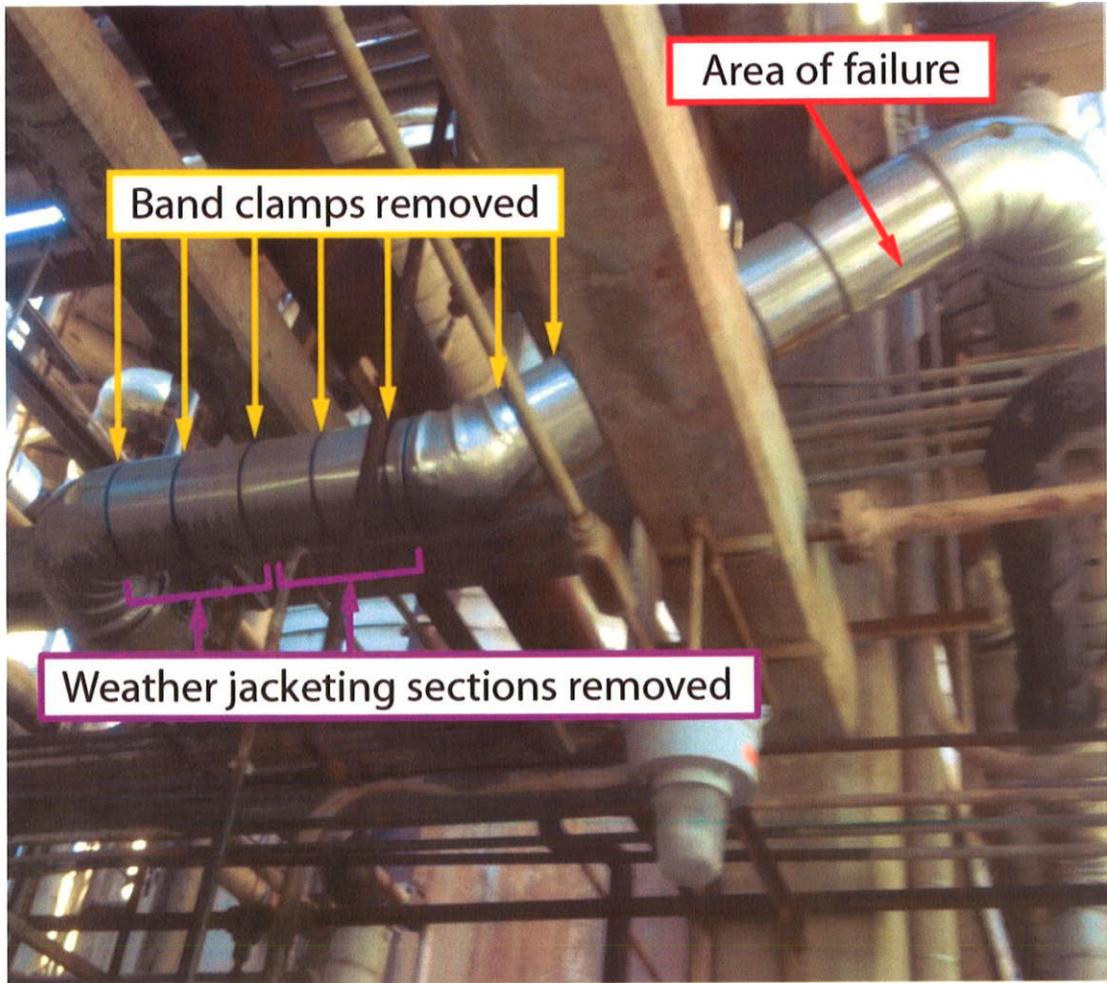
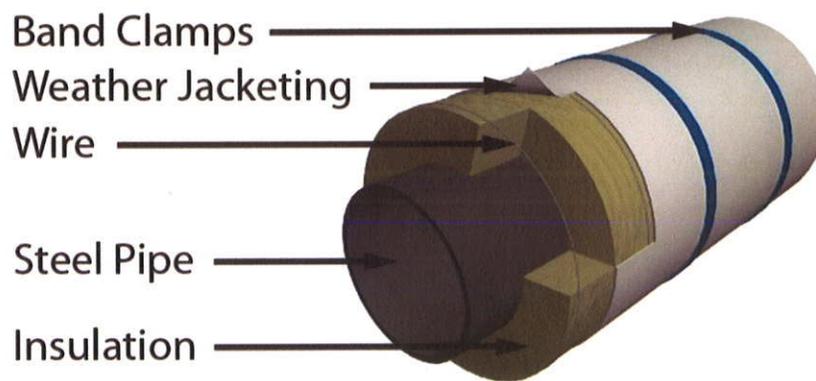
Figure 5. The steel pipe was encapsulated by insulation held in place by wire, which was covered by aluminum weather jacketing held in place with band clamps (bottom). The firefighters cut several band clamps (marked with yellow arrows) with pliers and removed two sections of the weather jacketing from the piping (marked with purple brackets).

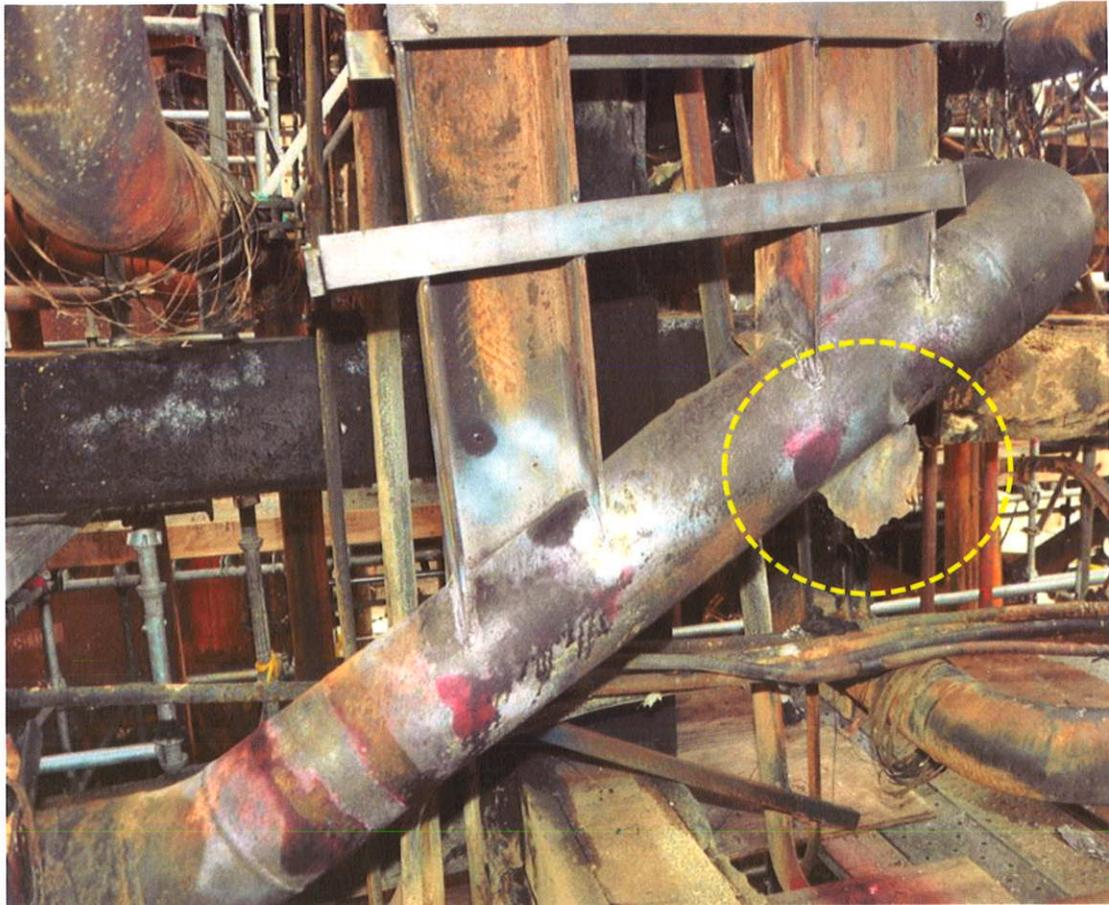
Figure 7. Photograph of the ruptured pipe component during inspection prior to removal. Area of the rupture is circled in yellow. (This photograph shows the same sloped portion of the pipe component shown in Figure 5.)

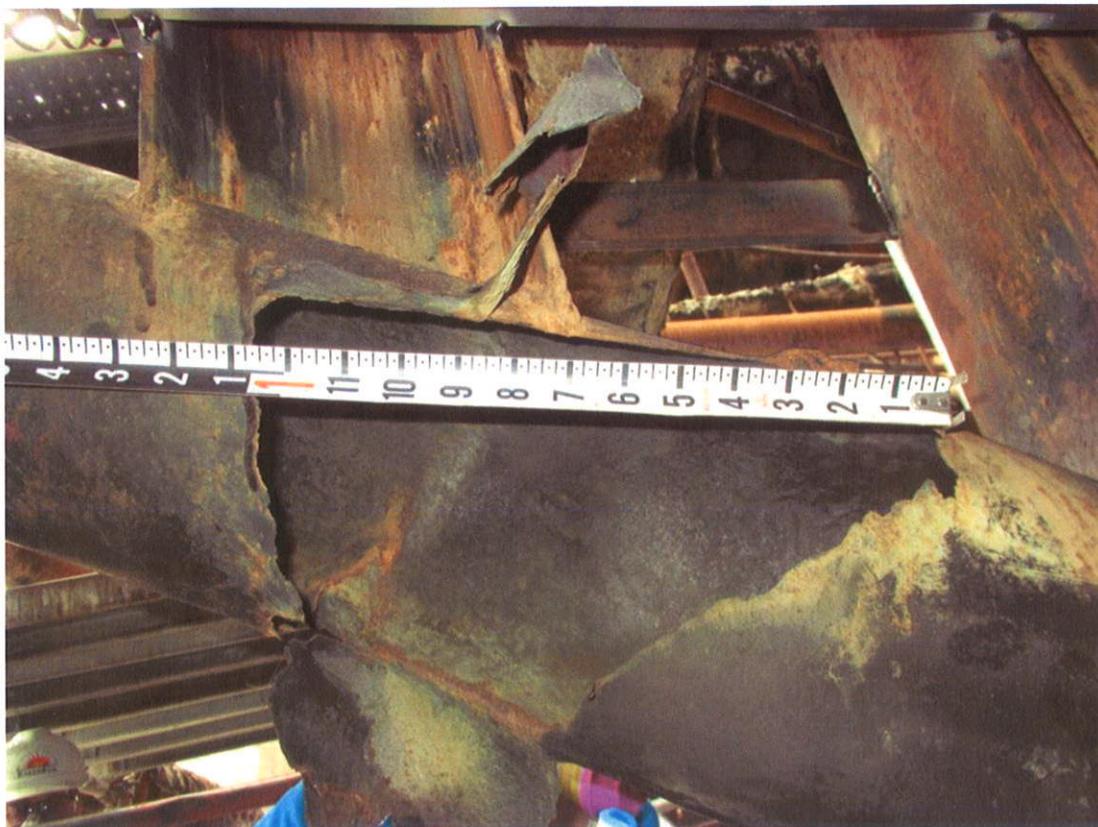
Figure 8. Close-up photograph of the ruptured pipe component taken during the inspection prior to removal.

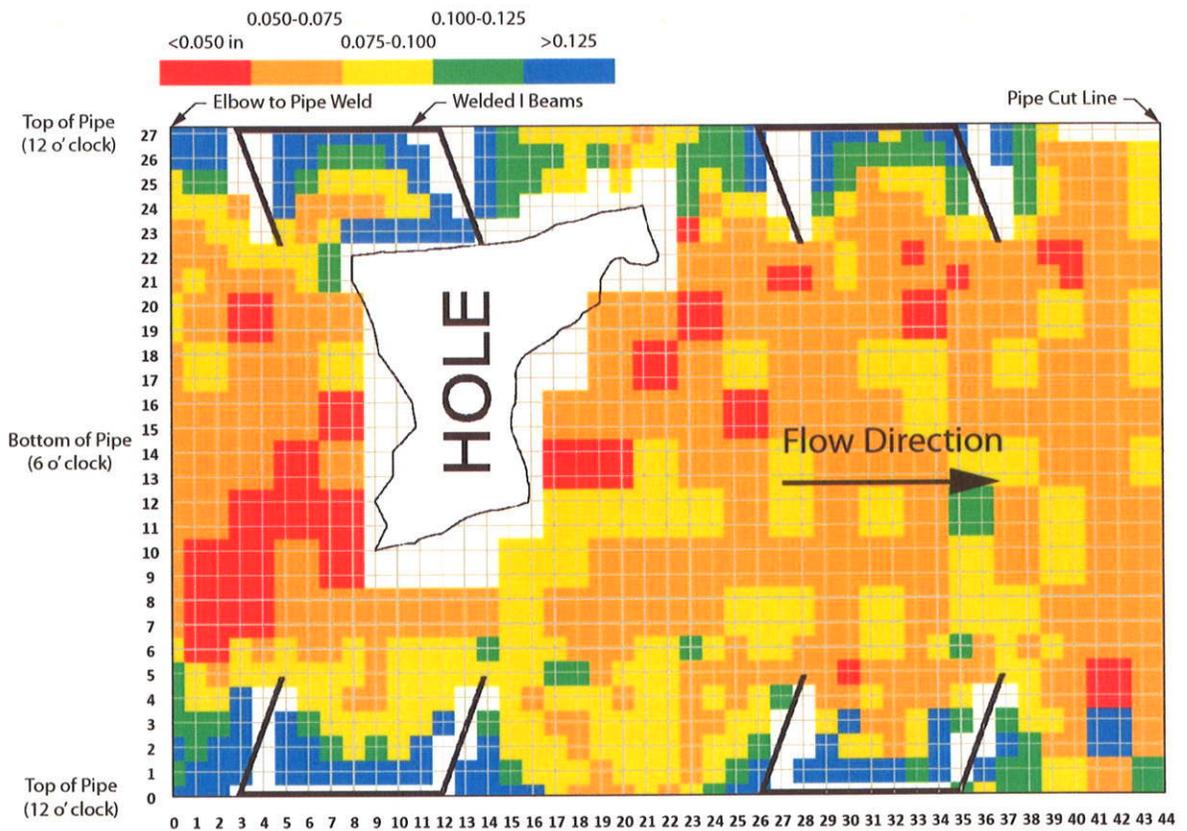
resulting in rupture. The corrosion pattern observed is considered “uniform thinning,” and is consistent with sulfidation corrosion.

Figure 9. Thickness measurement results from the ruptured pipe component. Virtually the entire 27-inch circumference and 44-inch length of the ruptured pipe component had thinned to less than 0.10 inches, consistent with sulfidation corrosion. The graphic represents the pipe as sliced longitudinally at the top of the pipe (12 o'clock) and rolled out flat. The areas in white could not be measured.

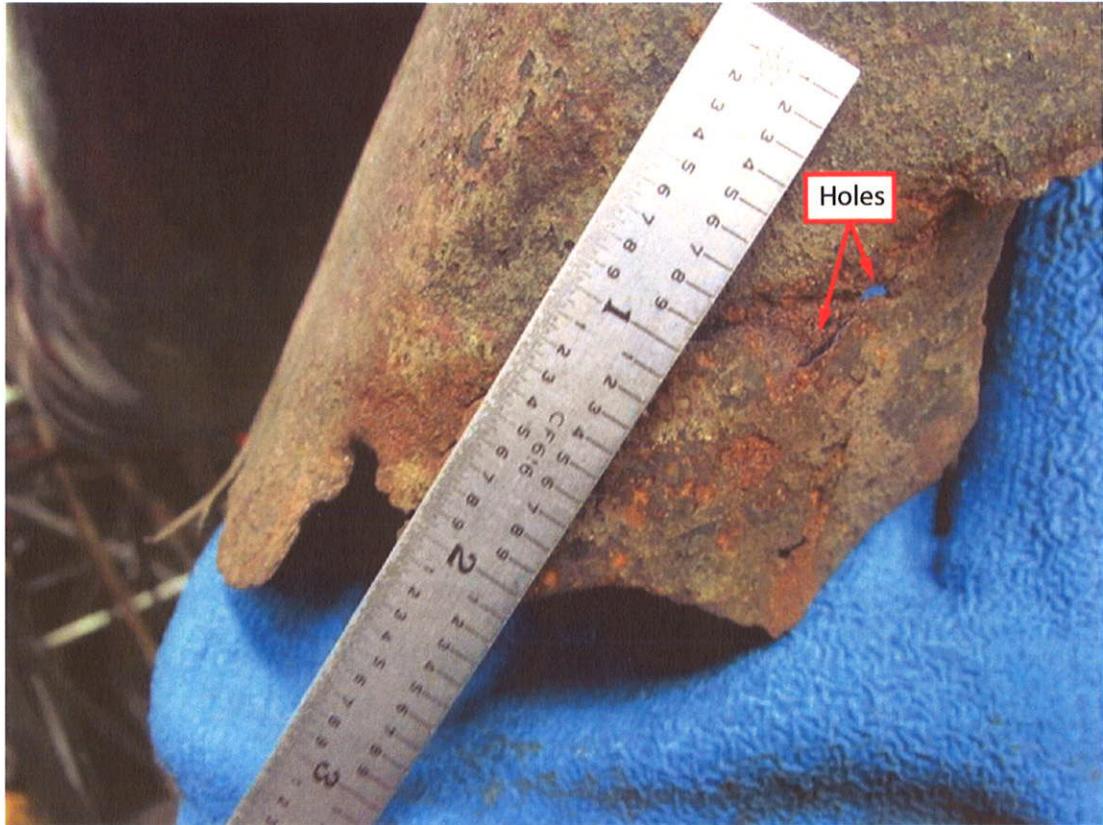
Figure 10. Photograph of one of the metal flaps associated with the 4SC rupture. Small perforations are visible in the flap.

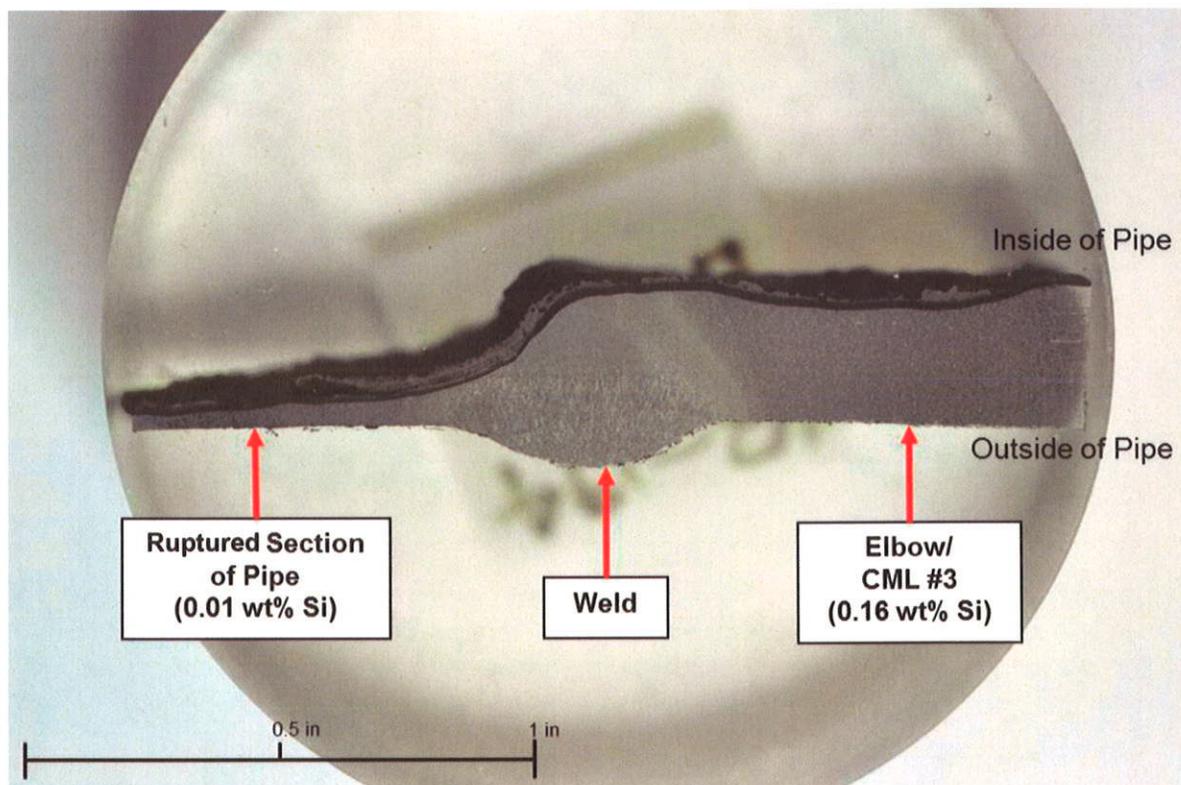
Figure 11 shows a cross section of the ruptured pipe, the adjacent elbow, and the weld between the two. Figure 12 shows the location where the sectioned sample was removed from the ruptured pipe. The ruptured component is clearly thinner than the adjacent elbow. The results of the chemical analysis indicate that the ruptured pipe component had a silicon content of approximately 0.01 wt% and the adjacent elbow had a silicon content of 0.16 wt%. As noted earlier, carbon steel with less than 0.10 wt% silicon content can exhibit higher sulfidation corrosion rates than carbon steel with higher levels of silicon. The impact of these differing corrosion rates is discussed in Section 4.

Figure 11. Cross section through the weld of the subject pipe showing thicknesses of the ruptured section (left) and the adjacent elbow, where CML #3 is located.

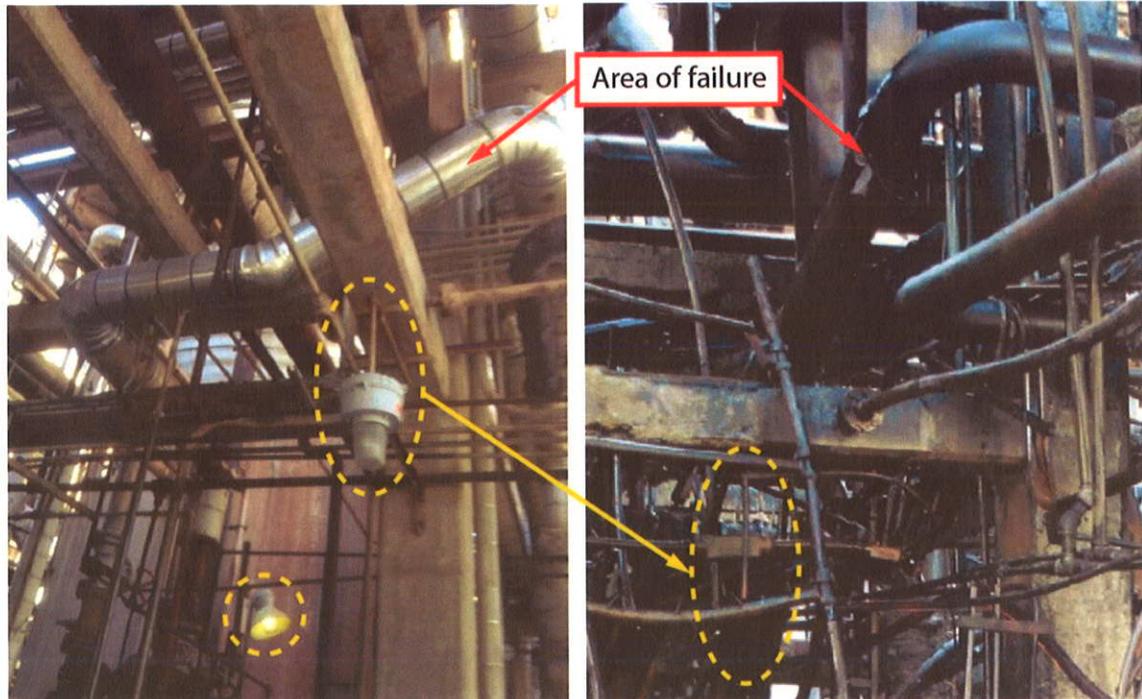
a photocell on the north side of the MCC located approximately 280 feet west of the failed pipe. After the Incident, the light fixture was missing, but the electrical conduit remained, as shown in Figure 15.

Figure 15. Lighting fixtures at the time the leak was discovered (photograph taken during the initial response) (left); and missing light after the Incident (right).

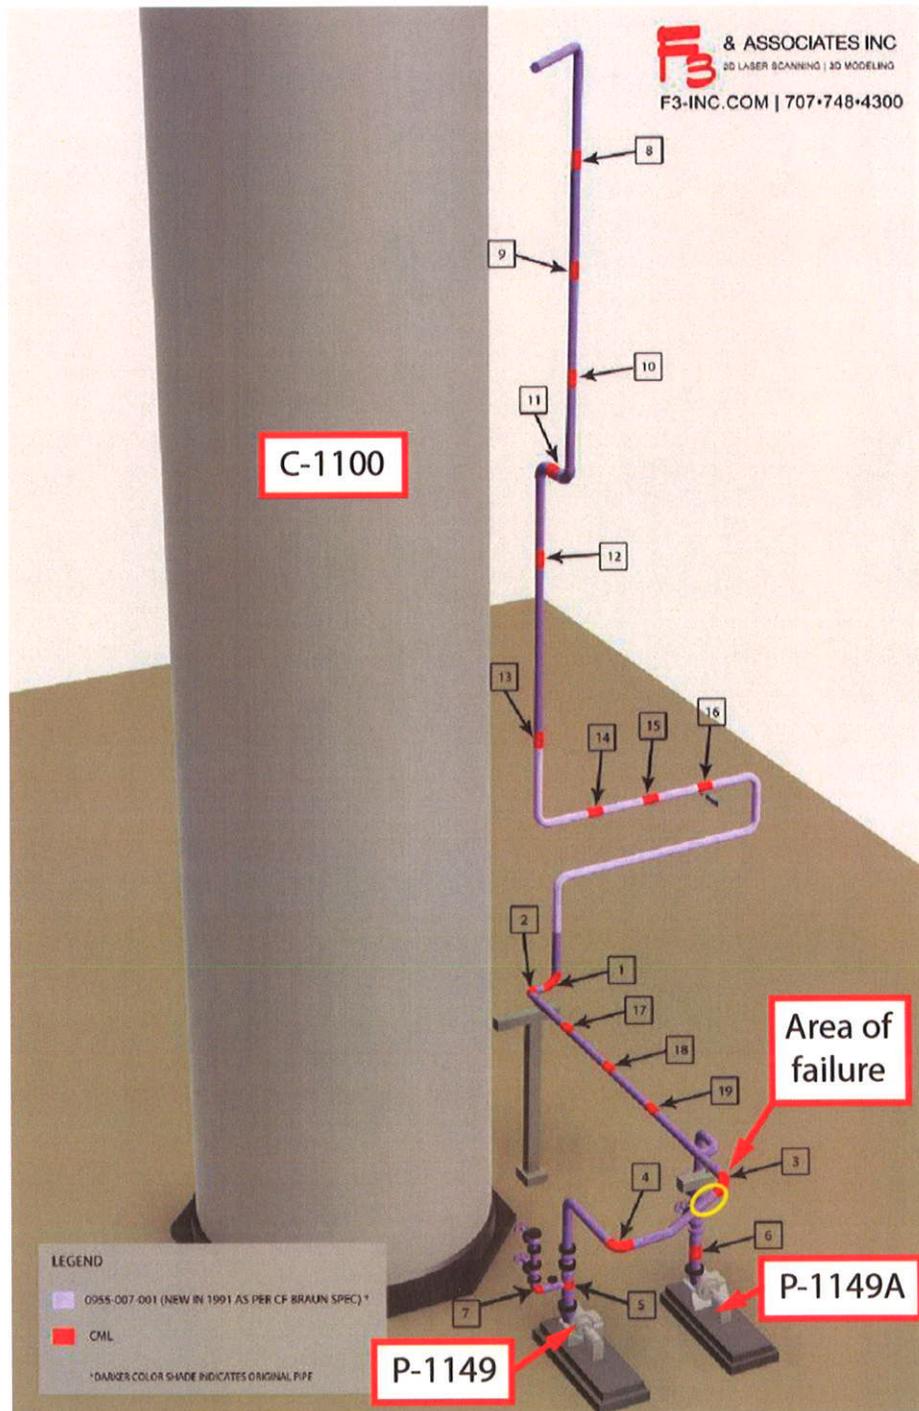
The 4SC inspection plan was to periodically measure thickness at CMLs considered representative of the piping circuit between the C-1100 and P-1149/A (see Appendix 2). The nearest CML to the failed pipe component was CML #3, which is located at the elbow directly upstream of the failure location, as shown in Figure 16.

Figure 16. Three-dimensional model of the 8-inch 4SC line showing the CML locations. CMLs 1-6 were original, CML 7 was added in 2002, and CMLs 8-19 were added in 2011.

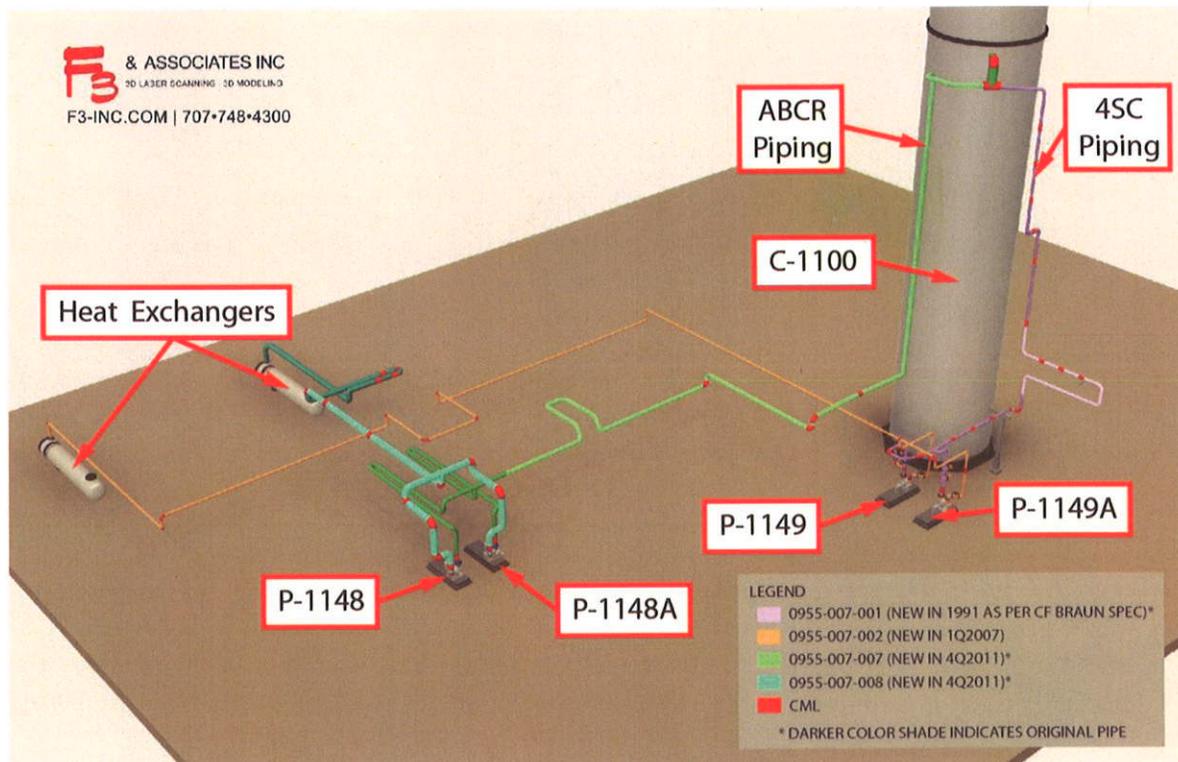
CML inspections of the ABCR piping showed wall thicknesses as low as 0.10 inches, indicating that the pipe could be too close to minimum thickness before the next Turnaround, scheduled for 2016, to leave it in service. Hence, portions of the ABCR piping were replaced with carbon steel piping during the 2011 Turnaround (see Figure 17).

Figure 17. Three-dimensional model showing the locations of the CMLs in the 4SC and the ABCR piping within the 4CU.
