Improving Public and Worker Safety at Oil Refineries

**Draft Report of the
Interagency Working Group on Refinery Safety
Governor Jerry Brown**

July 2013

CHEVRON RICHMOND REFINERY FIRE

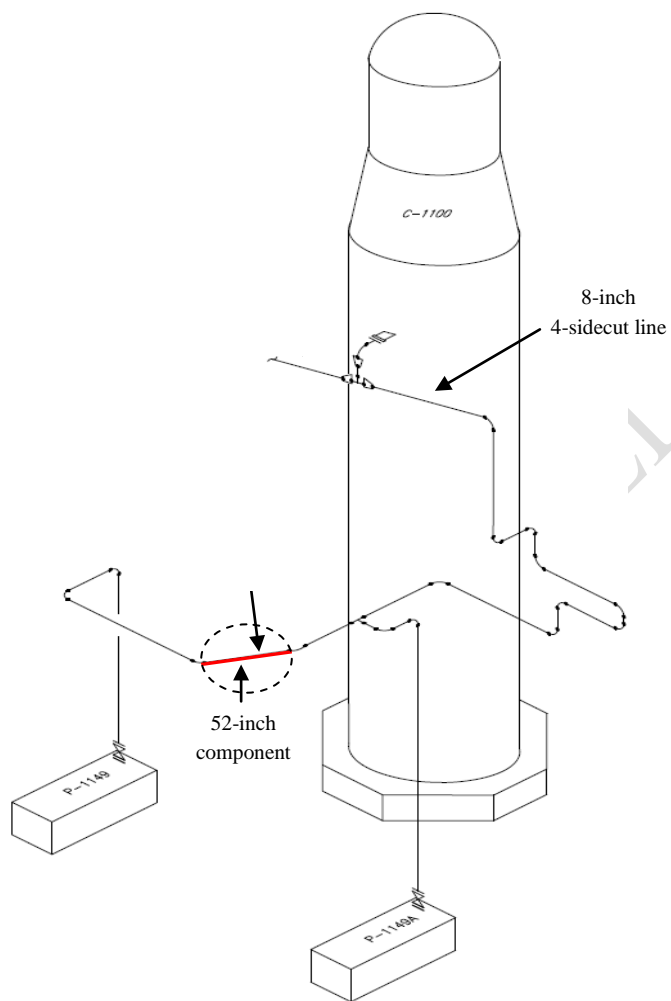
Figure 6. 4-sidecut line configuration and rupture location

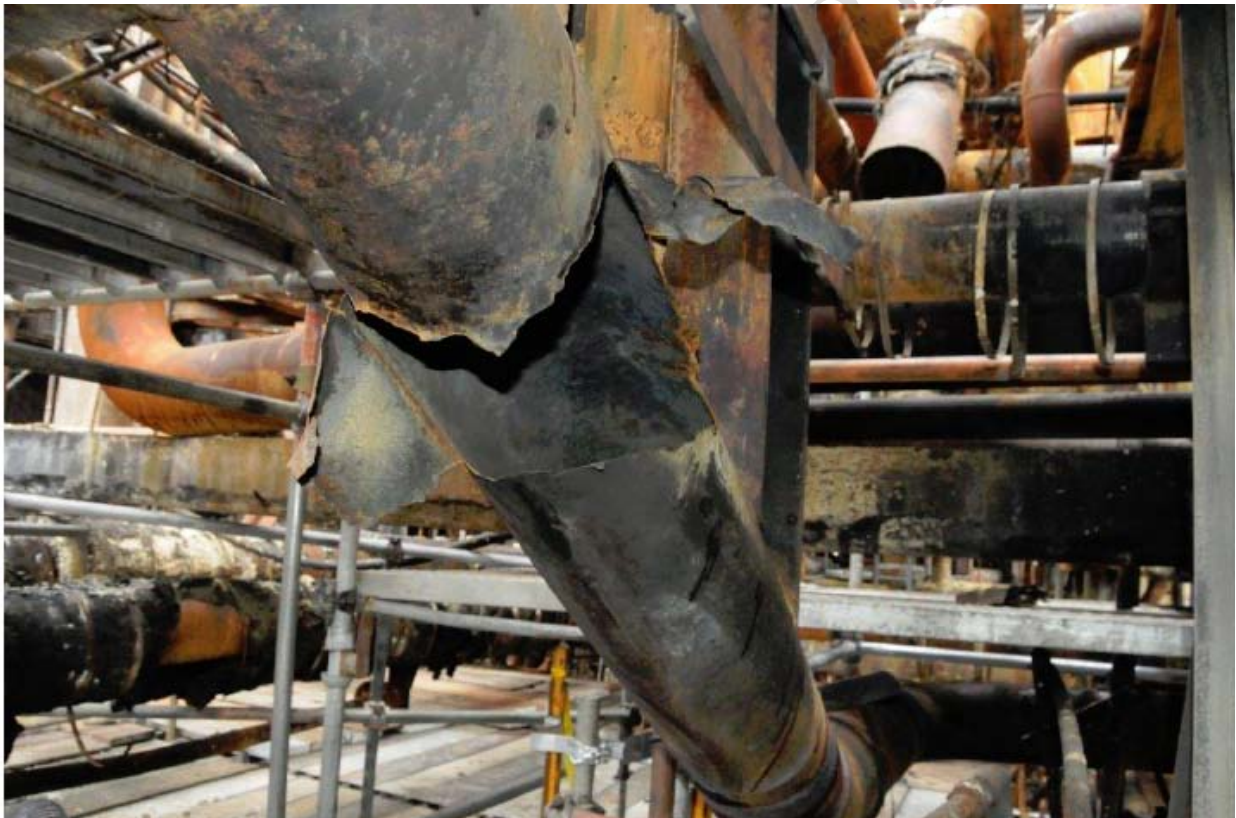
4. The CSB commissioned Anamet, Inc., a materials engineering and laboratory testing company, to conduct testing of the 4-sidecut pipe, including the failed 52-inch component. The testing concluded that the rupture was due to pipe wall thinning caused by sulfidation corrosion,³ which is discussed below.
5. Anamet's metallurgical analysis found that the 52-inch component where the rupture occurred had experienced extreme thinning; the average wall thickness near the rupture location was approximately 40 percent thinner than a dimeⁱ (the thinnest American coin). Between 1976 and 2012, the 52-inch piping component had lost, on average, 90 percent of its original wall thickness in the area near the rupture. The piping had an initial nominal wall thickness of 0.322-inchⁱⁱ when it was installed in 1976.

Figure 7. Photo of rupture on 4-sidecut 52-inch component

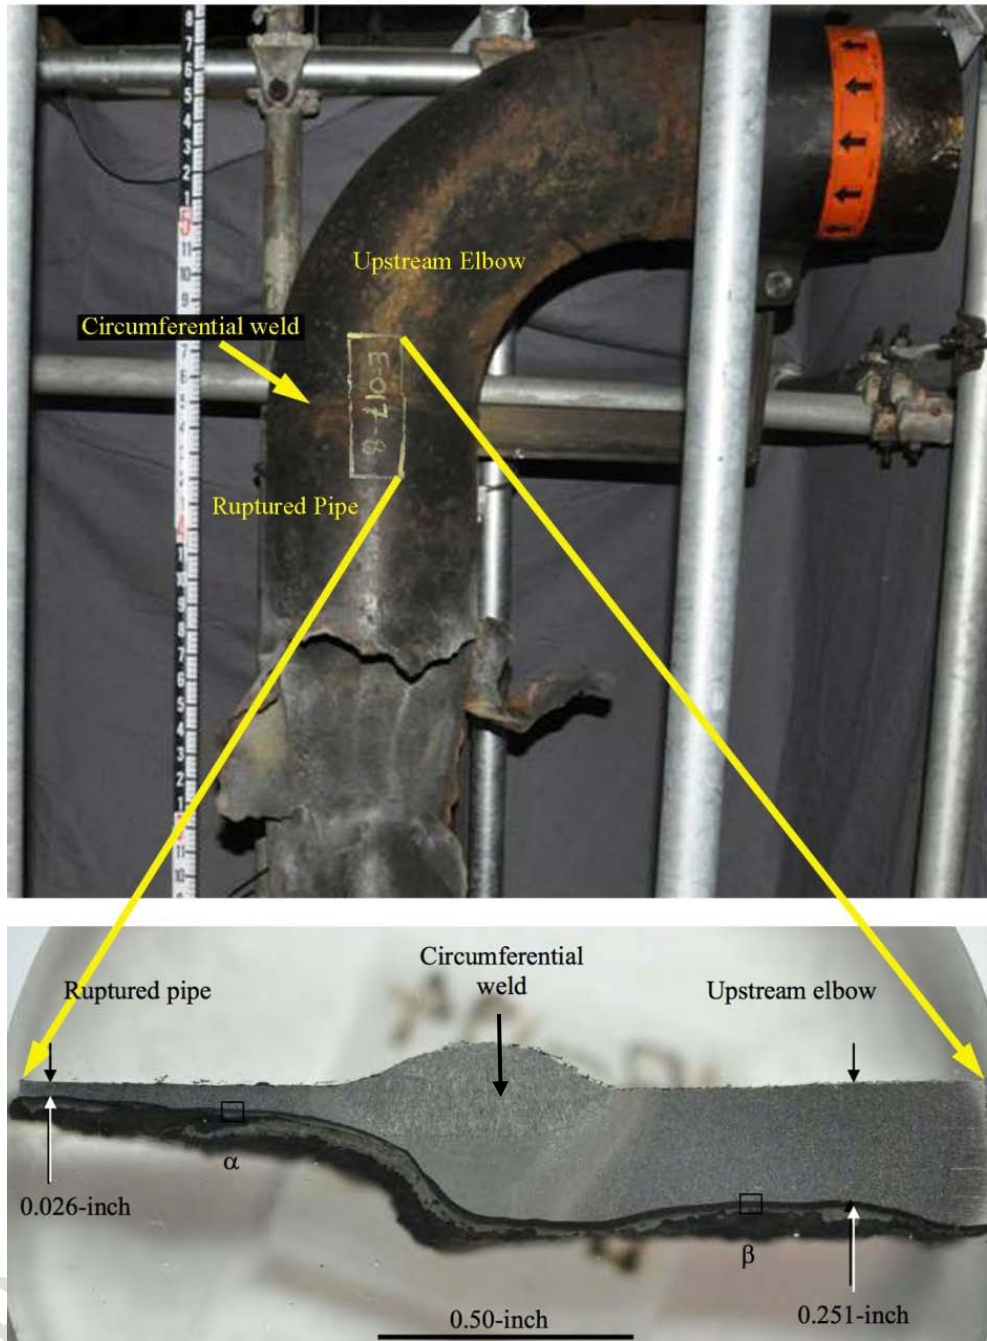
Figure 9. 4-sidecut piping sample (E-017-8) analyzed by Anamet Labs showing the relative thickness of low silicon piping on the left and the high silicon piping on the right. The ruptured pipe component (left) contained 0.01 % silicon and the upstream elbow component (right) contained 0.16 % silicon.¹⁹ The initial nominal thickness of this piping was 0.322-inch.

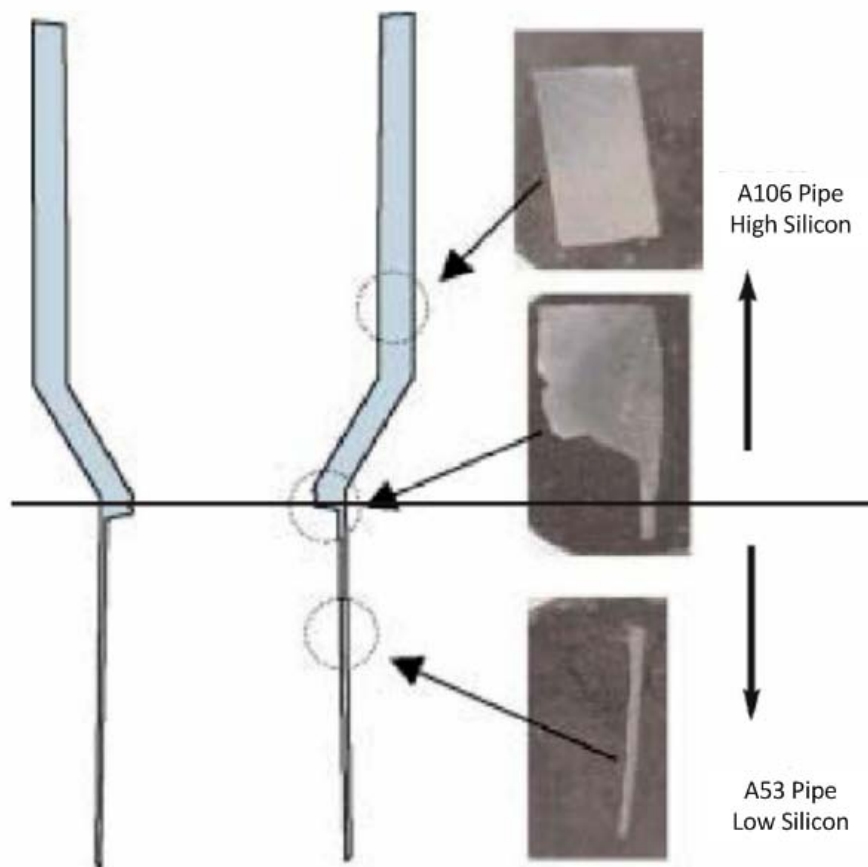
Figure 12. Schematic of failed piping from the Chevron Salt Lake Refinery. Similar to the Chevron Richmond Refinery incident, the failed piping contained low amounts of silicon and corroded significantly faster than adjacent piping components.

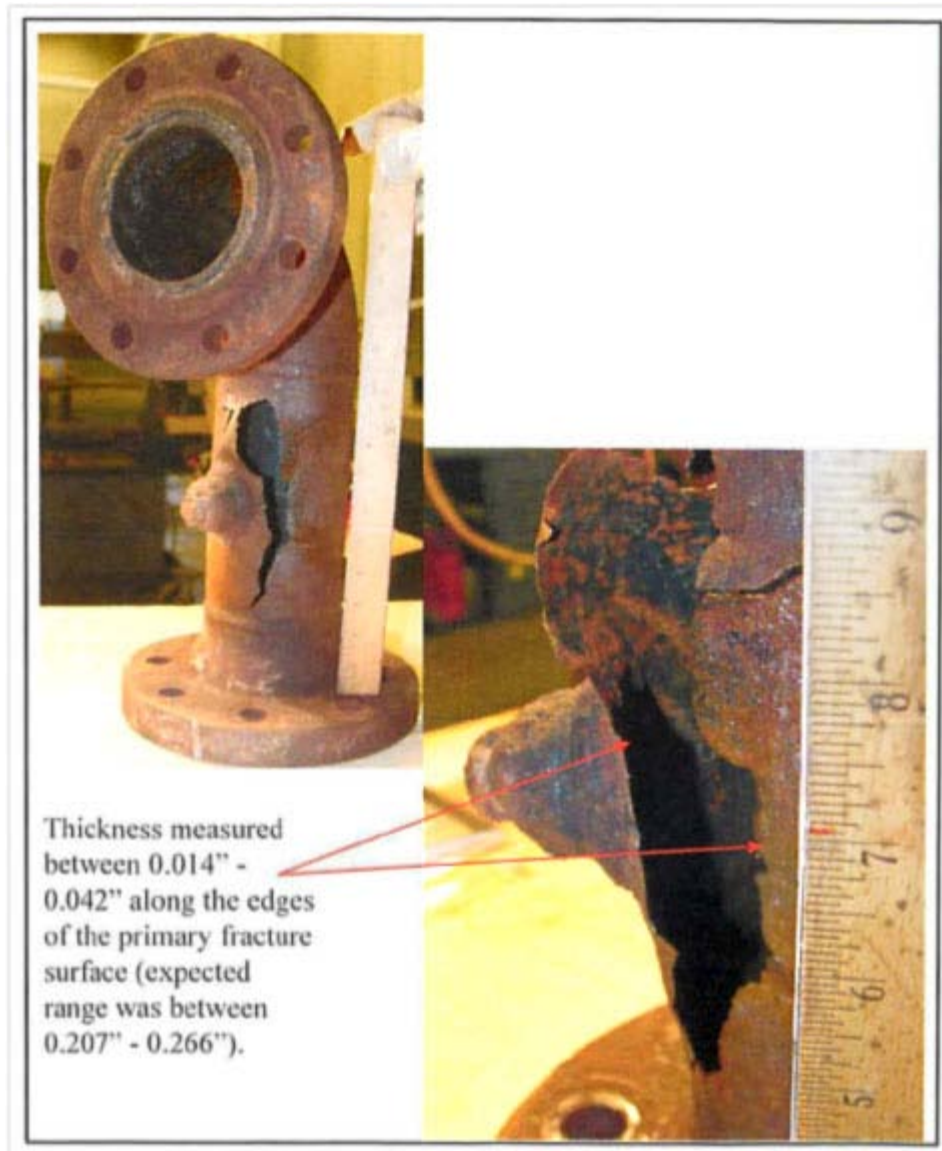
28. In January 2007, a failure due to sulfidation corrosion caused a serious fire in the Chevron Richmond Refinery crude unit resulting in a CWS Level 3 alert, initiating a shelter-in-place for the surrounding community. A carbon steel piping spoolⁱ failed catastrophically during operation (Figure 13). The carbon steel piping contained a low percentage of silicon (<0.005 wt. %). The process fluid ignited, injuring a nearby worker. Chevron informed Contra Costa County in a letter that the metallurgy had been upgraded following this incident as an inherently safer solution. However, the CSB learned that this upgrade was limited to only the immediate piping spool that failed. The inherently safer, more corrosion resistant metallurgy was not implemented more broadly in crude unit high temperature service as a result of this incident.

Figure 13. Failed piping component that resulted in the 2007 Richmond crude unit fire. This carbon steel piping was found to contain less than 0.005 percent silicon.

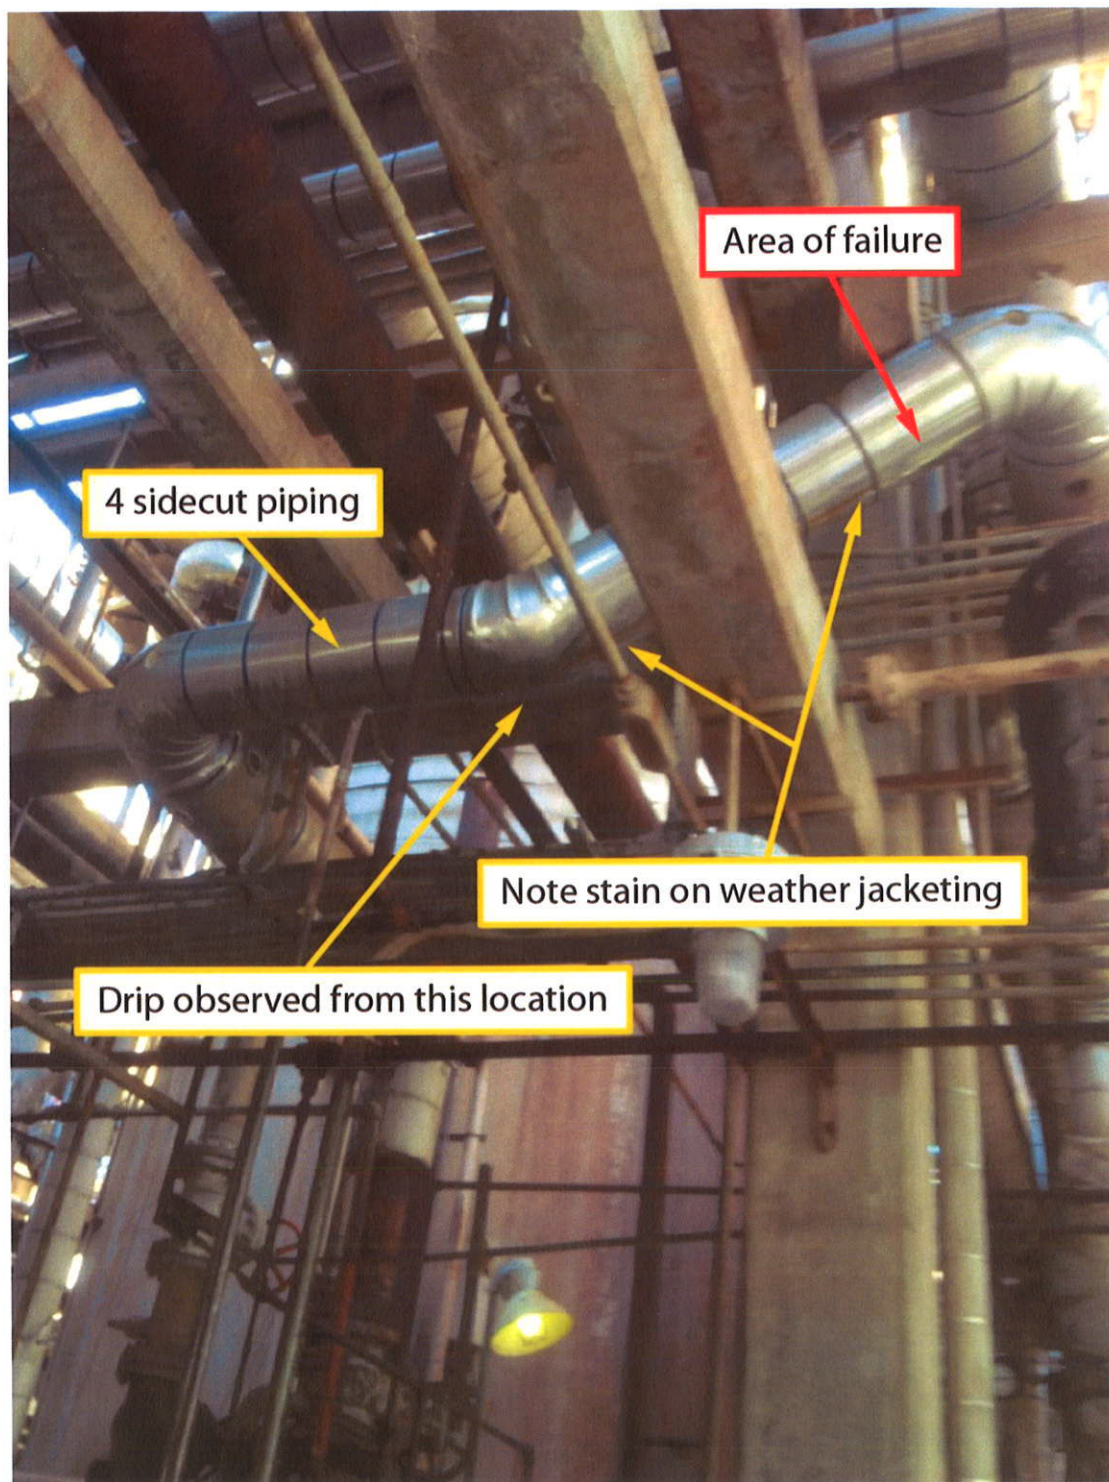
Figure 4. Photograph taken by STL2 during the initial response to the leak, but before the pipe rupture. The area where the rupture subsequently occurred (indicated by a red arrow) is approximately 16 feet from the ground.

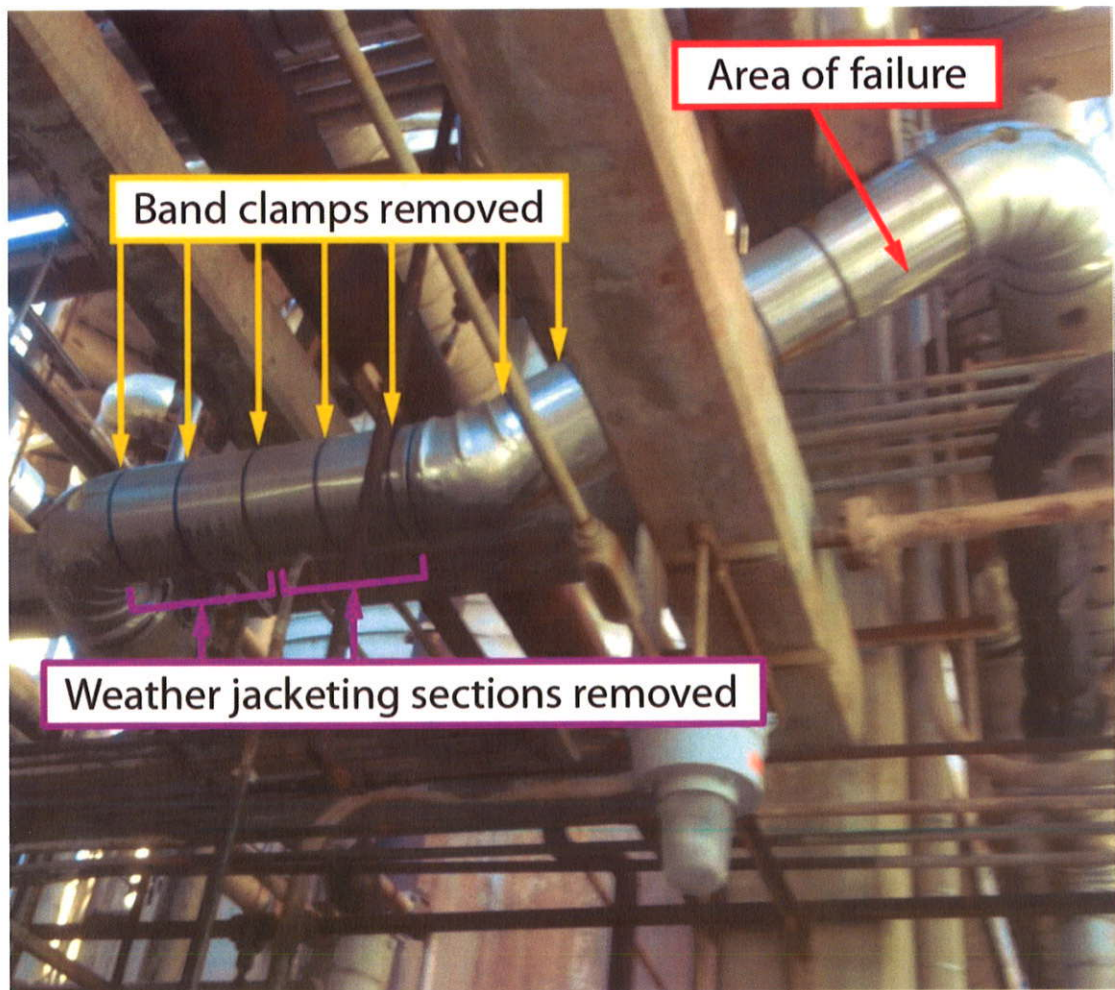
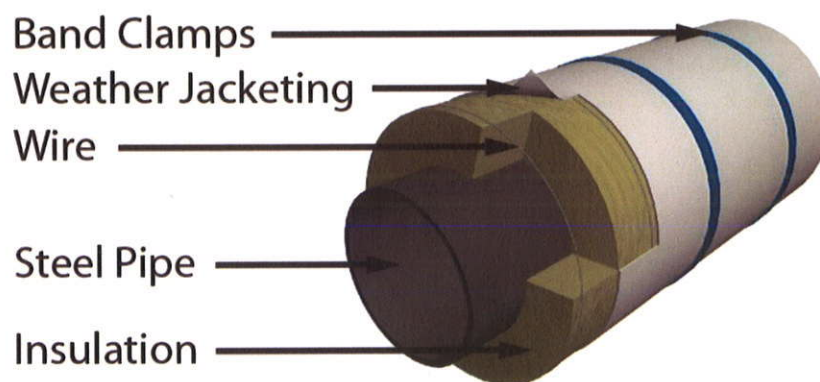
Figure 5. The steel pipe was encapsulated by insulation held in place by wire, which was covered by aluminum weather jacketing held in place with band clamps (bottom). The firefighters cut several band clamps (marked with yellow arrows) with pliers and removed two sections of the weather jacketing from the piping (marked with purple brackets).

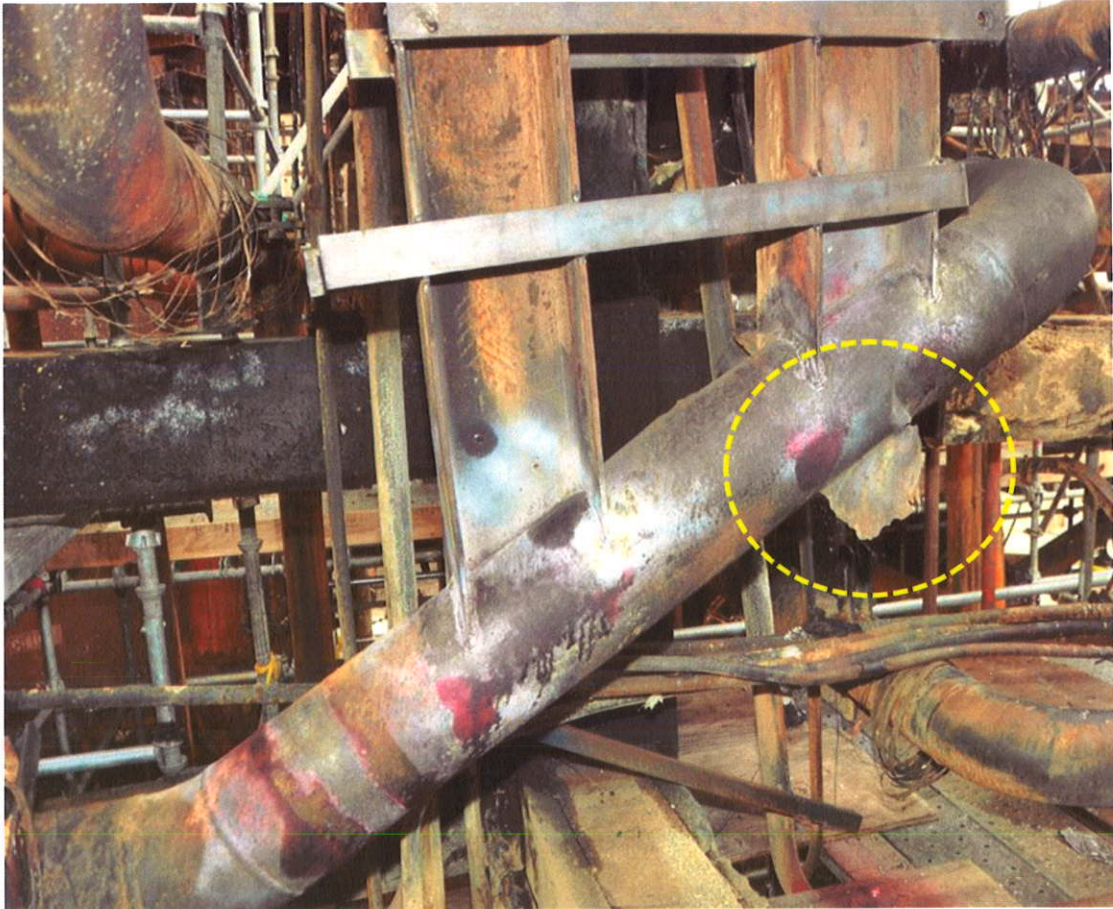
The ruptured pipe is shown in Figure 7 and Figure 8.

Figure 7. Photograph of the ruptured pipe component during inspection prior to removal. Area of the rupture is circled in yellow. (This photograph shows the same sloped portion of the pipe component shown in Figure 5.)

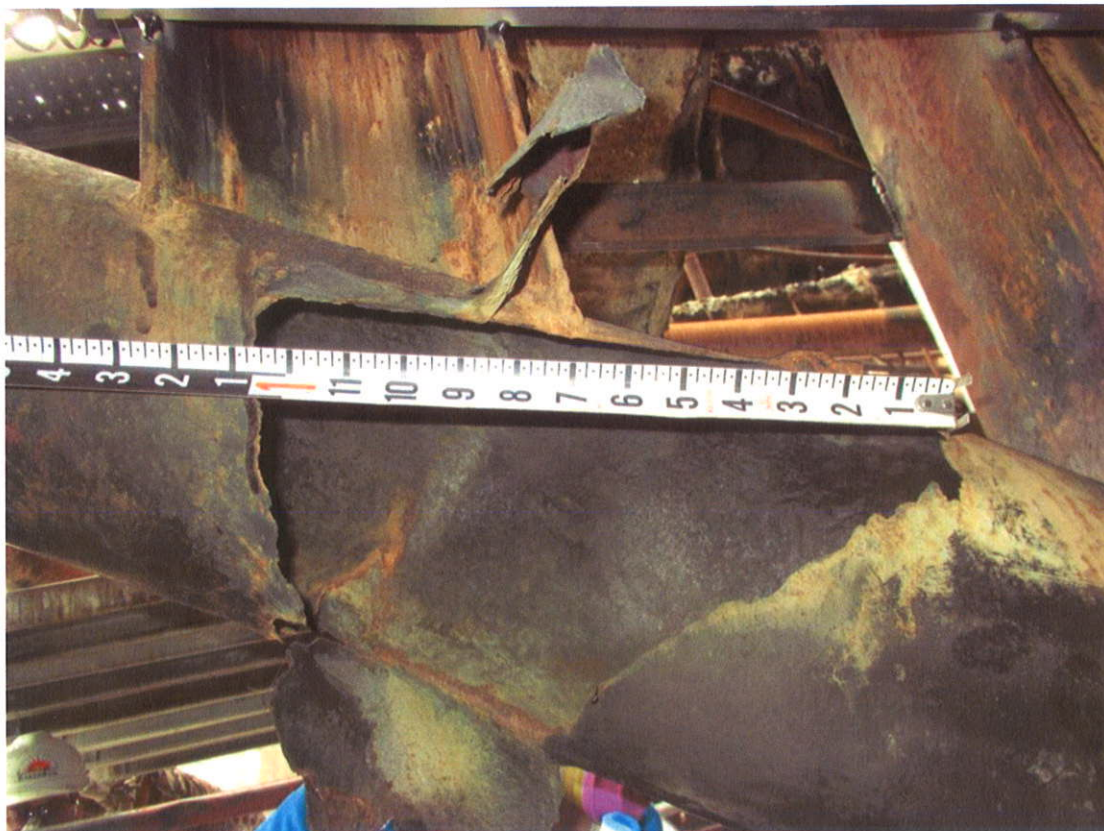
Figure 8. Close-up photograph of the ruptured pipe component taken during the inspection prior to removal.

resulting in rupture. The corrosion pattern observed is considered “uniform thinning,” and is consistent with sulfidation corrosion.

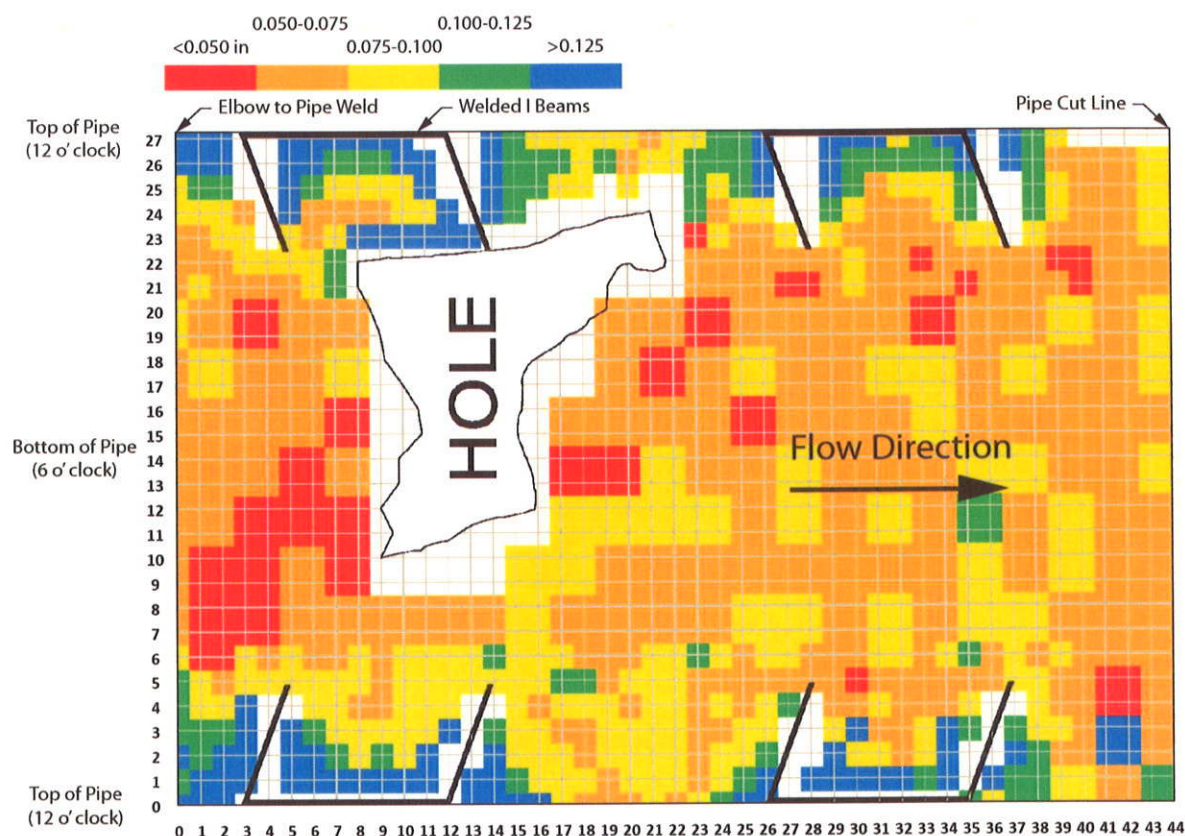
Figure 9. Thickness measurement results from the ruptured pipe component. Virtually the entire 27-inch circumference and 44-inch length of the ruptured pipe component had thinned to less than 0.10 inches, consistent with sulfidation corrosion. The graphic represents the pipe as sliced longitudinally at the top of the pipe (12 o'clock) and rolled out flat. The areas in white could not be measured.

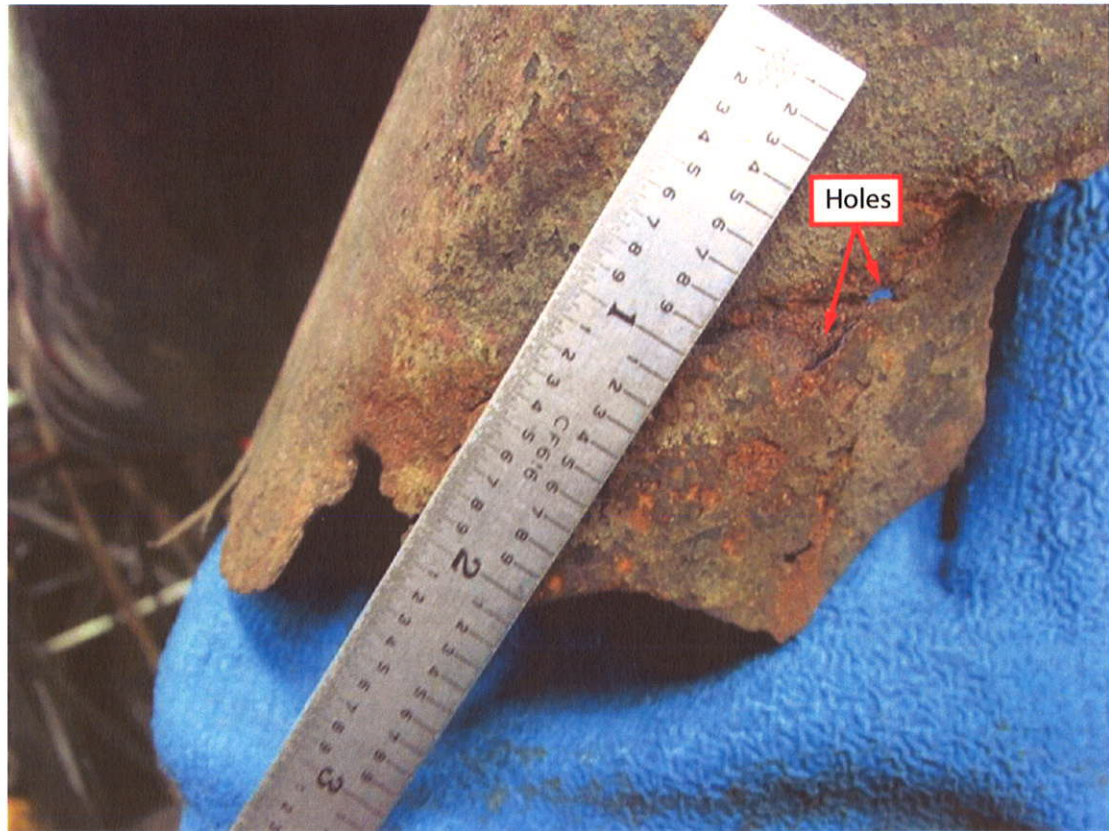
Figure 10. Photograph of one of the metal flaps associated with the 4SC rupture. Small perforations are visible in the flap.

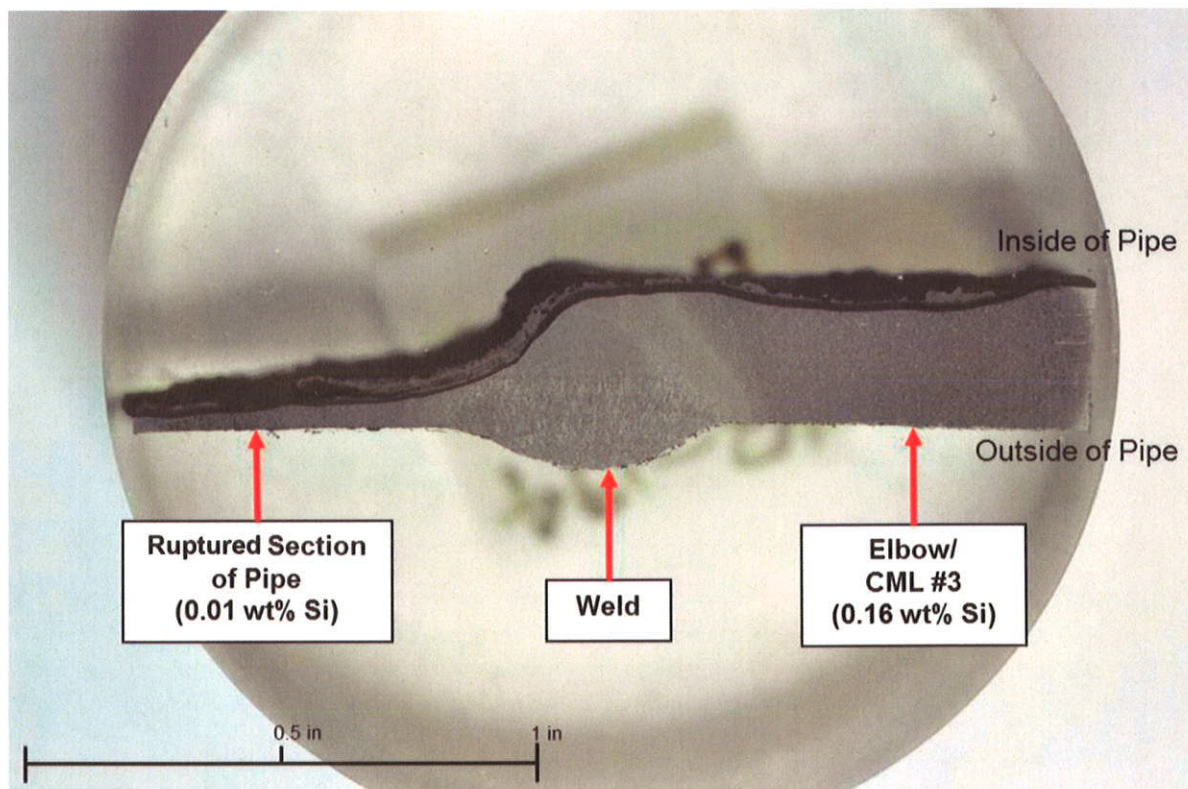
Figure 11 shows a cross section of the ruptured pipe, the adjacent elbow, and the weld between the two. Figure 12 shows the location where the sectioned sample was removed from the ruptured pipe. The ruptured component is clearly thinner than the adjacent elbow. The results of the chemical analysis indicate that the ruptured pipe component had a silicon content of approximately 0.01 wt% and the adjacent elbow had a silicon content of 0.16 wt%. As noted earlier, carbon steel with less than 0.10 wt% silicon content can exhibit higher sulfidation corrosion rates than carbon steel with higher levels of silicon. The impact of these differing corrosion rates is discussed in Section 4.

Figure 11. Cross section through the weld of the subject pipe showing thicknesses of the ruptured section (left) and the adjacent elbow, where CML #3 is located.

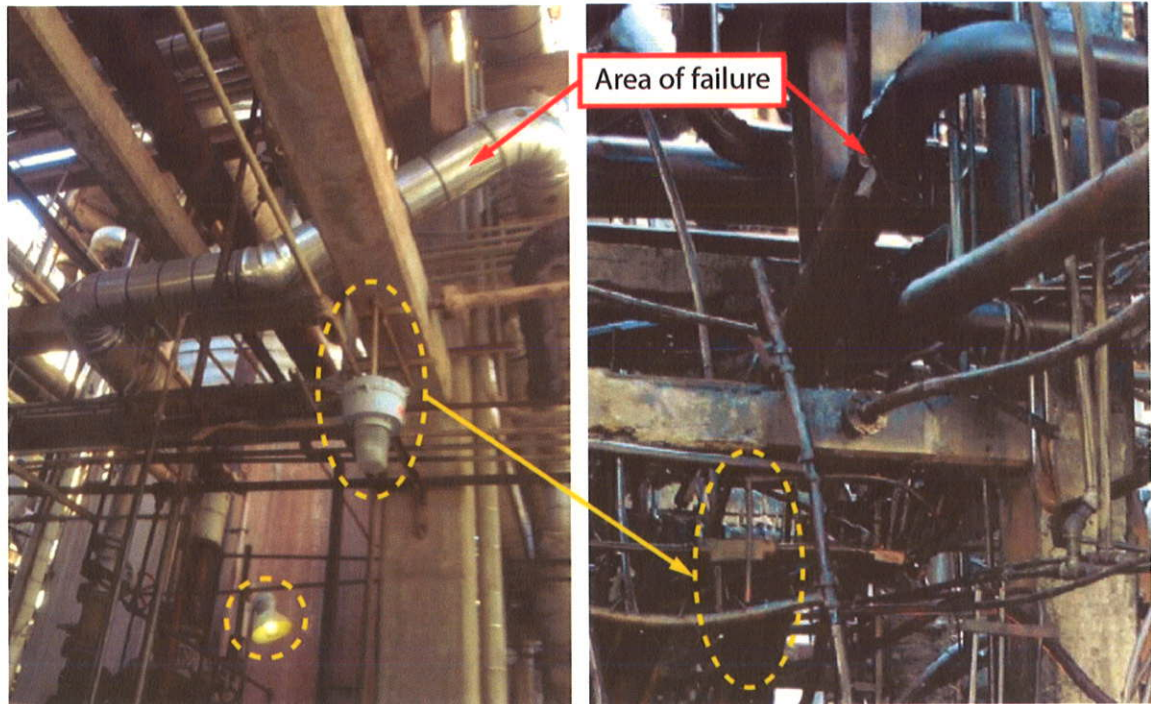
a photocell on the north side of the MCC located approximately 280 feet west of the failed pipe. After the Incident, the light fixture was missing, but the electrical conduit remained, as shown in Figure 15.

Figure 15. Lighting fixtures at the time the leak was discovered (photograph taken during the initial response) (left); and missing light after the Incident (right).

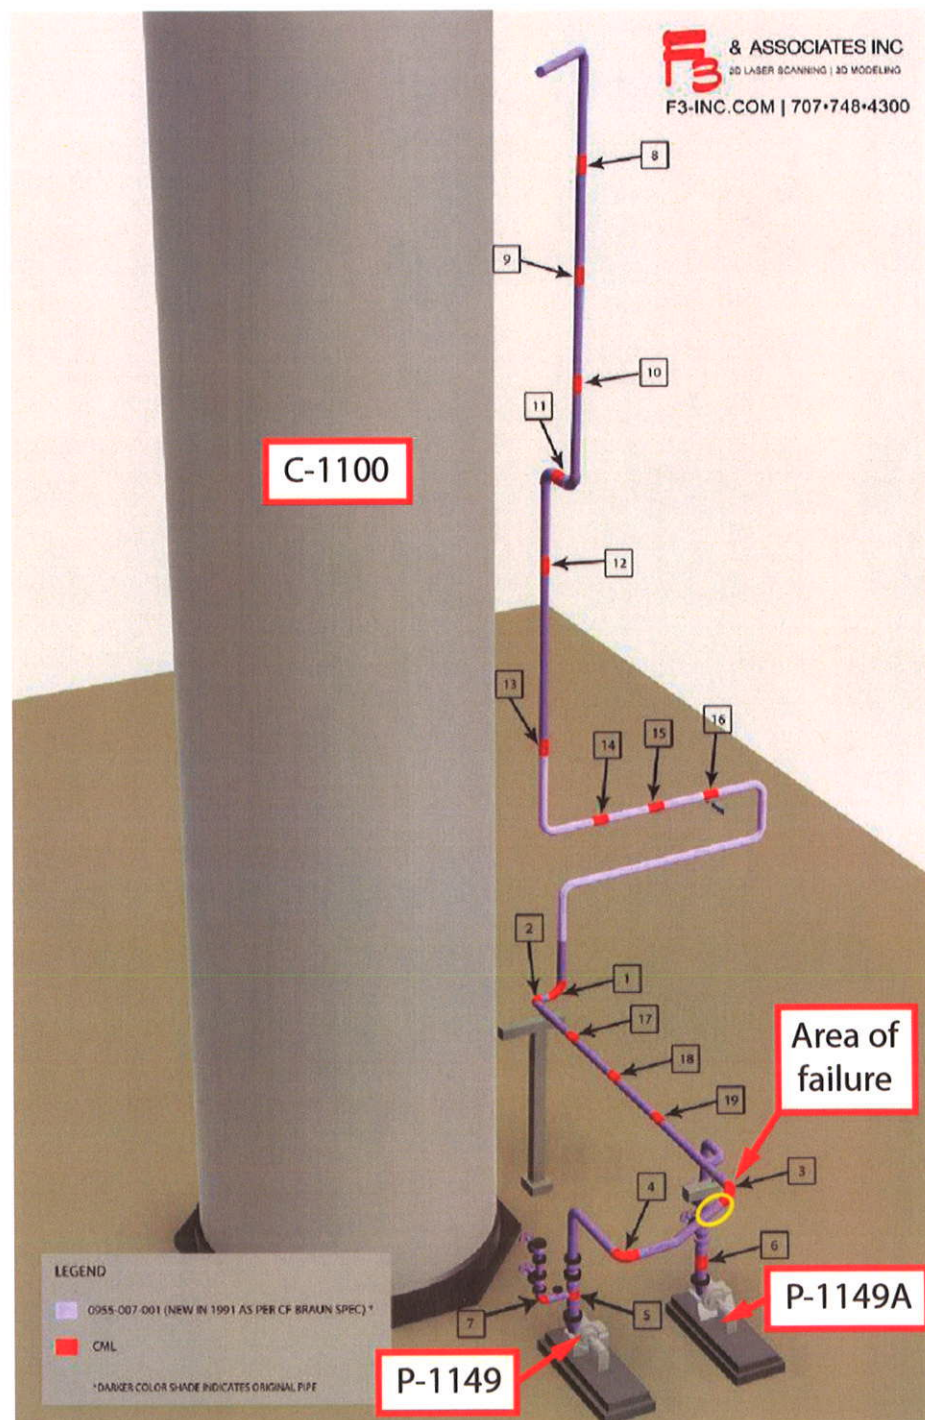
The 4SC inspection plan was to periodically measure thickness at CMLs considered representative of the piping circuit between the C-1100 and P-1149/A (see Appendix 2). The nearest CML to the failed pipe component was CML #3, which is located at the elbow directly upstream of the failure location, as shown in Figure 16.

Figure 16. Three-dimensional model of the 8-inch 4SC line showing the CML locations. CMLs 1-6 were original, CML 7 was added in 2002, and CMLs 8-19 were added in 2011.

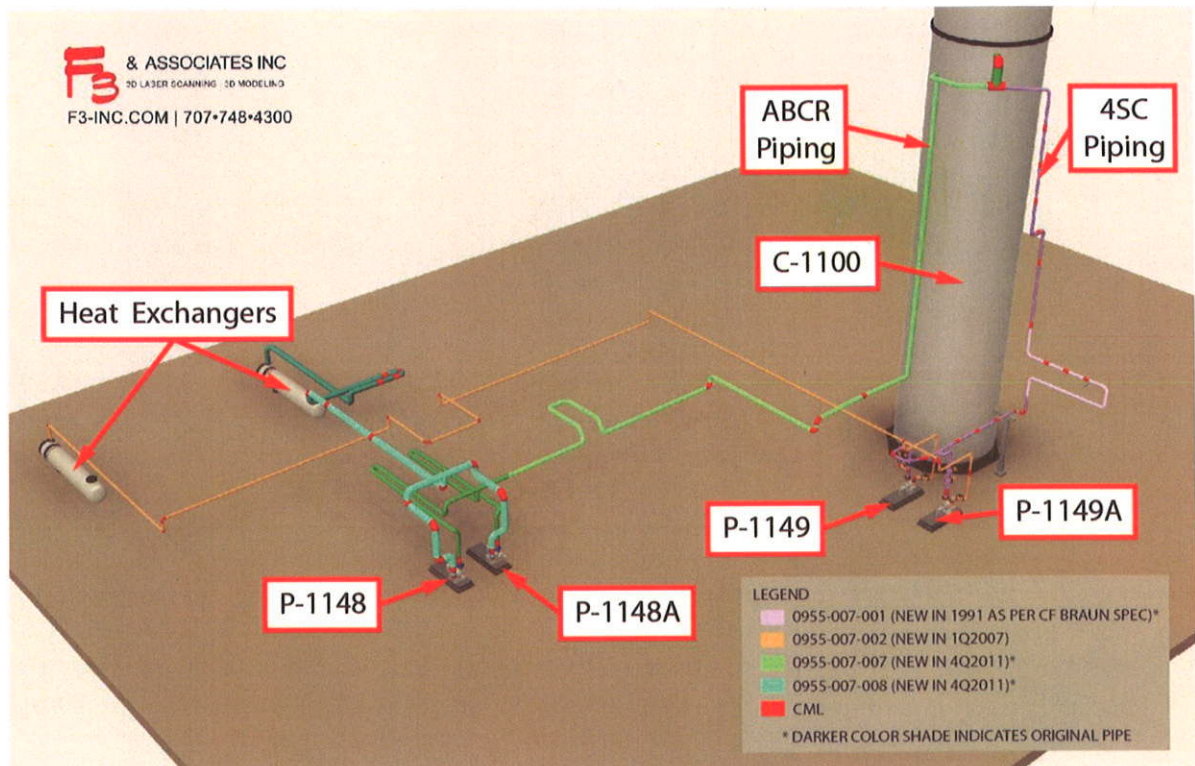
CML inspections of the ABCR piping showed wall thicknesses as low as 0.10 inches, indicating that the pipe could be too close to minimum thickness before the next Turnaround, scheduled for 2016, to leave it in service. Hence, portions of the ABCR piping were replaced with carbon steel piping during the 2011 Turnaround (see Figure 17).

Figure 17. Three-dimensional model showing the locations of the CMLs in the 4SC and the ABCR piping within the 4CU.
