APPENDIX TO:
**Improving Public and Worker
Safety at Oil Refineries**

Report of the Interagency Working Group on Refinery Safety

CHEVRON RICHMOND REFINERY FIRE

CHEVRON RICHMOND REFINERY

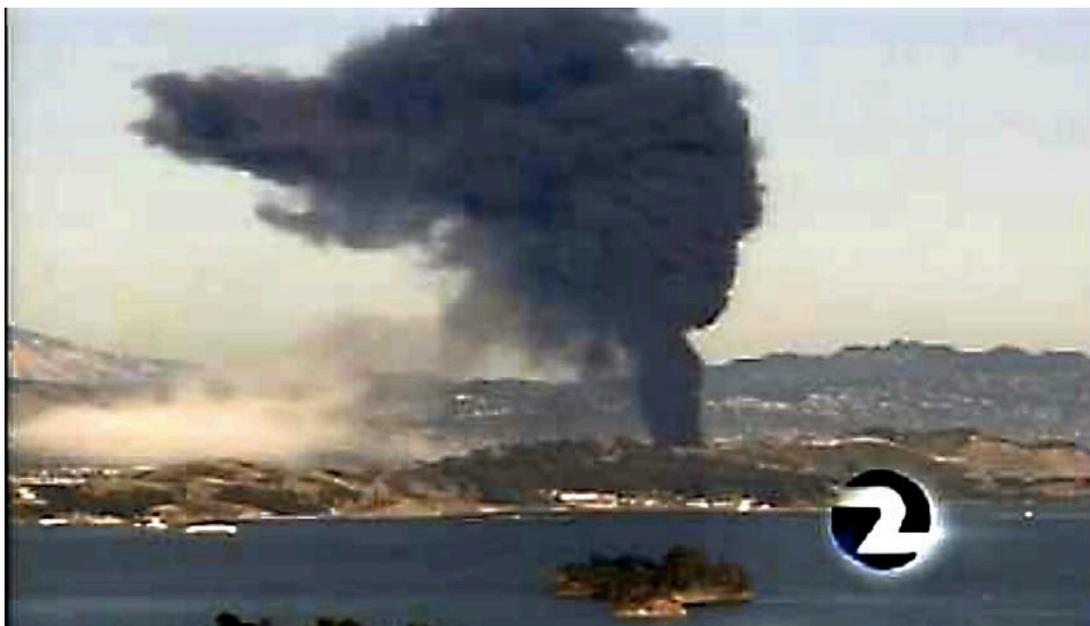
2. The ignition and subsequent continued burning of the hydrocarbon process fluid resulted in a large plume of unknown and unquantified particulates and vapor traveling across the Richmond, California, area (Figures 2 and 3). This resulted in a Community Warning System (CWS) Level 3 alert,ⁱ and a shelter-in-placeⁱⁱ (SIP) was issued at 6:38 pm¹ for the cities of Richmond, San Pablo, and North Richmond. It was lifted later that night at 11:12 pm after the fire was fully under control. In the weeks following the incident, nearby medical facilities received over 15,000 members of the public seeking treatment for ailments including breathing problems, chest pain, shortness of breath, sore throat, and headaches. Approximately 20 people were admitted to local hospitals as inpatients for treatment.

Figure 2. Vapor cloud (white) over Richmond area and smoke (black) from Chevron Richmond Refinery fire as seen from San Rafael in Marin County.²

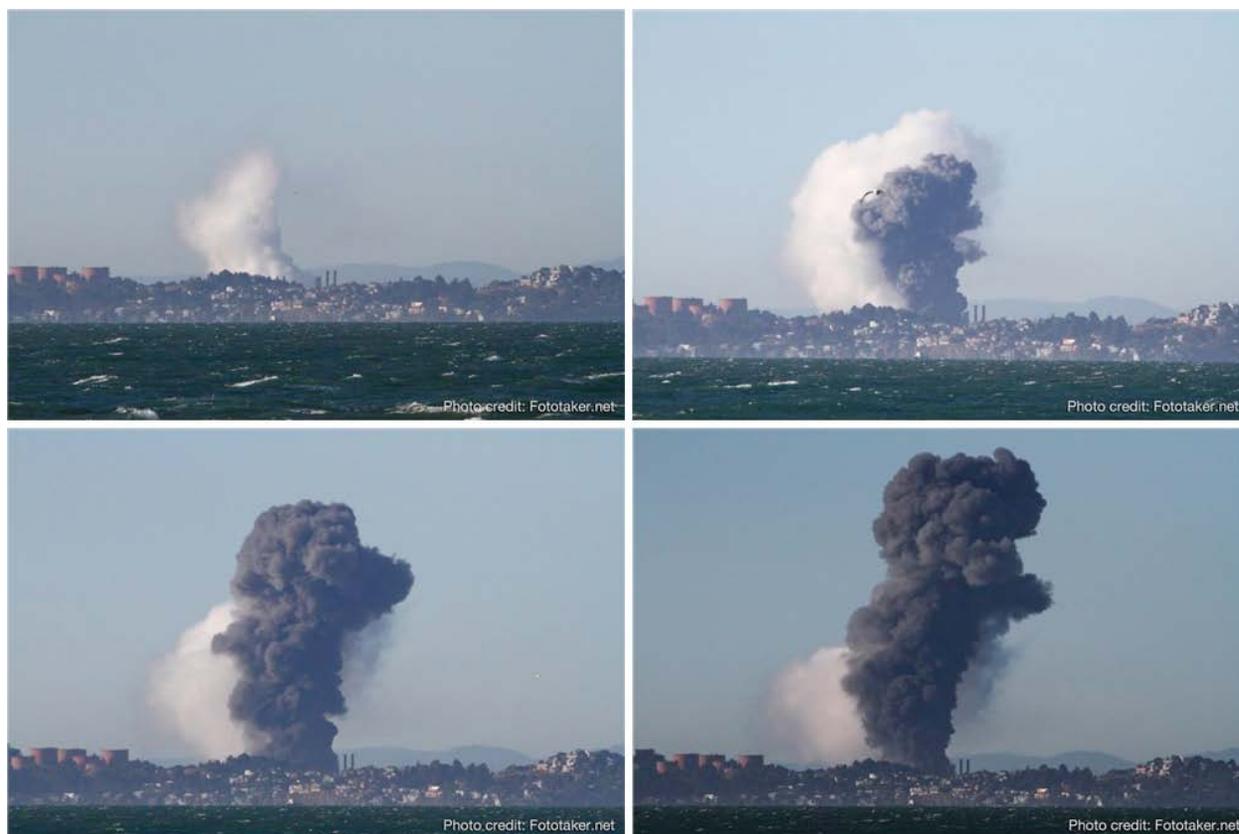
Figure 3. Initial vapor cloud formation (white cloud) and subsequent ignition (black smoke) as seen from a pier in San Francisco, California.

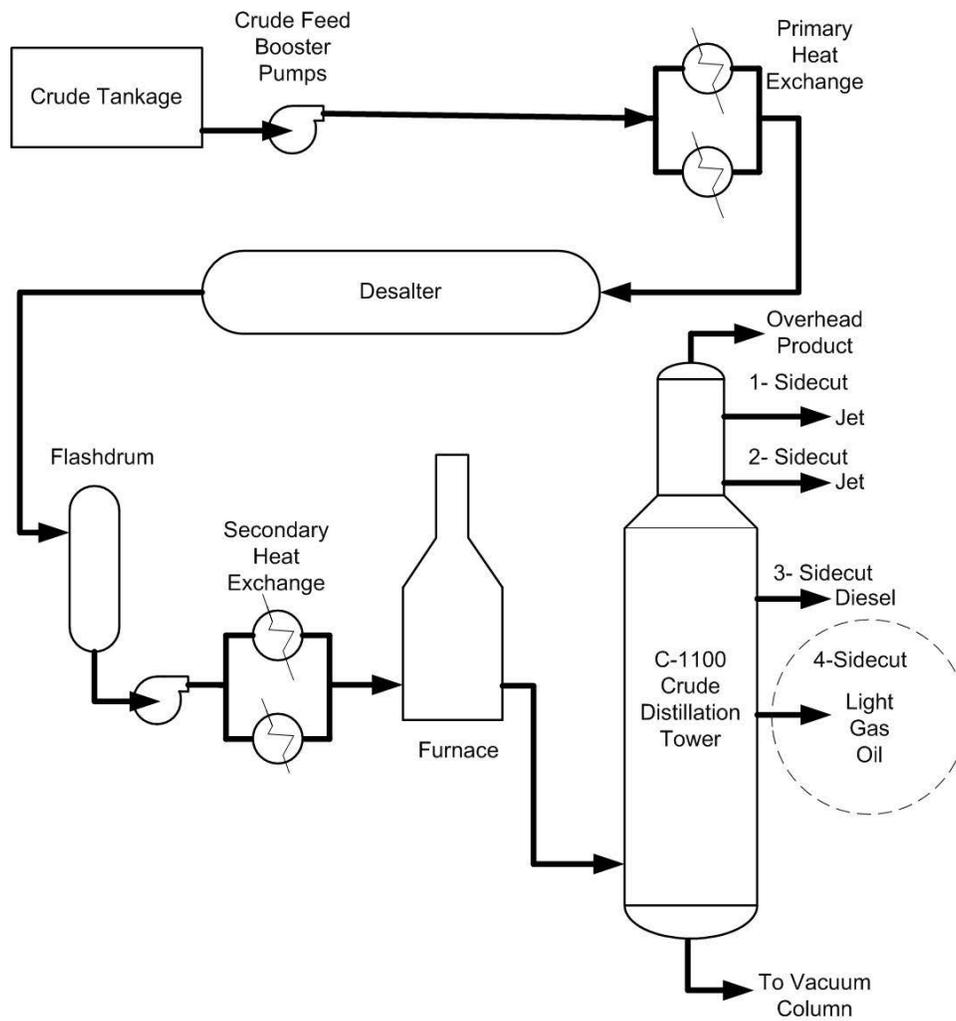
3. The incident occurred from the piping referred to as the “4-sidecut” stream, one of several process streams exiting the C-1100 Crude Unit Atmospheric Column (Figure 4).ⁱ A plot plan of the crude unit shows the leak location relative to C-1100 (Figure 5). As shown in Figure 6, light gas oil (the crude unit 4-sidecut process fluid) exits the atmospheric column via a 20-inch nozzle and is split into a 12-inch line and an 8-inch line. The August 6, 2012, pipe rupture (Figure 7) occurred on a 52-inch long componentⁱⁱ of the 4-sidecut 8-inch line (the 52-inch component). The line operated at a temperature of 640 degrees Fahrenheit (°F)ⁱⁱⁱ and had an operating pressure of approximately 55 pounds per square inch gauge (psig) at the rupture location. At the

Figure 4. C-1100 Crude Unit Atmospheric Column and Upstream Process Equipment.

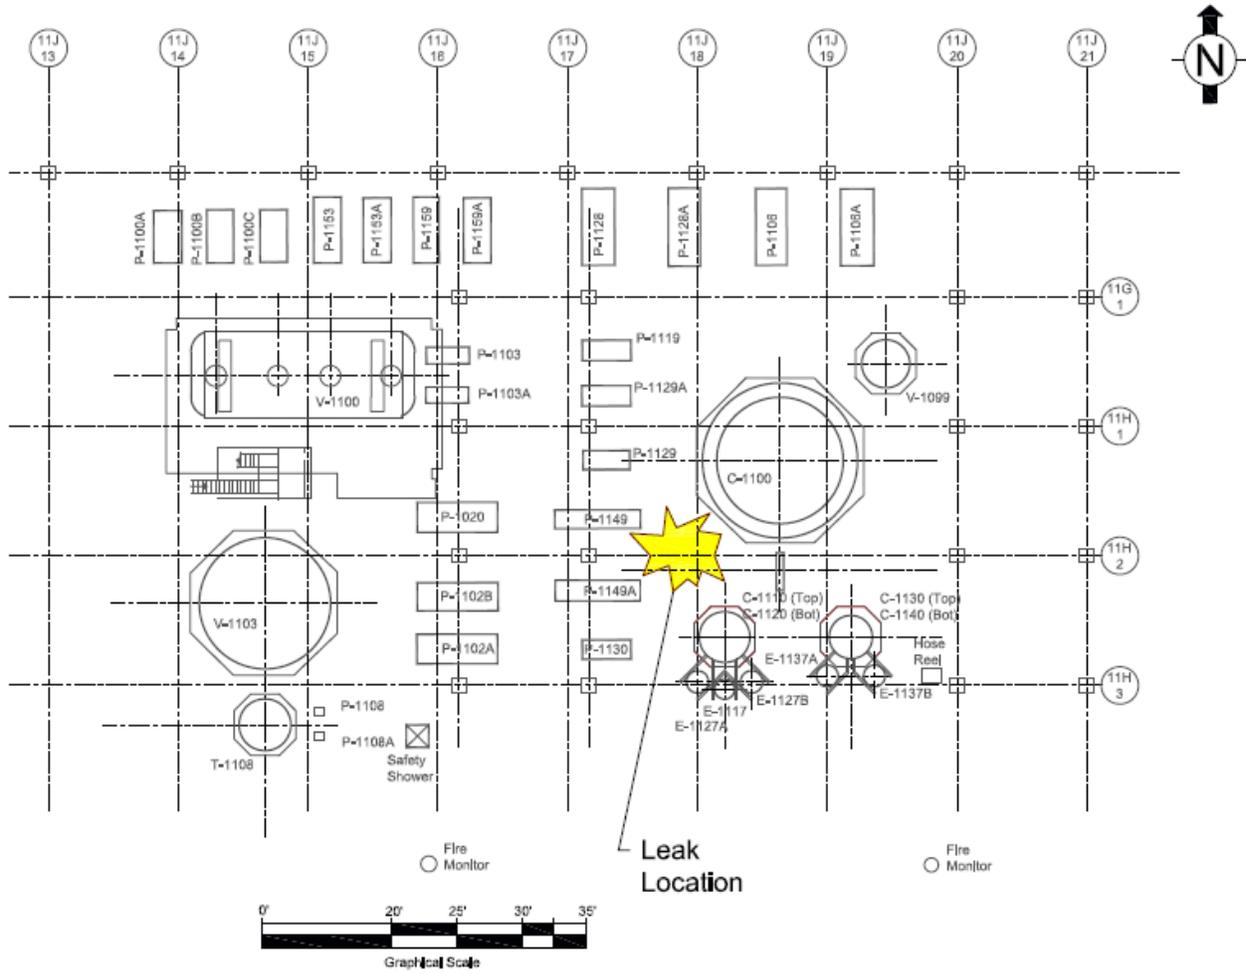
Figure 5. Overhead view of the equipment in the #4 Crude Unit showing the leak location, commonly referred to as a plot plan.

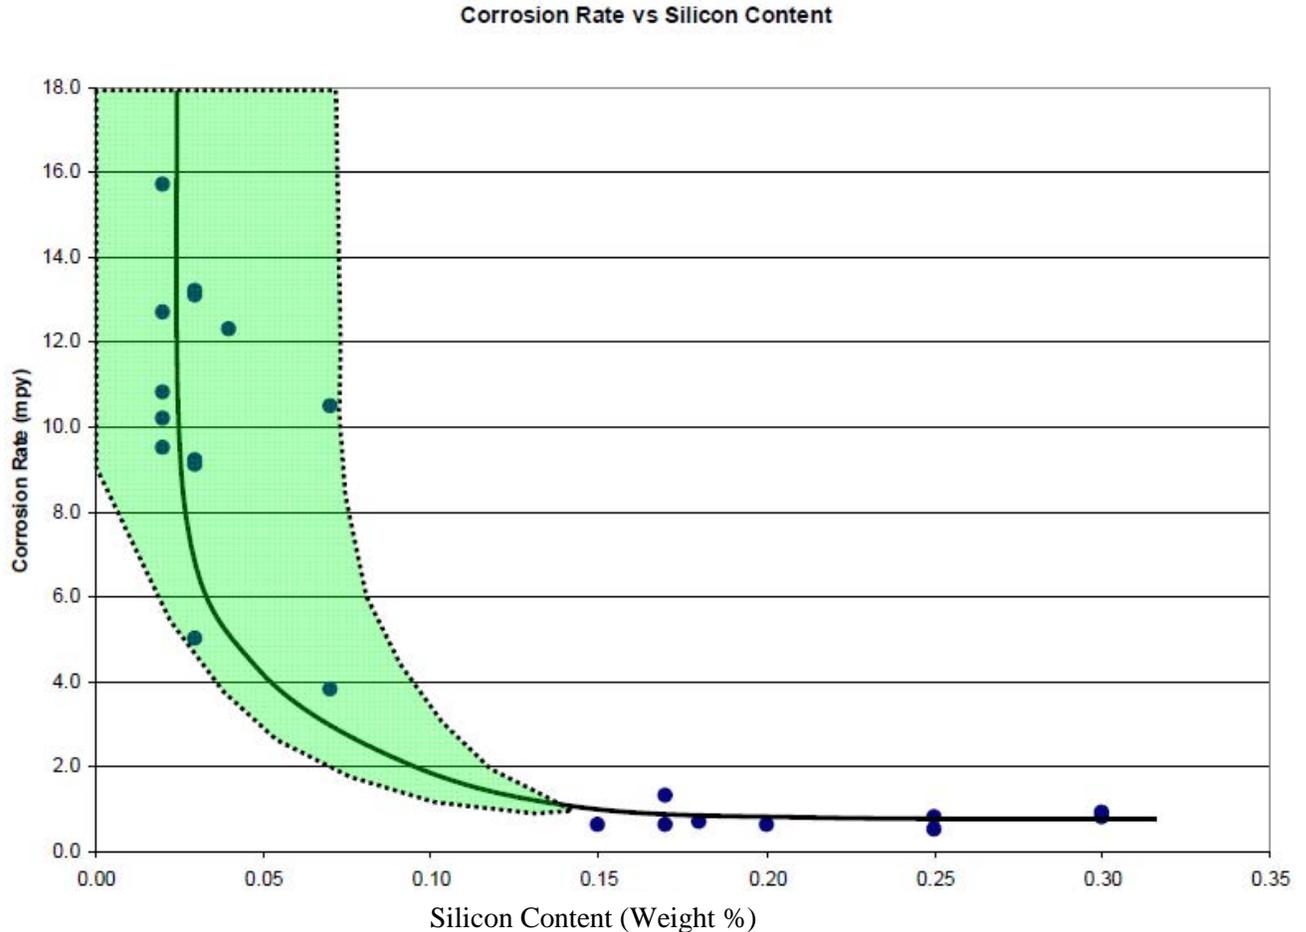
9. In addition to its inherently faster rate of sulfidation corrosion when compared with higher chromium steels, carbon steel also experiences significant variation in corrosion rates due to variances in silicon content, a component used in the steel manufacturing process. Carbon steel piping containing silicon content less than 0.10 wt. % can corrode at accelerated rates,¹² up to sixteen times faster than carbon steel piping containing higher percentages of silicon as shown in Figure 8. This figure shows how carbon steel corrosion rates can greatly vary depending on silicon content.

Figure 8. This graph shows how corrosion rates increase in carbon steel containing decreasing percentages of silicon. This information can be found in Annex C of API RP 939-C.ⁱ

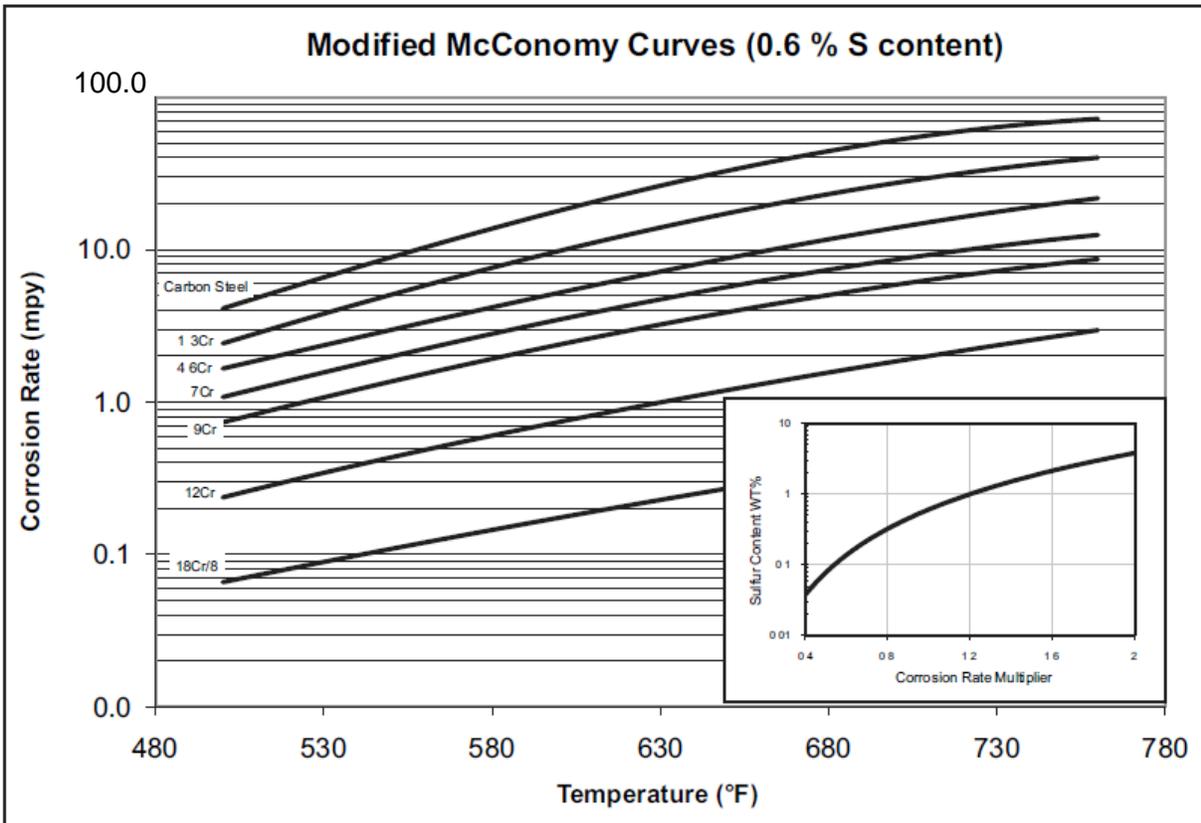
sulfidation corrosion environments.ⁱ As shown in the Modified McConomy Curvesⁱⁱ from API RP 939-C (Figure 10), 9-Chromeⁱⁱⁱ corrodes 15 times faster than stainless steel,^{iv} and carbon steel^v corrodes 125 times faster than stainless steel.²⁷

Figure 10. Modified McConomy Curves from API RP 939-C.

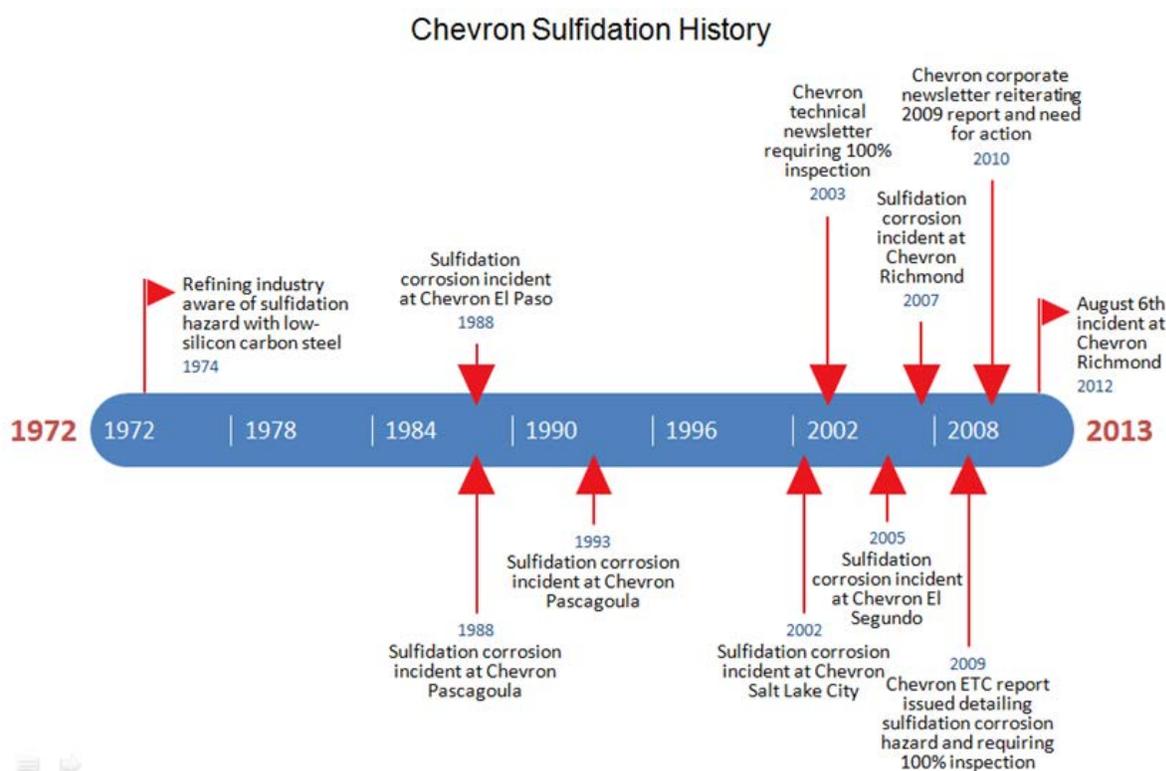
21. Figure 11 shows a timeline of Chevron's key sulfidation events. Chevron technical staff has considerable knowledge and expertise regarding sulfidation corrosion, specifically with respect to corrosion rate variations caused by differing silicon concentration in carbon steel piping. Chevron employees have authored industry papers on sulfidation corrosion and had significant influence in the development of the industry sulfidation corrosion recommended practice, API RP 939-C. This recommended practice, first published in 2009, was developed under Chevron leadership. At the approximate time of publication of API RP 939-C, Chevron Energy Technology Company (Chevron ETC)ⁱ created an internal document on the subject of sulfidation corrosion. Chevron ETC metallurgists released a formal report dated September 30, 2009 (nearly 3 years prior to the incident) to Chevron refinery-based reliability managers and chief inspectors entitled *Updated Inspection Strategies for Preventing Sulfidation Corrosion Failures in Chevron Refineries*.

Figure 11. Chevron's key sulfidation events between 1974 and 2013.

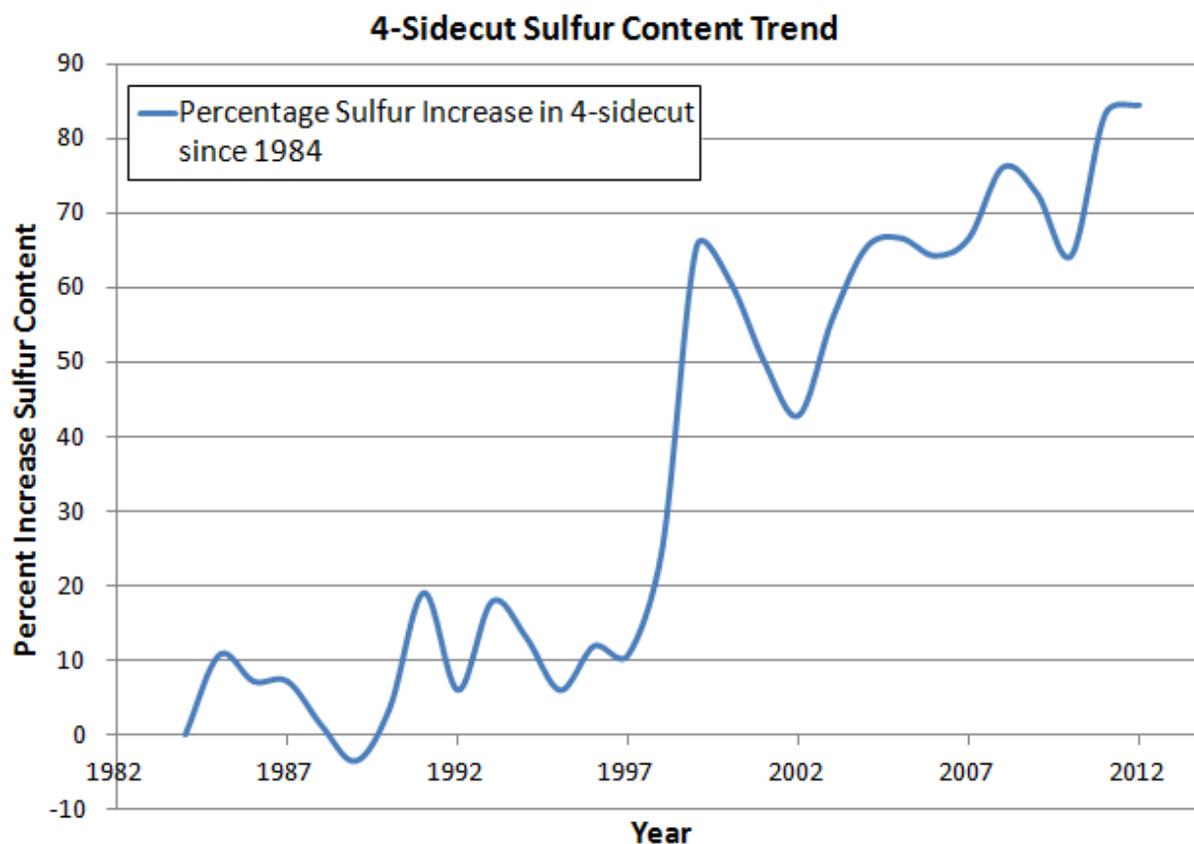
38. Crude oil feedstock used at the Chevron Richmond Refinery is obtained from a variety of different sources that are blended before processing. These various crudes have different compositions, such as varying sulfur compounds and concentrations. These crudes can have differing corrosion effects on process equipment and piping. There is an increasing trend in crude oil refining to process less expensive “opportunity crudes” because they can provide significant cost savings to the company.ⁱⁱ However, these crudes may contain more undesirable characteristics such as high sulfur content, high naphthenic acid content, or very heavy hydrocarbons³³ that a refinery may not have been originally designed to process. Refinery equipment may not be the proper material of construction to achieve the design life of the equipment when exposed to the different operating conditions. Additional mitigation may be needed to reduce risk. In 1984, the Chevron Richmond Refinery crude oil feed contained approximately 85 volume % Alaskan North Slope (1 wt. %) crude oil. As the refinery began running more high-sulfur content crudes, the sulfur content in the 4-sidecut line steadily increased (Figure 14), as discussed below.

Figure 14. Graph shows the percentage increase from 1984 values of the sulfur content in the 4-sidecut.

39. When Chevron introduces a new crude, an MOC is generated to evaluate the potential impact on the refinery.ⁱ While Chevron stayed under its established crude unit design basis for total wt. % sulfur of the blended feed to the crude unit, the sulfur composition significantly increased over time. Historic data indicates that the sulfur in the 4-sidecut stream has increased from 0.8 to 1.6 wt%. This increase in sulfur composition likely increased corrosion rates in the 4-sidecut line. Chevron did not conduct an MOC analyzing the impact that increases in sulfur composition would have on corrosion in the crude unit. Chevron also did not change its corrosion monitoring programs in response to the increased sulfur content.

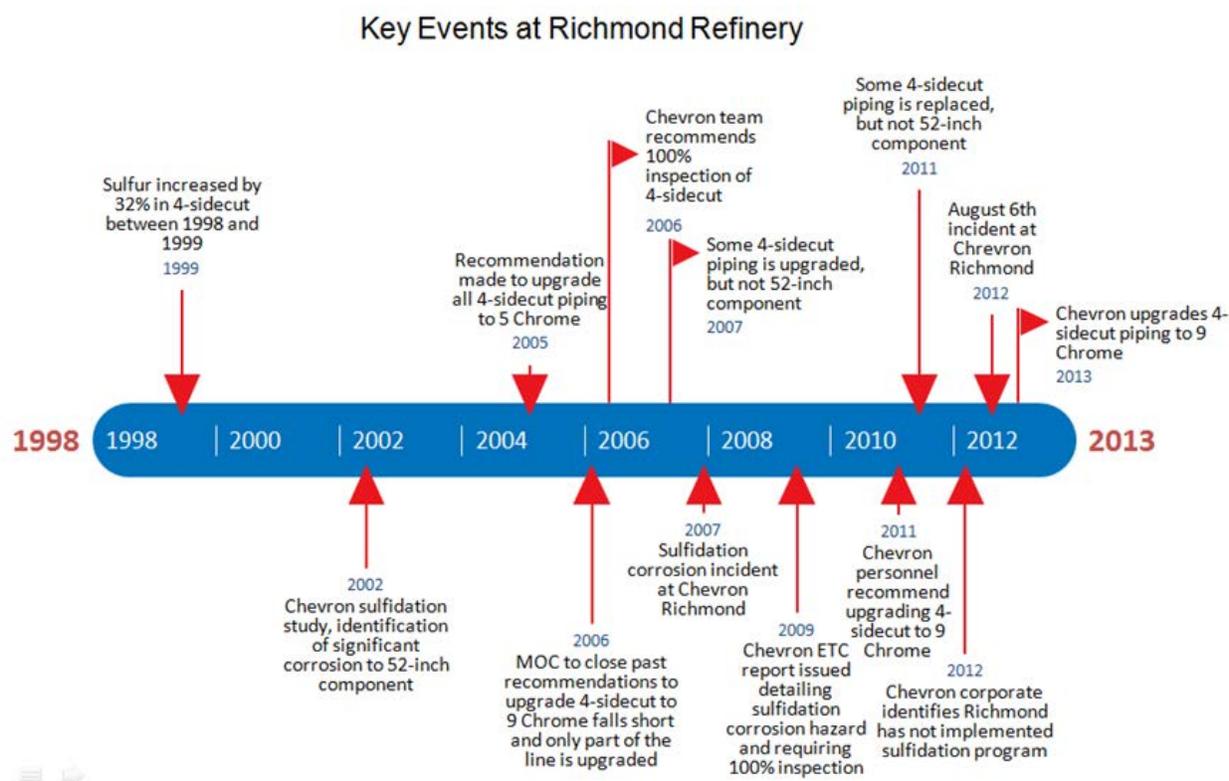
44. In the ten years prior to the incident, a small number of Chevron personnel with knowledge and understanding of sulfidation corrosion made at least six recommendations (listed in the following six paragraphs and included in Figure 15) to increase inspections or upgrade the metallurgy in the 4-sidecut piping. The recommendations made by these personnel were not implemented by Chevron management.

Figure 15. Key events at the Richmond refinery between 1998 and 2013.

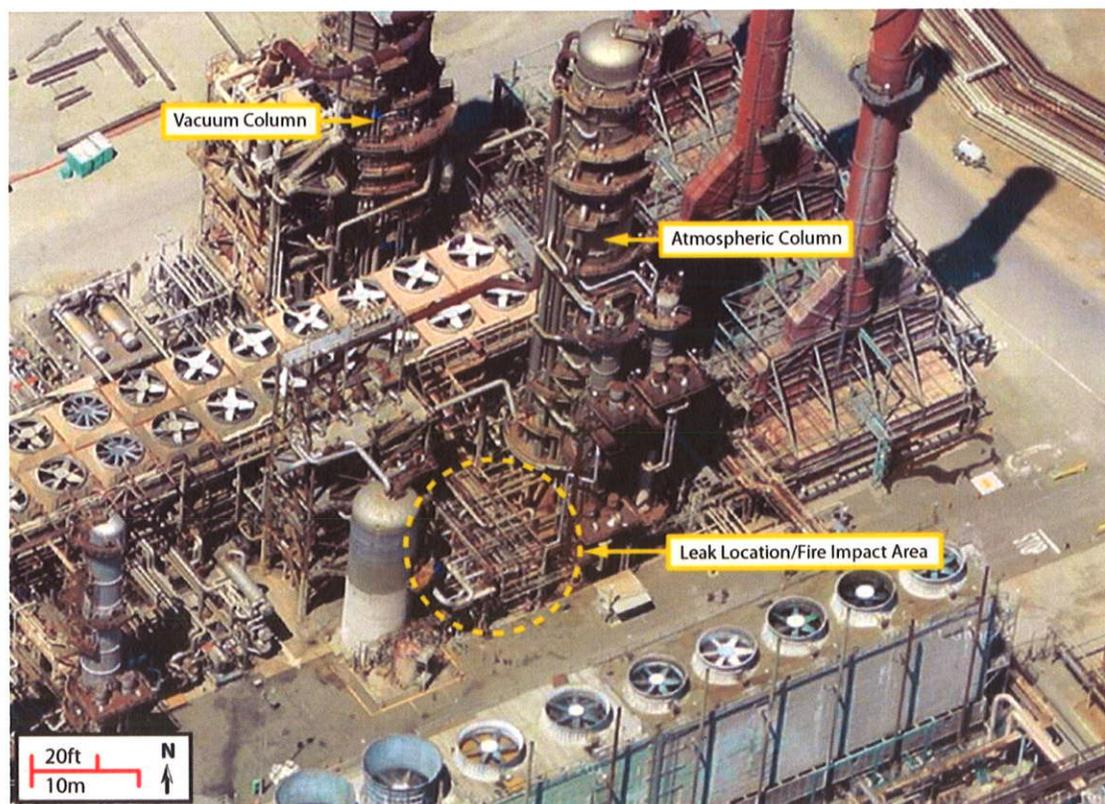
Figure 1. Overhead view of the 4CU prior to the Incident with the location of the rupture circled in yellow (image from Google Maps®).

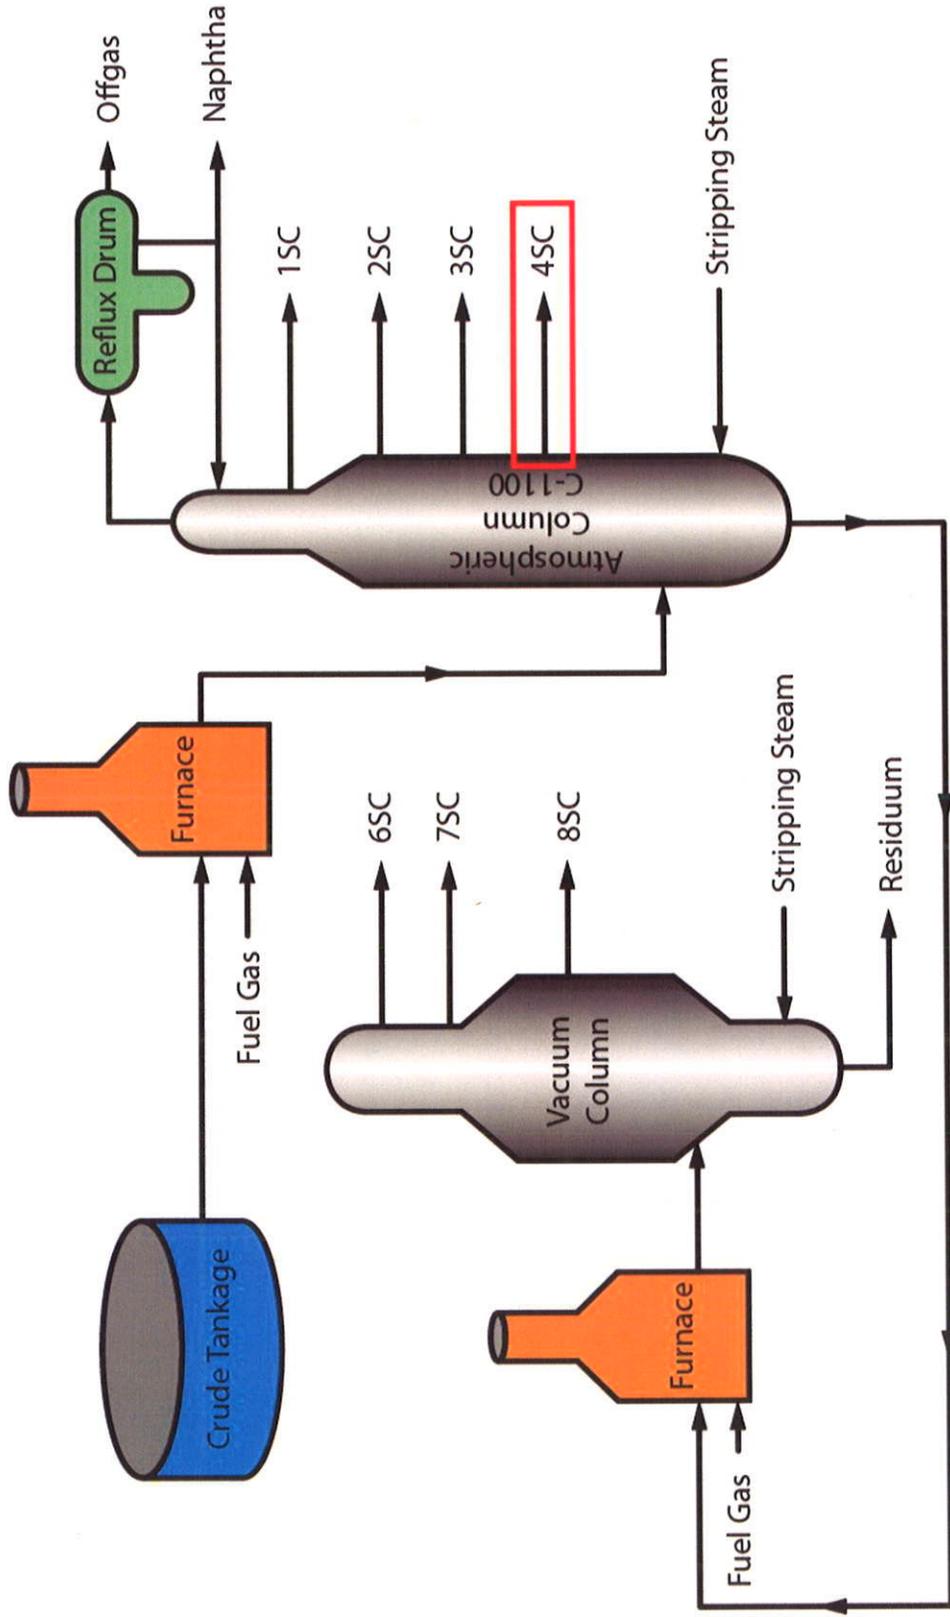
Figure 2. Simplified 4CU flow diagram. The failure occurred in the 4SC piping of the C-1100 (marked in red).

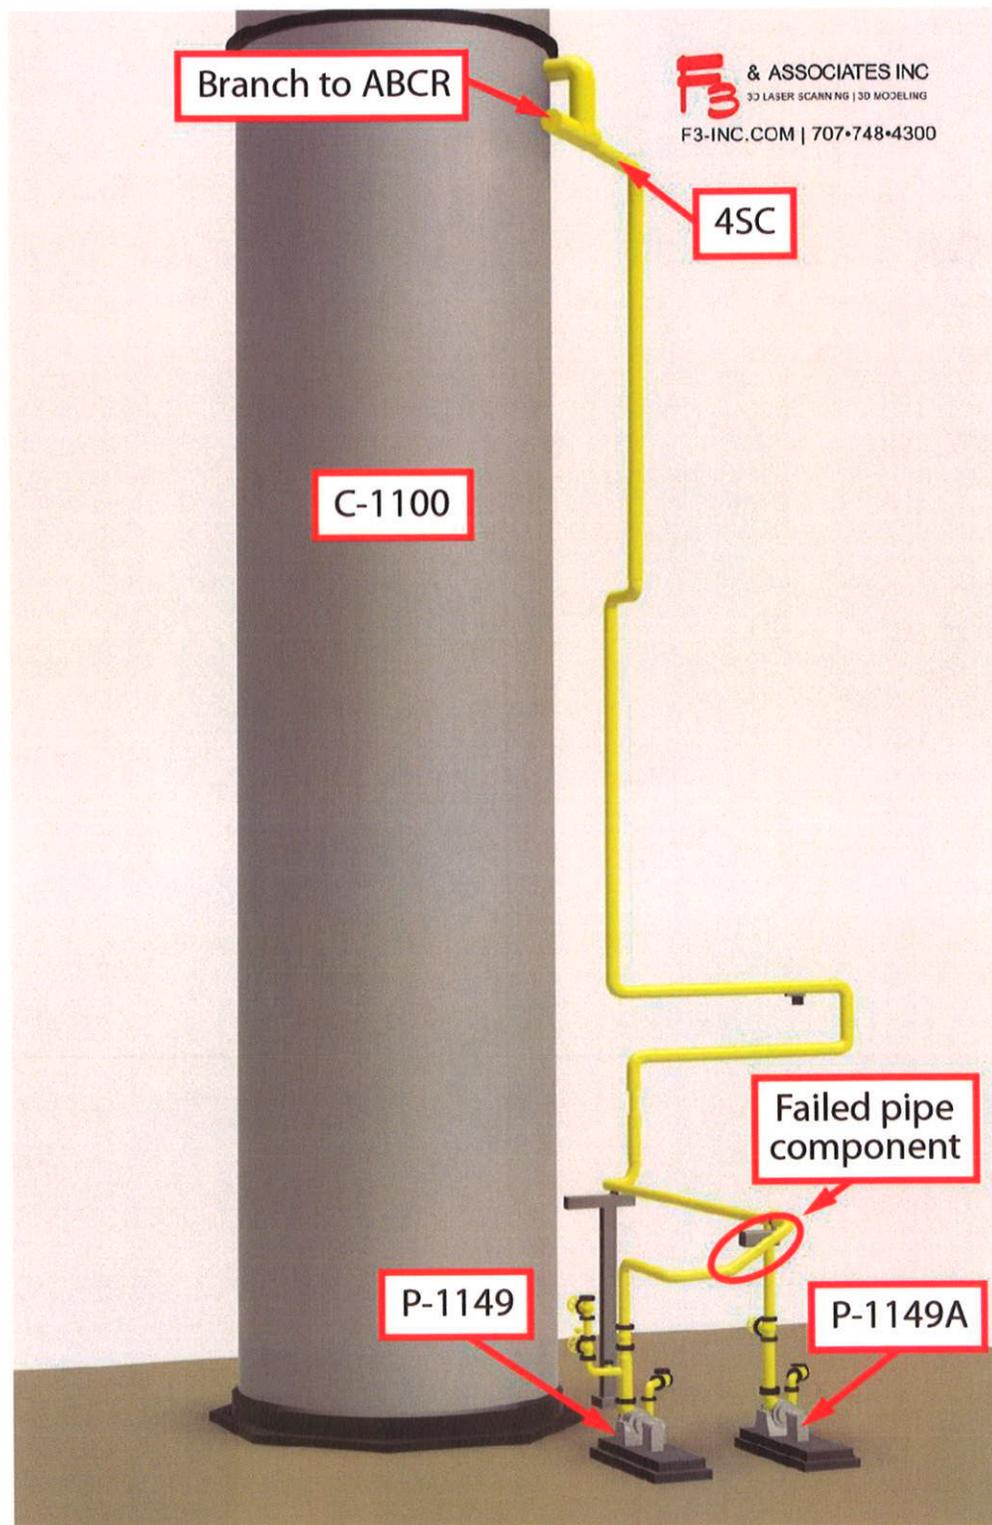
The 4SC and the Atmospheric Bottom Circulating Reflux (ABCR) are drawn via a 20-inch nozzle from the C-1100 (Figure 3). The piping branches to a 12-inch ABCR pipe and a separate 8-inch 4SC pipe. Post-Incident inspection showed that there were 67 components, including straight pipe and fittings (elbows, tees, flanges, etc.) in the 4SC piping between the piping branch and the 4SC stripper pumps.

Figure 3. Three-dimensional model showing the 4SC and the ABCR drawn via a 20-inch nozzle from the C-1100. Note: the ABCR piping is not shown beyond the initial branch.

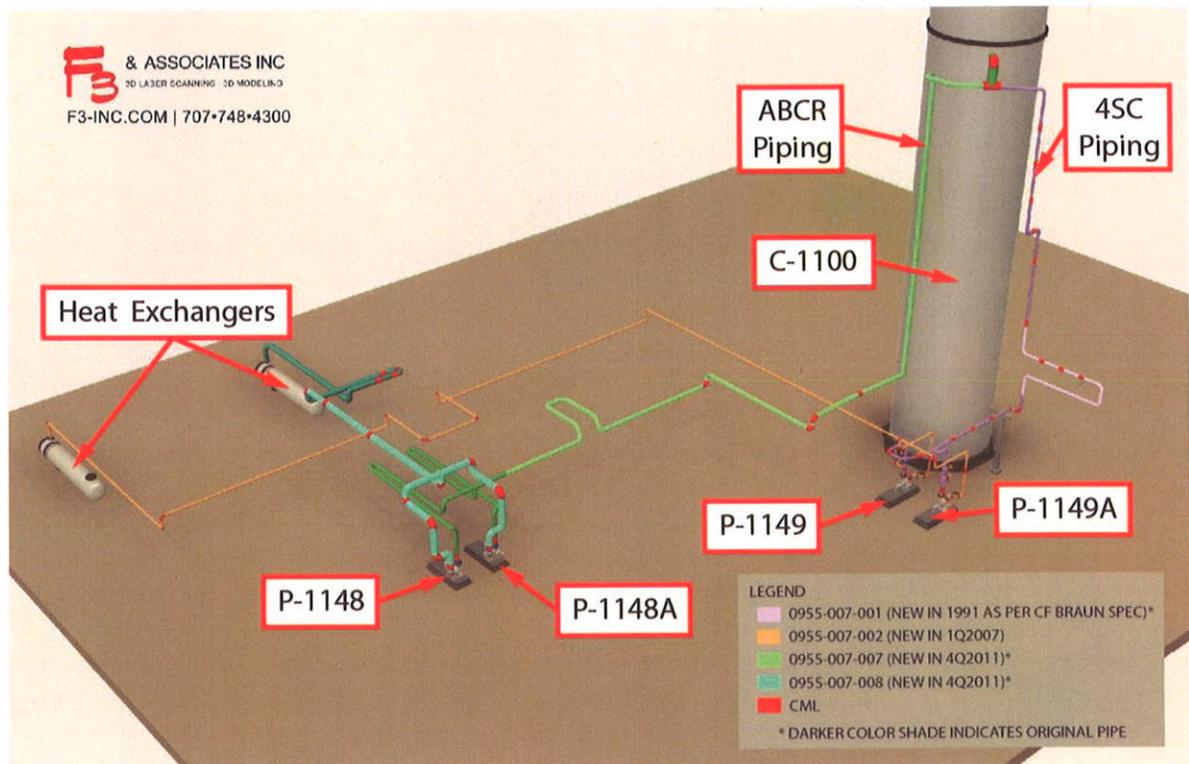
Figure 17. Three-dimensional model showing the locations of the CMLs in the 4SC and the ABCR piping within the 4CU.

CML inspections of the ABCR piping showed wall thicknesses as low as 0.10 inches, indicating that the pipe could be too close to minimum thickness before the next Turnaround, scheduled for 2016, to leave it in service. Hence, portions of the ABCR piping were replaced with carbon steel piping during the 2011 Turnaround (see Figure 17).
