Improving Public and Worker Safety at Oil Refineries

Draft Report of the Interagency Working Group on Refinery Safety Governor Jerry Brown

July 2013

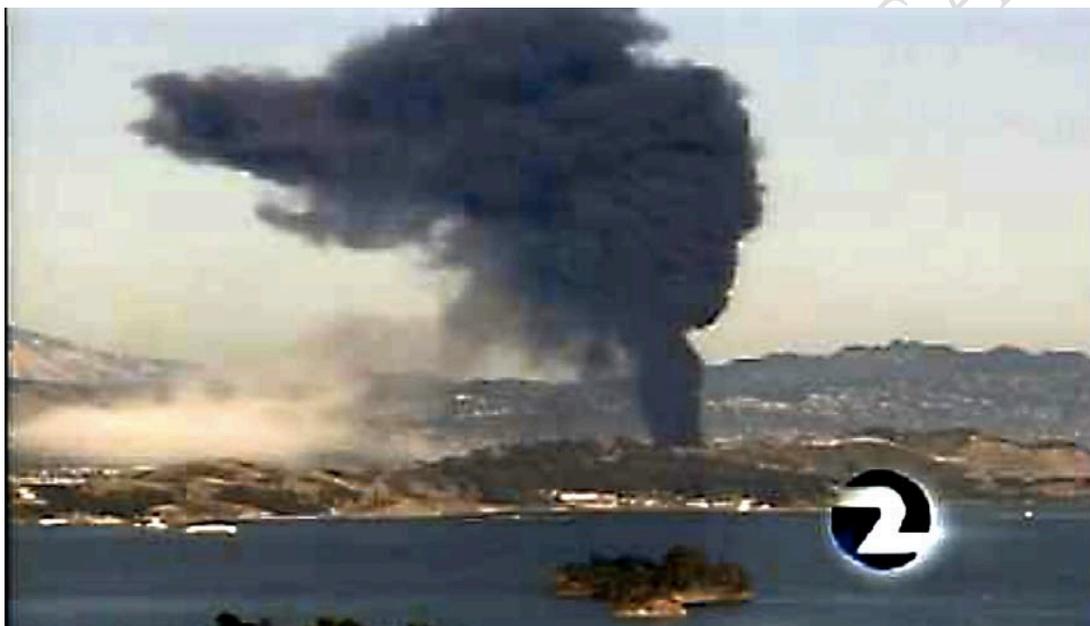
2. The ignition and subsequent continued burning of the hydrocarbon process fluid resulted in a large plume of unknown and unquantified particulates and vapor traveling across the Richmond, California, area (Figure 2 and Figure 3). This resulted in a Community Warning System (CWS) Level 3 alertⁱ and a shelter-in-placeⁱⁱ was issued at 6:38 pm¹ for the cities of Richmond, San Pablo, and North Richmond. It was lifted later that night at 11:12 pm after the fire was fully under control. In the weeks following the incident, nearby medical facilities received over 15,000 members of the public seeking treatment for ailments including breathing problems, chest pain, shortness of breath, sore throat, and headaches. Approximately 20 people were admitted to local hospitals as inpatients for treatment.

Figure 2. Vapor cloud (white) over Richmond area and smoke (black) from Chevron Richmond Refinery fire as seen from San Rafael in Marin County.²

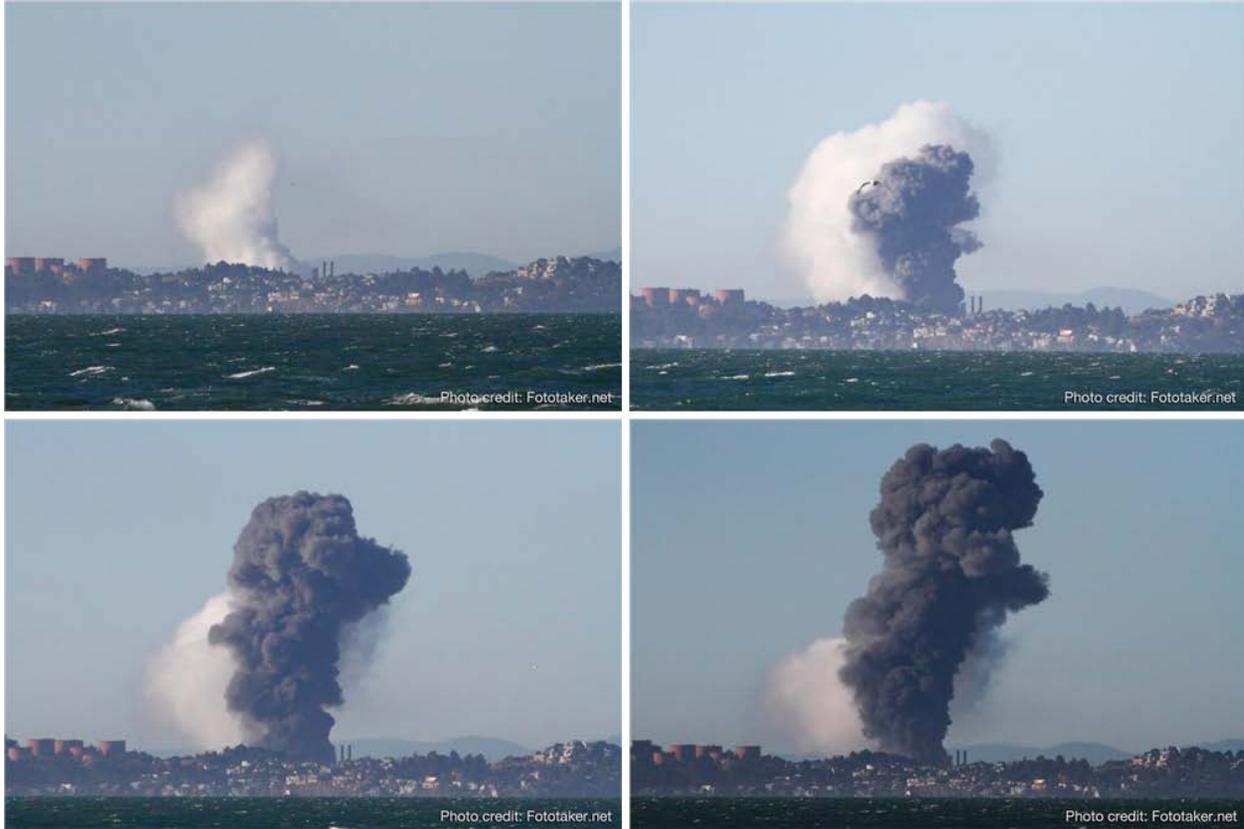
Figure 3. Initial vapor cloud formation (white cloud) and subsequent ignition (black smoke) as seen from a pier in San Francisco, California.

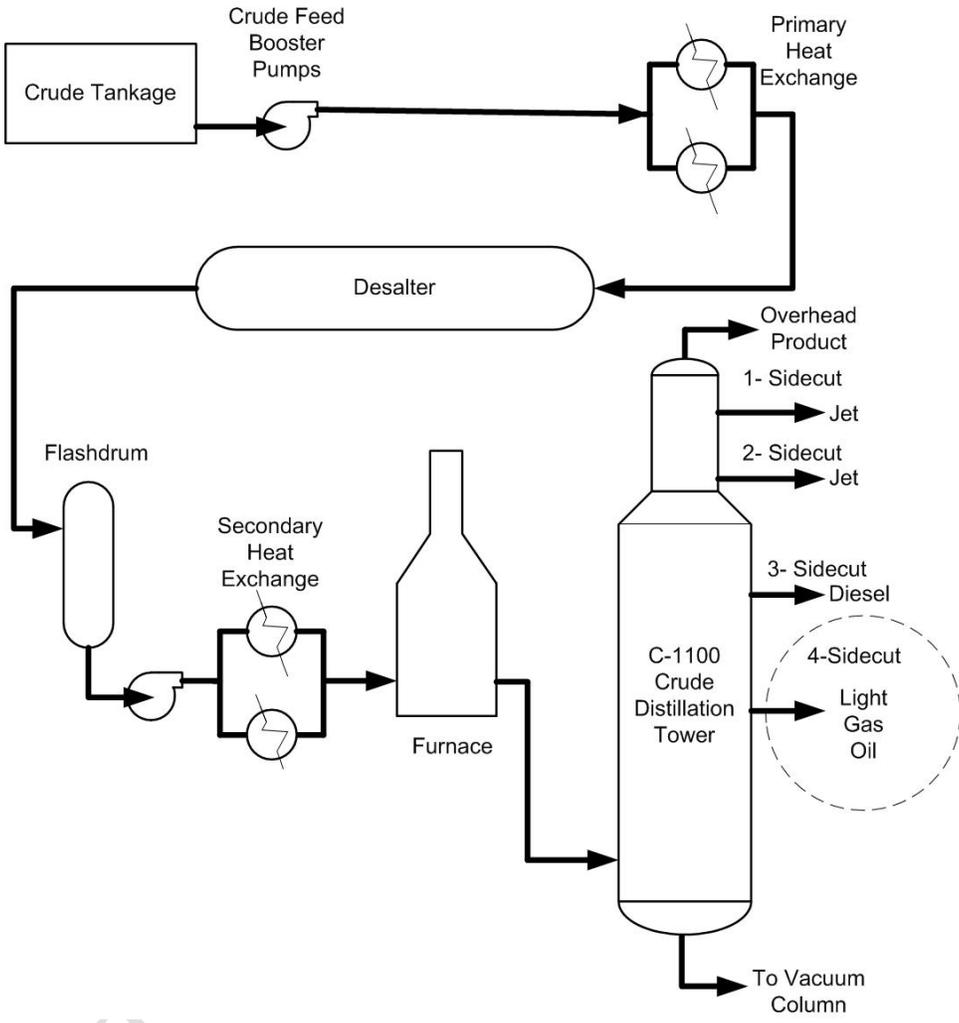
3. The incident occurred from the piping referred to as the “4-sidecut” stream, one of several process streams exiting the C-1100 Crude Unit Atmospheric Column (Figure 4).ⁱ A plot plan of the crude unit shows the leak location relative to C-1100 (Figure 5). As shown in Figure 6, light gas oil (the crude unit 4-sidecut process fluid) exits the atmospheric column via a 20-inch nozzle and is split into a 12-inch line and an 8-inch line. The August 6, 2012, pipe rupture (Figure 7) occurred on a 52-inch long componentⁱⁱ of the 4-sidecut 8-inch line (the 52-inch component). The line operated at a temperature of 640 degrees Fahrenheit (°F)ⁱⁱⁱ and had an operating pressure of approximately 55 pounds per square inch gauge (psig) at the rupture location. At the

Figure 4. C-1100 Crude Unit Atmospheric Column and Upstream Process Equipment

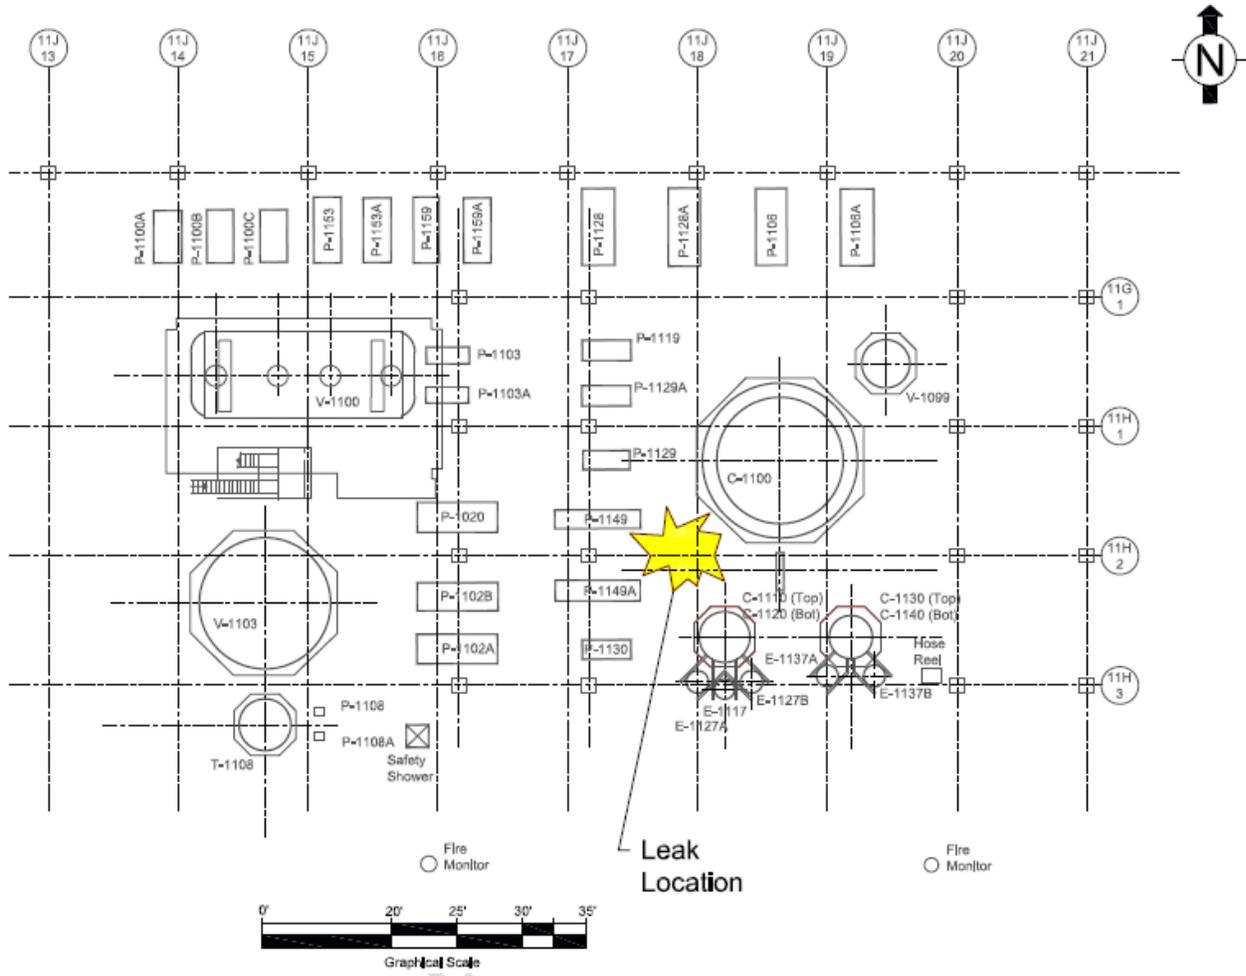
Figure 5. Overhead view of the equipment in the #4 Crude Unit showing the leak location, commonly referred to as a plot plan.

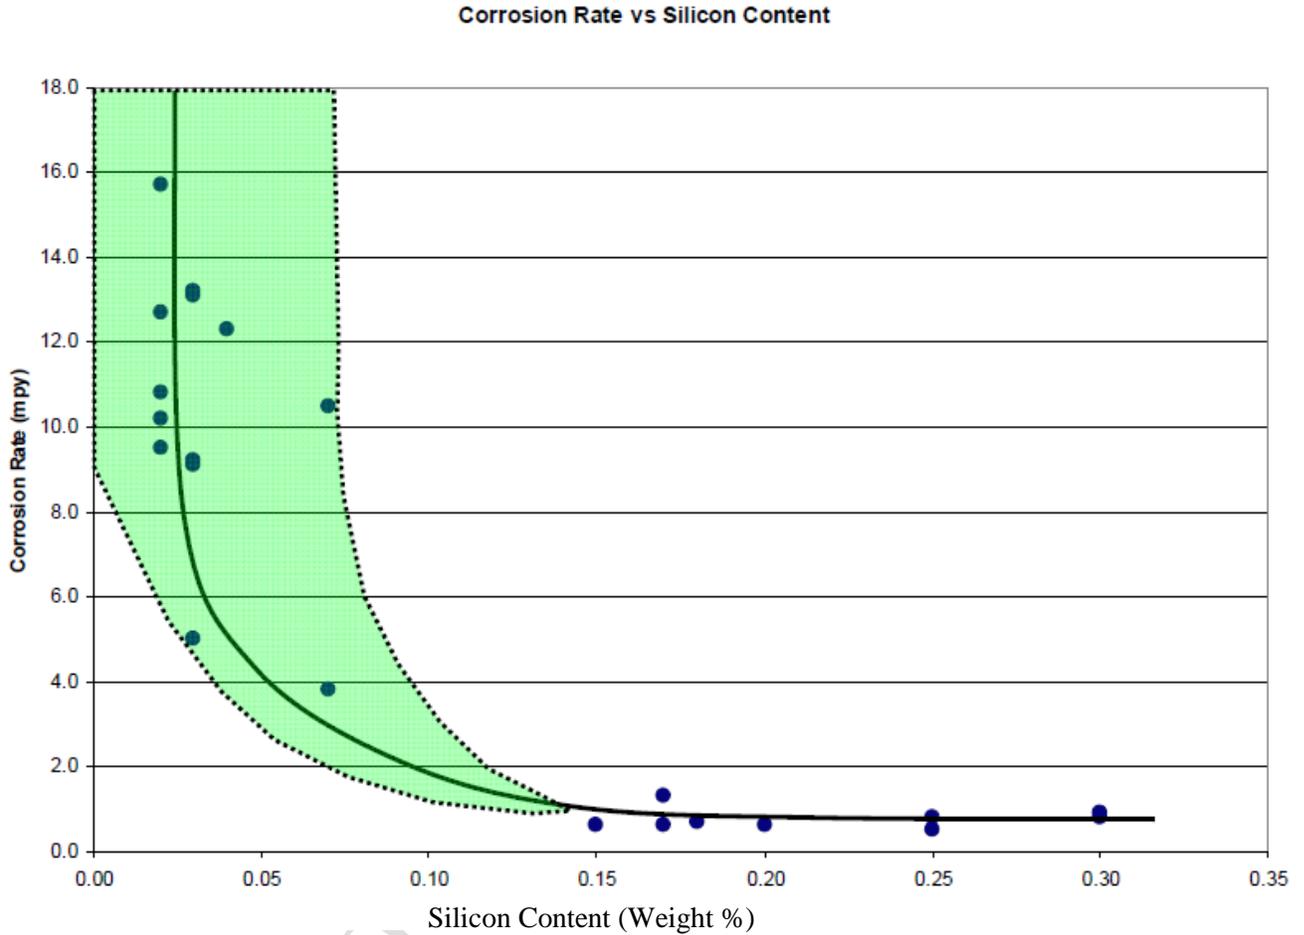
Figure 8. This graph shows how corrosion rates increase in carbon steel containing decreasing percentages of silicon. This information can be found in Annex C of API RP 939-C.ⁱ

10. The refining industry has been aware of increased rates of sulfidation corrosion in low-silicon carbon steel piping since as early as 1974,¹³ nearly 40 years before the August 6, 2012, incident and two years before the Chevron crude unit was constructed. Prior to the incident, Chevron documented its understanding of the significant consequences of sulfidation corrosion. This is reflected in Chevron’s *Corrosion Prevention and Metallurgy Manual*, which states:

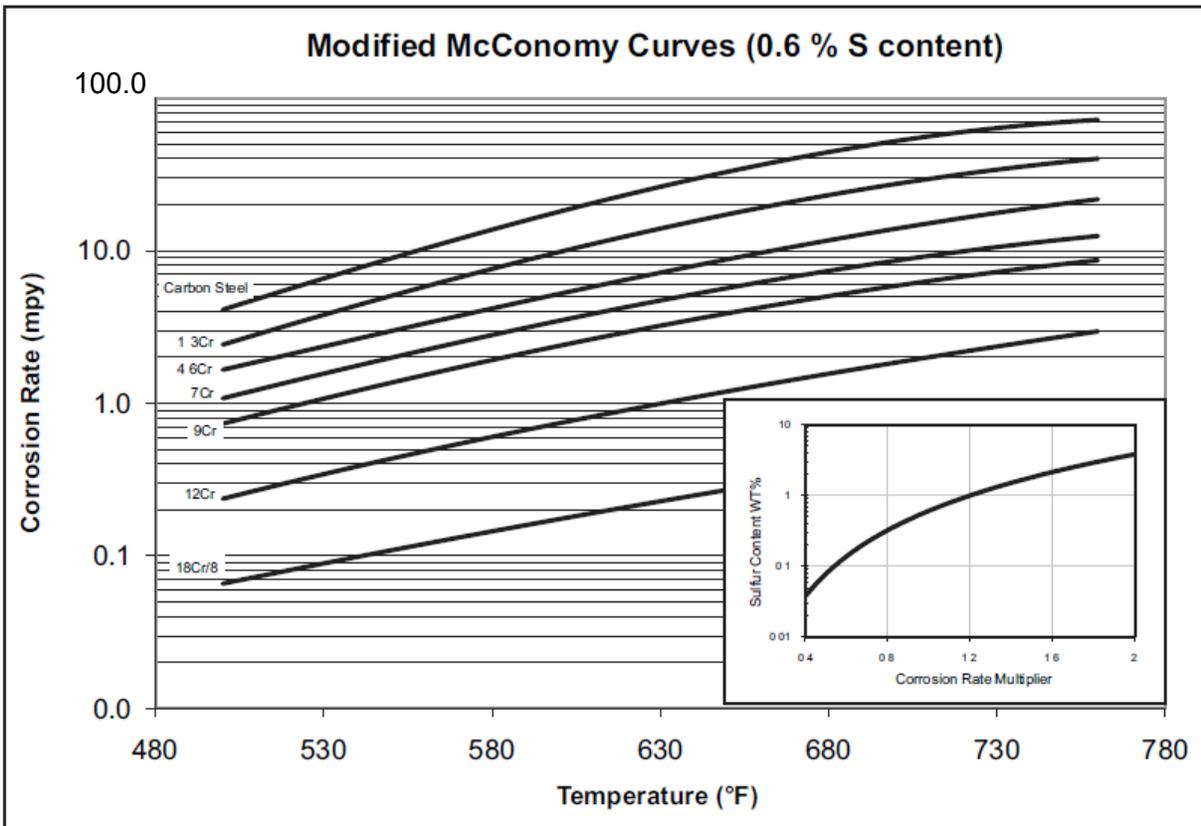
This makes alloys with higher chromium content an inherently safer choice in high temperature sulfidation corrosion environments.ⁱ As shown in the Modified McCconomy Curvesⁱⁱ (Figure 10) from API RP 939-C, 9-Chromeⁱⁱⁱ corrodes 15 times faster than stainless steel,^{iv} and carbon steel^v corrodes 125 times faster than stainless steel.²⁷

Figure 10. Modified McCconomy Curves from API RP 939-C.

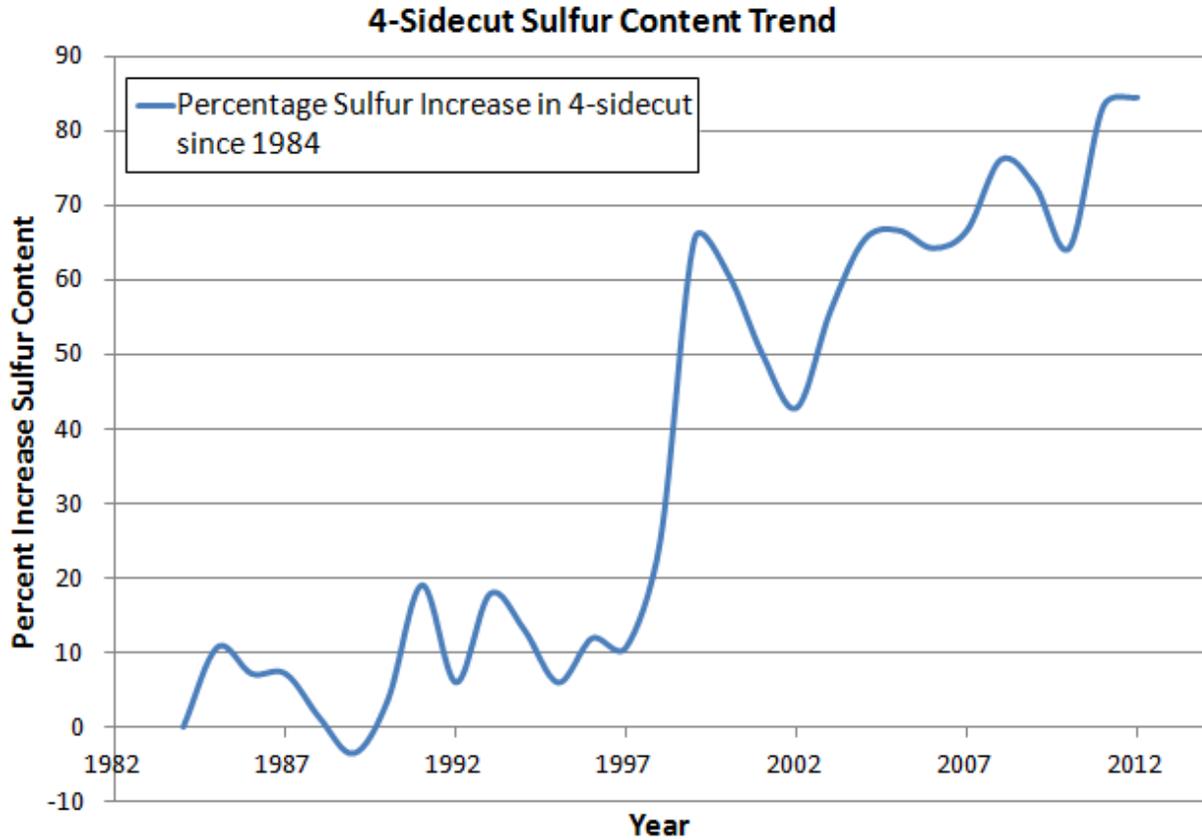
Figure 14. Graph shows the percentage increase from 1984 values of the sulfur content in the 4-sidecut.

40. When Chevron introduces a new crude, an MOC is generated to evaluate the potential impact on the refinery.ⁱ While Chevron stayed under its established crude unit design basis for total wt. % sulfur of the blended feed to the crude unit, the sulfur composition significantly increased over time. This increase in sulfur composition likely increased corrosion rates in the 4-sidecut line. Chevron did not conduct an MOC analyzing the impact that increases in sulfur composition would have on corrosion in the crude unit. Chevron also did not change its corrosion monitoring programs in response to the increased sulfur content.

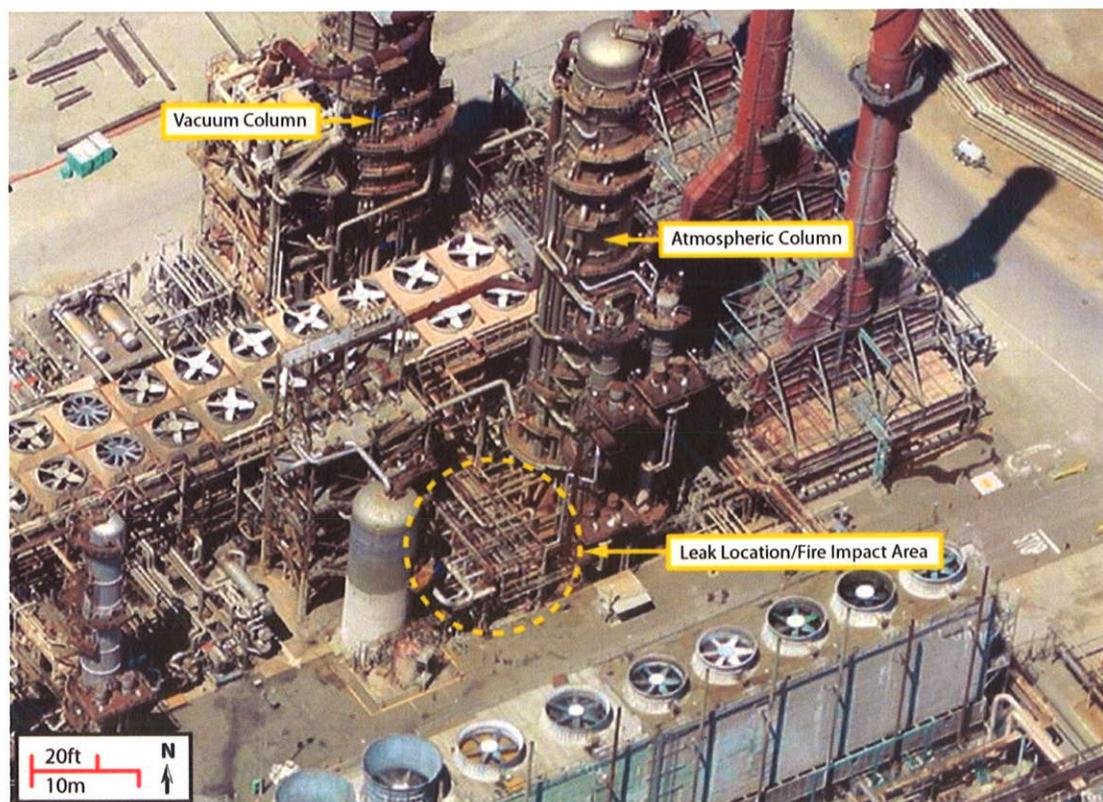
Figure 1. Overhead view of the 4CU prior to the Incident with the location of the rupture circled in yellow (image from Google Maps®).

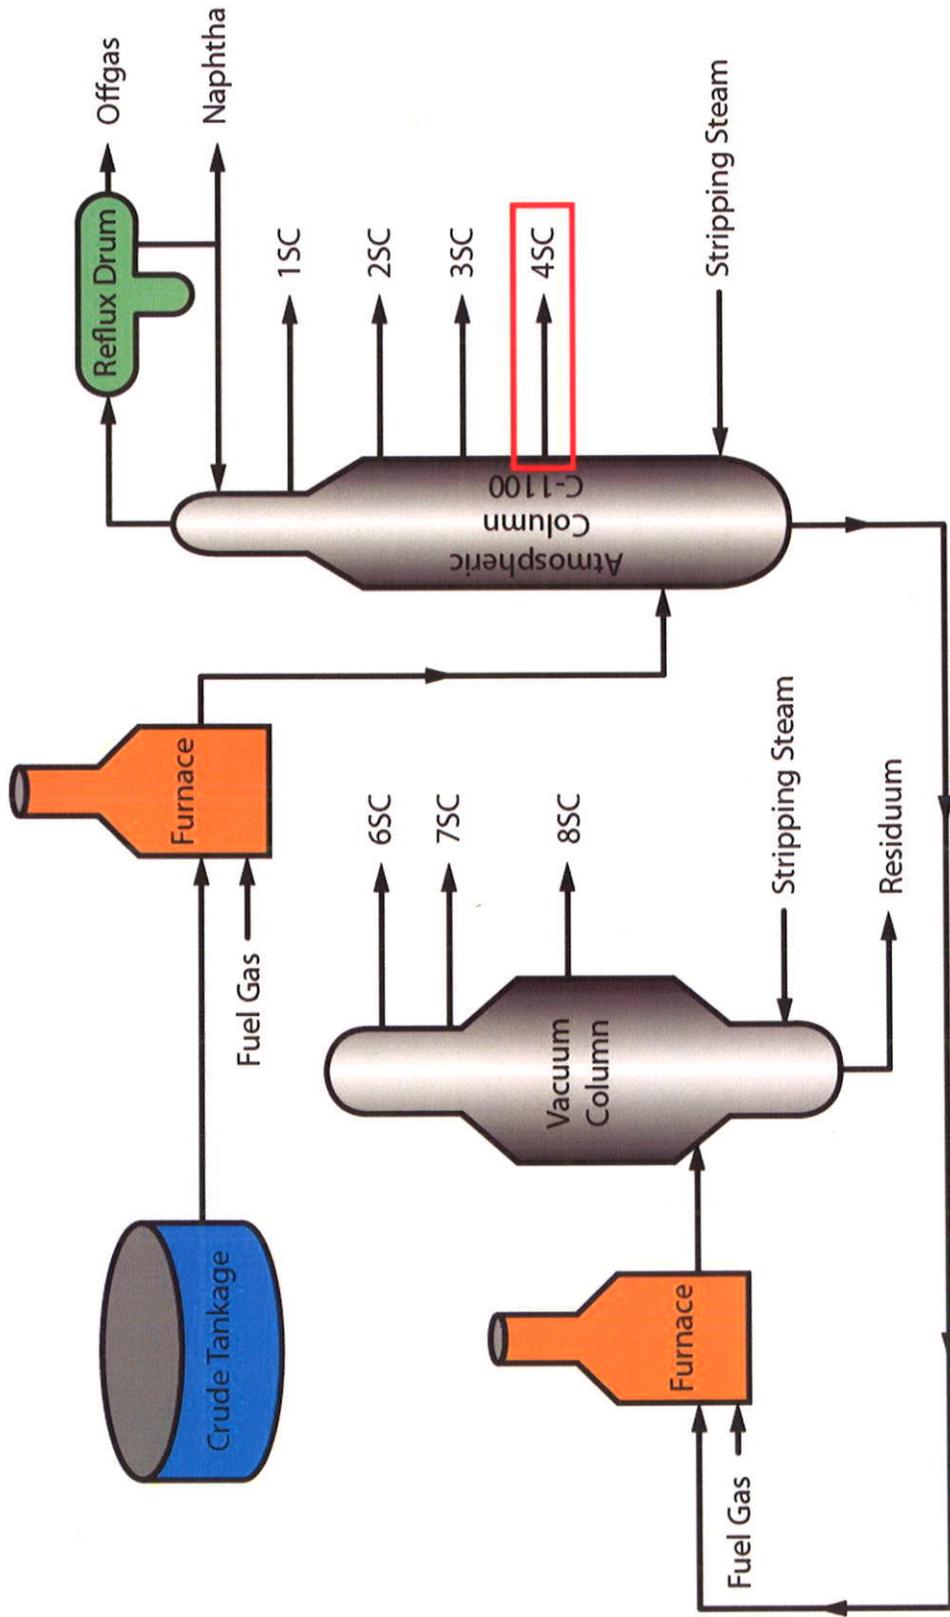
Figure 2. Simplified 4CU flow diagram. The failure occurred in the 4SC piping of the C-1100 (marked in red).

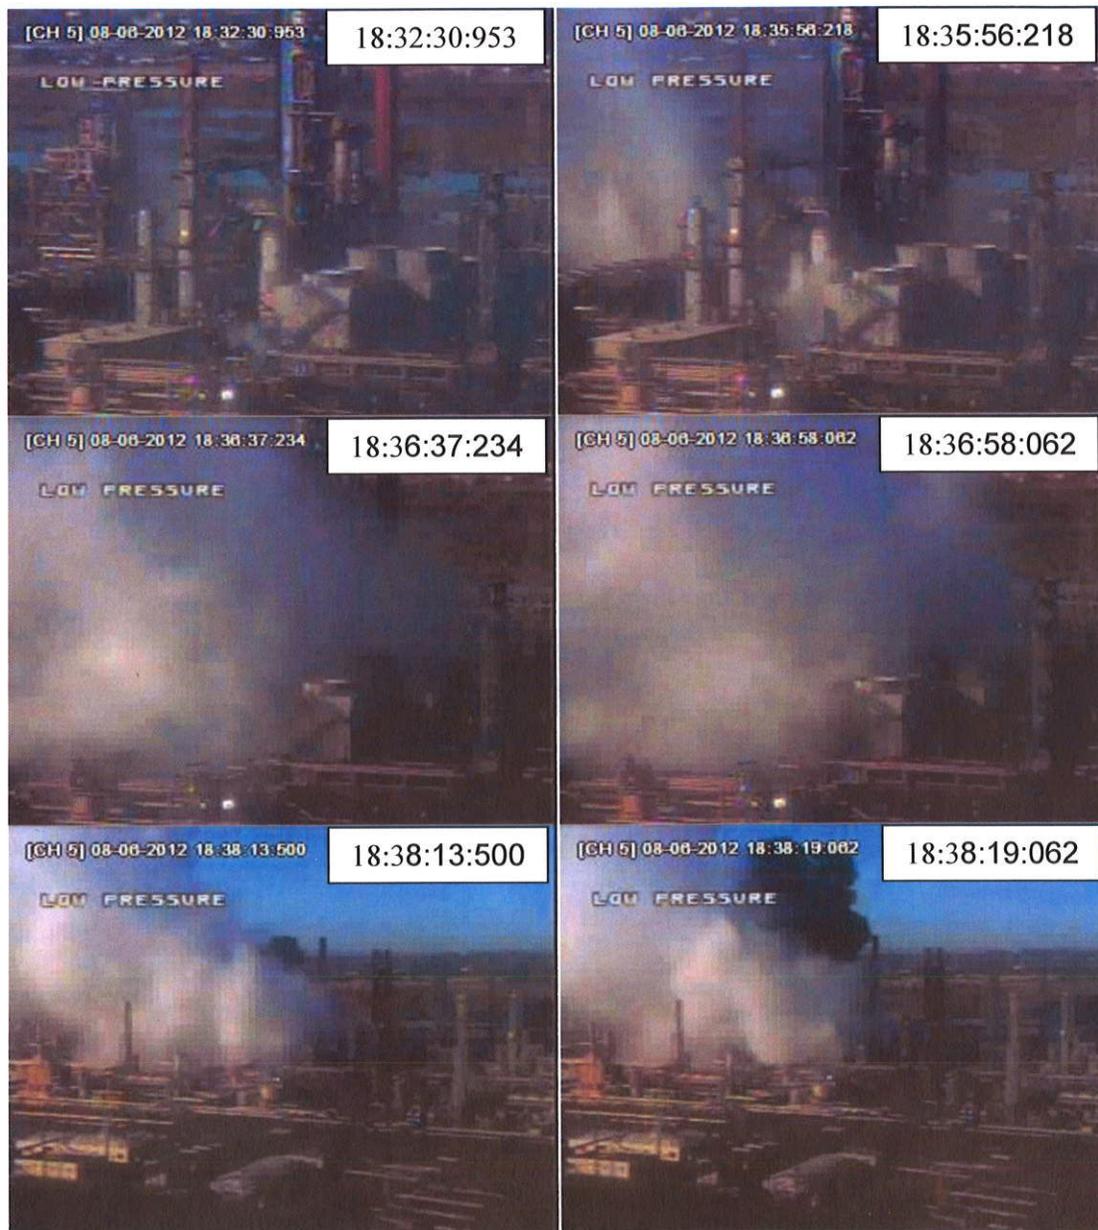
At approximately 1830 hours, the leak rapidly worsened, as confirmed by a radio transmission and video footage (Figure 6). As a result, a large white cloud formed and quickly enveloped the 4CU and downwind processing plants. Consequently, the CFD hose teams shut off the hose nozzles and withdrew from the area. Water application via the portable Blitz monitor continued and water flow from Engine Foam 60’s deck monitor was activated and directed toward the general area of the leak.

Figure 6. CUSA surveillance camera showing the 4CU (top left). A white cloud is shown forming (top-right and middle-right/left) for approximately 2 minutes and 30 seconds after the leak escalated and before the fire ignited (bottom, camera had been zoomed out). (The clock in these images is approximately 5-7 minutes ahead of actual time.)

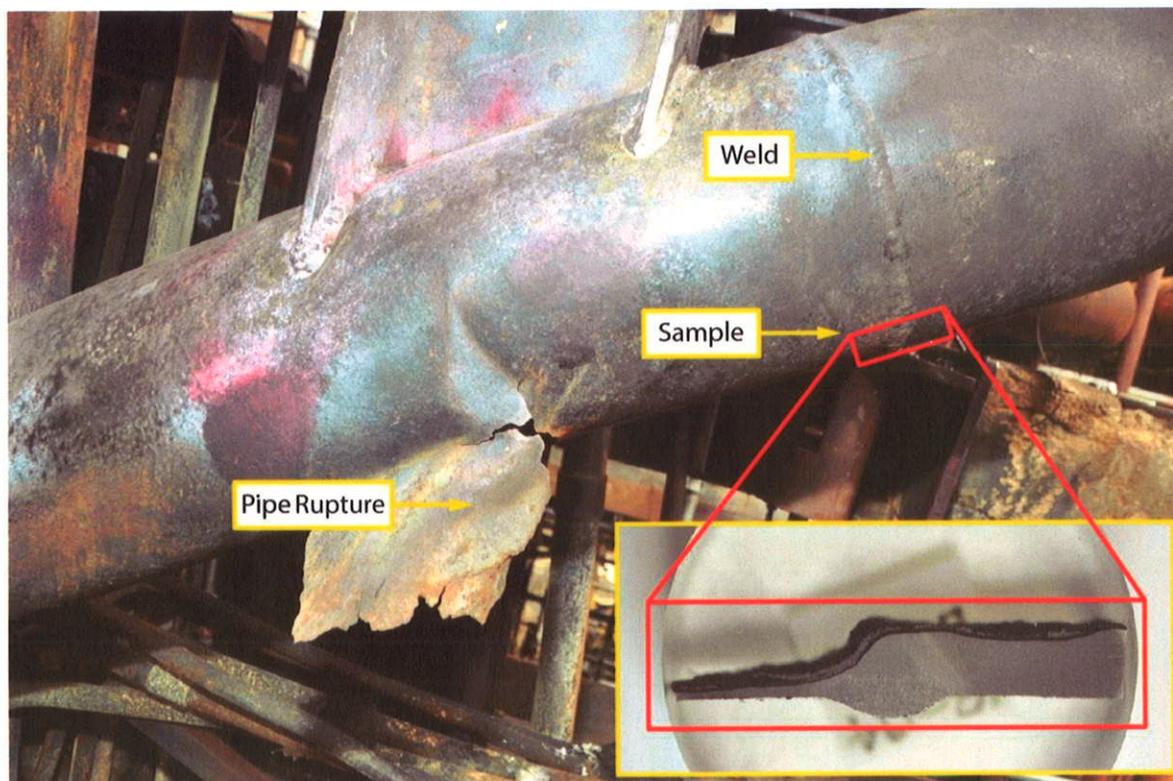
Figure 11 shows a cross section of the ruptured pipe, the adjacent elbow, and the weld between the two. Figure 12 shows the location where the sectioned sample was removed from the ruptured pipe. The ruptured component is clearly thinner than the adjacent elbow. The results of the chemical analysis indicate that the ruptured pipe component had a silicon content of approximately 0.01 wt% and the adjacent elbow had a silicon content of 0.16 wt%. As noted earlier, carbon steel with less than 0.10 wt% silicon content can exhibit higher sulfidation corrosion rates than carbon steel with higher levels of silicon. The impact of these differing corrosion rates is discussed in Section 4.

Figure 12. Image showing the location where the sectioned sample was removed from the ruptured pipe component.

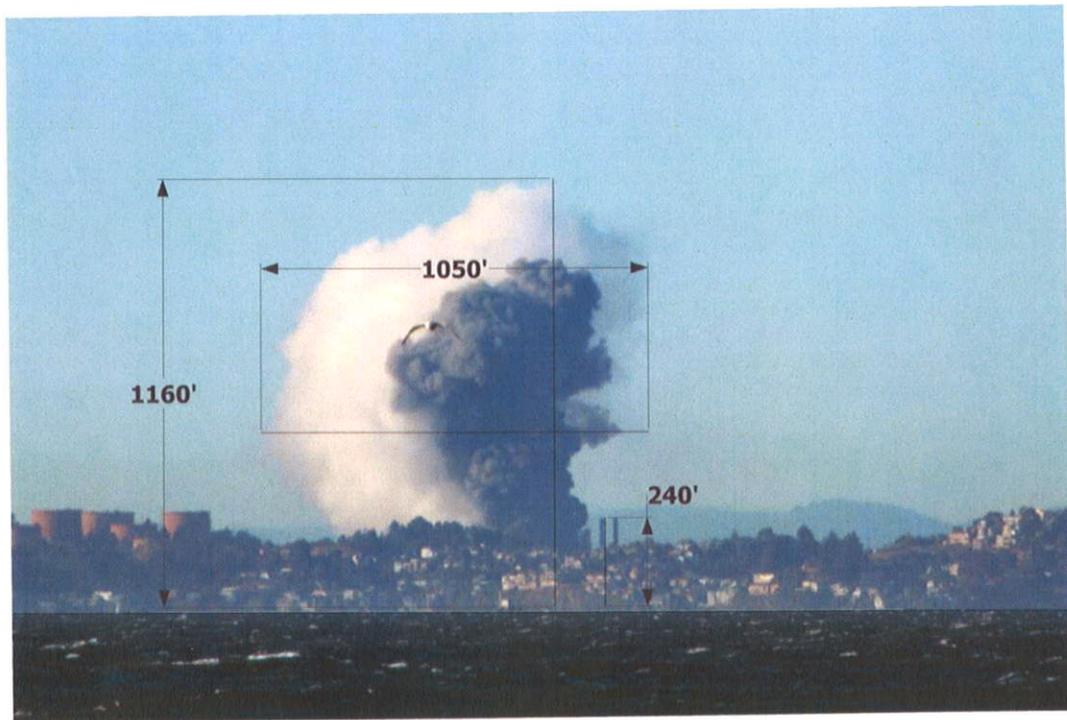
Just after ignition, a freelance photographer at Pier 39 in San Francisco and video footage shot from Marine View Avenue in Point Richmond captured the white cloud. Analysis was performed to estimate the size of the white cloud at the time witnesses reported the fire started. The largest dimensions of the white cloud were approximately 1,100 feet wide (in the east-west direction) and approximately 1,200 feet high, as shown in Figure 13.

Figure 13. Estimated size of the white cloud utilizing a photograph taken at Pier 39 in San Francisco. The 240 foot dimension shows the height of the 4CU furnace stacks.

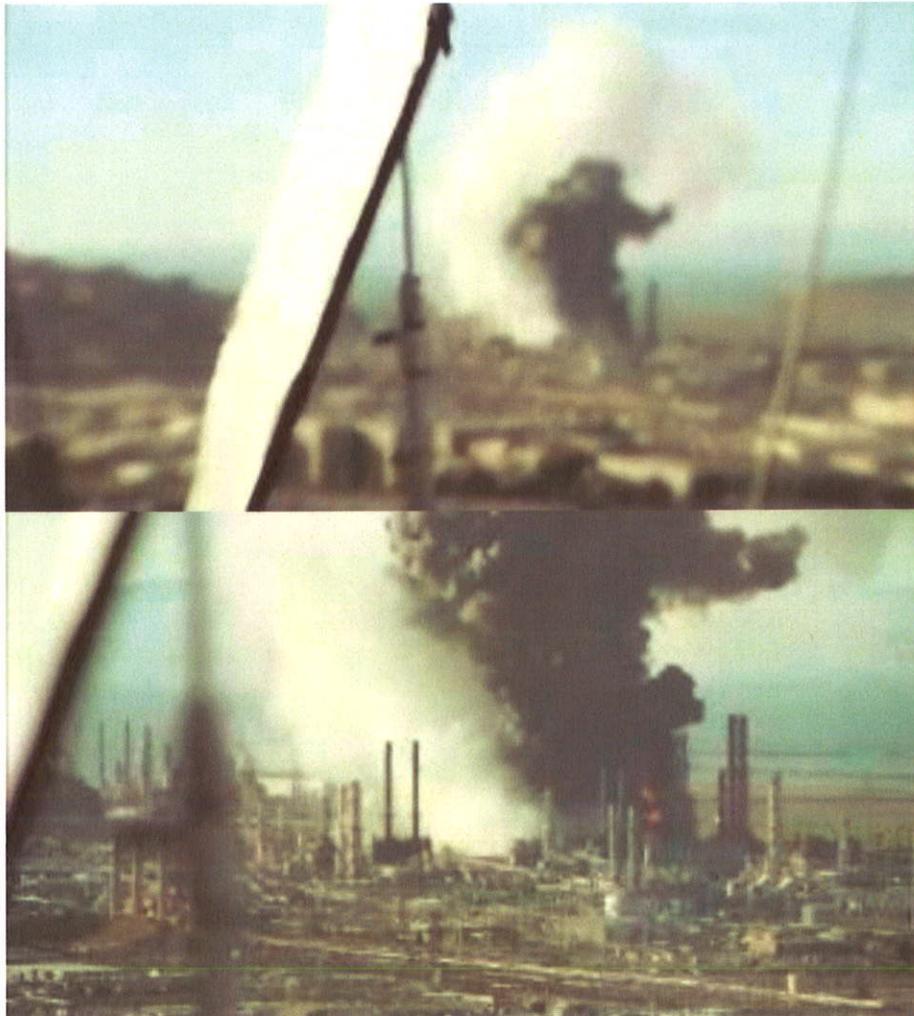
Incident site inspections, witness observations, and video footage show that the vast majority of the white cloud did not ignite. According to witnesses, ignition occurred near the pipe rupture, resulting in a black smoke plume. A clear demarcation was observed between the black smoke plume and the white cloud, as shown in Figure 14. Flames were visible in the video footage, providing a competent ignition source for the white cloud. However, the white cloud persisted for several minutes in the immediate vicinity of the black smoke plume even after the ignition. No flames were observed propagating through the white cloud and no signs of overpressure were observed.

Figure 14. Stills from video footage taken from Marine View Avenue in Point Richmond that shows the formation of the black plume shortly after ignition of the fire (top), and after continued burning (bottom).
