Improving Public and Worker Safety at Oil Refineries

**Draft Report of the
Interagency Working Group on Refinery Safety
Governor Jerry Brown**

July 2013

CHEVRON RICHMOND REFINERY FIRE

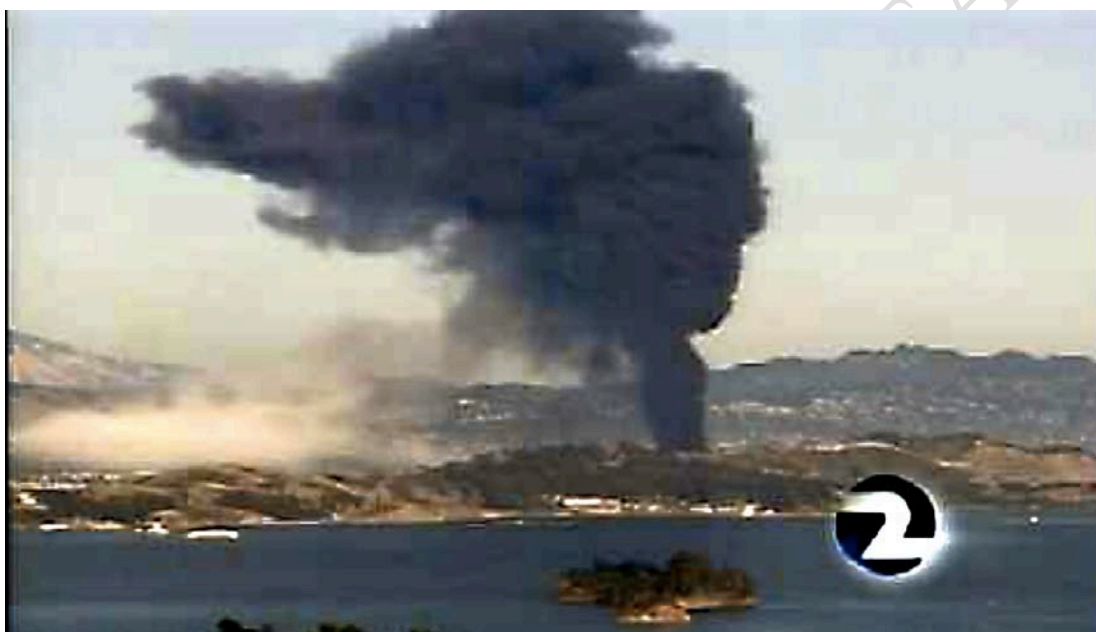
2. The ignition and subsequent continued burning of the hydrocarbon process fluid resulted in a large plume of unknown and unquantified particulates and vapor traveling across the Richmond, California, area (Figure 2 and Figure 3). This resulted in a Community Warning System (CWS) Level 3 alertⁱ and a shelter-in-placeⁱⁱ was issued at 6:38 pm¹ for the cities of Richmond, San Pablo, and North Richmond. It was lifted later that night at 11:12 pm after the fire was fully under control. In the weeks following the incident, nearby medical facilities received over 15,000 members of the public seeking treatment for ailments including breathing problems, chest pain, shortness of breath, sore throat, and headaches. Approximately 20 people were admitted to local hospitals as inpatients for treatment.

Figure 2. Vapor cloud (white) over Richmond area and smoke (black) from Chevron Richmond Refinery fire as seen from San Rafael in Marin County.²

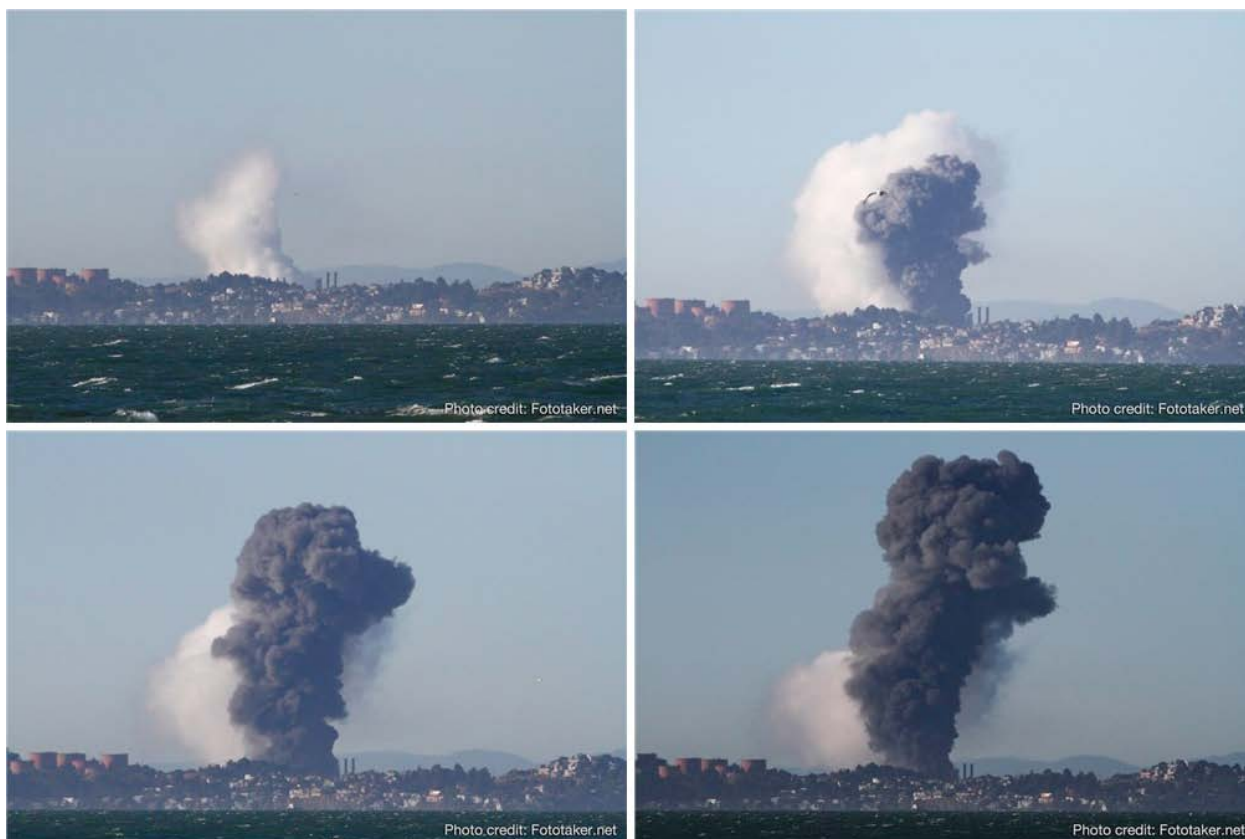
Figure 3. Initial vapor cloud formation (white cloud) and subsequent ignition (black smoke) as seen from a pier in San Francisco, California.

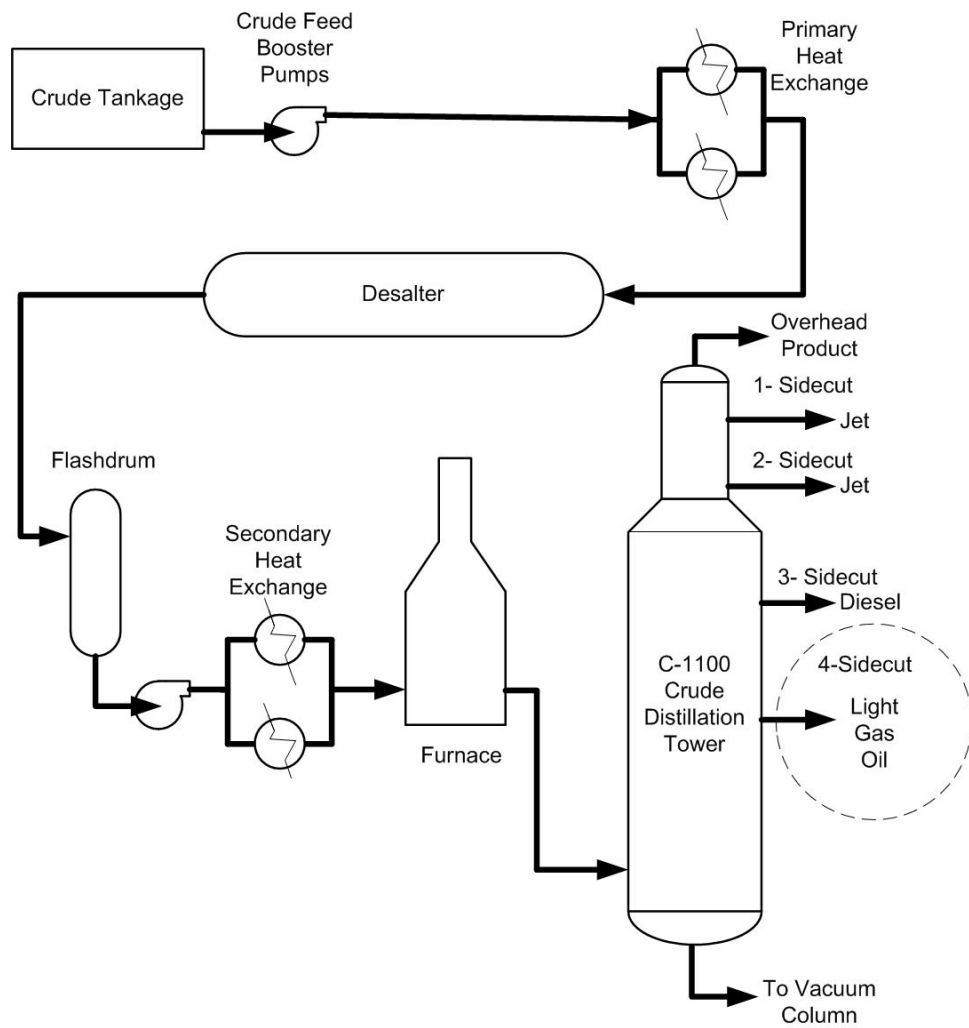
3. The incident occurred from the piping referred to as the “4-sidecut” stream, one of several process streams exiting the C-1100 Crude Unit Atmospheric Column (Figure 4).ⁱ A plot plan of the crude unit shows the leak location relative to C-1100 (Figure 5). As shown in Figure 6, light gas oil (the crude unit 4-sidecut process fluid) exits the atmospheric column via a 20-inch nozzle and is split into a 12-inch line and an 8-inch line. The August 6, 2012, pipe rupture (Figure 7) occurred on a 52-inch long componentⁱⁱ of the 4-sidecut 8-inch line (the 52-inch component). The line operated at a temperature of 640 degrees Fahrenheit (°F)ⁱⁱⁱ and had an operating pressure of approximately 55 pounds per square inch gauge (psig) at the rupture location. At the

Figure 4. C-1100 Crude Unit Atmospheric Column and Upstream Process Equipment

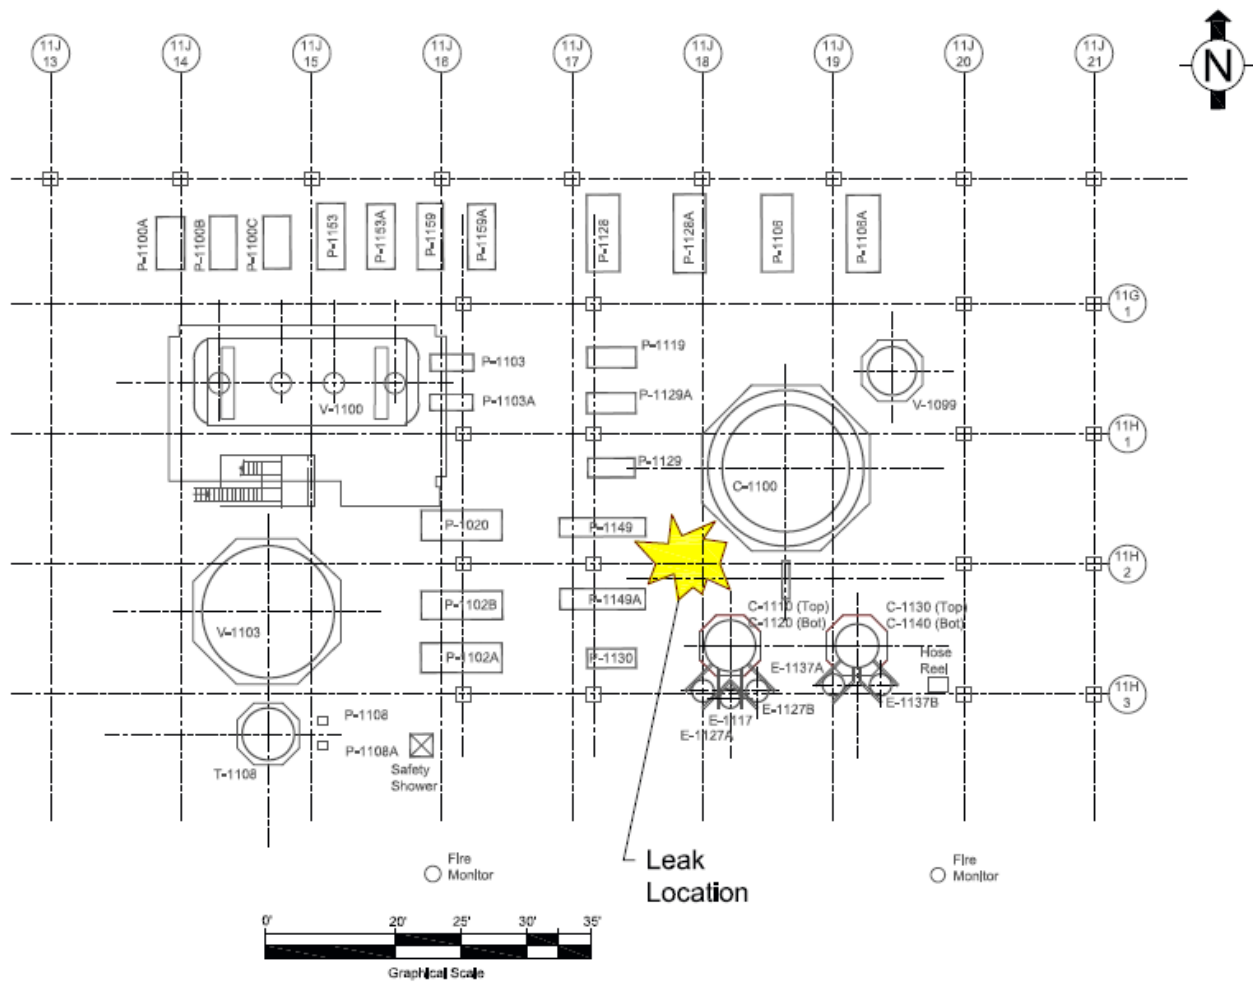
Figure 5. Overhead view of the equipment in the #4 Crude Unit showing the leak location, commonly referred to as a plot plan.

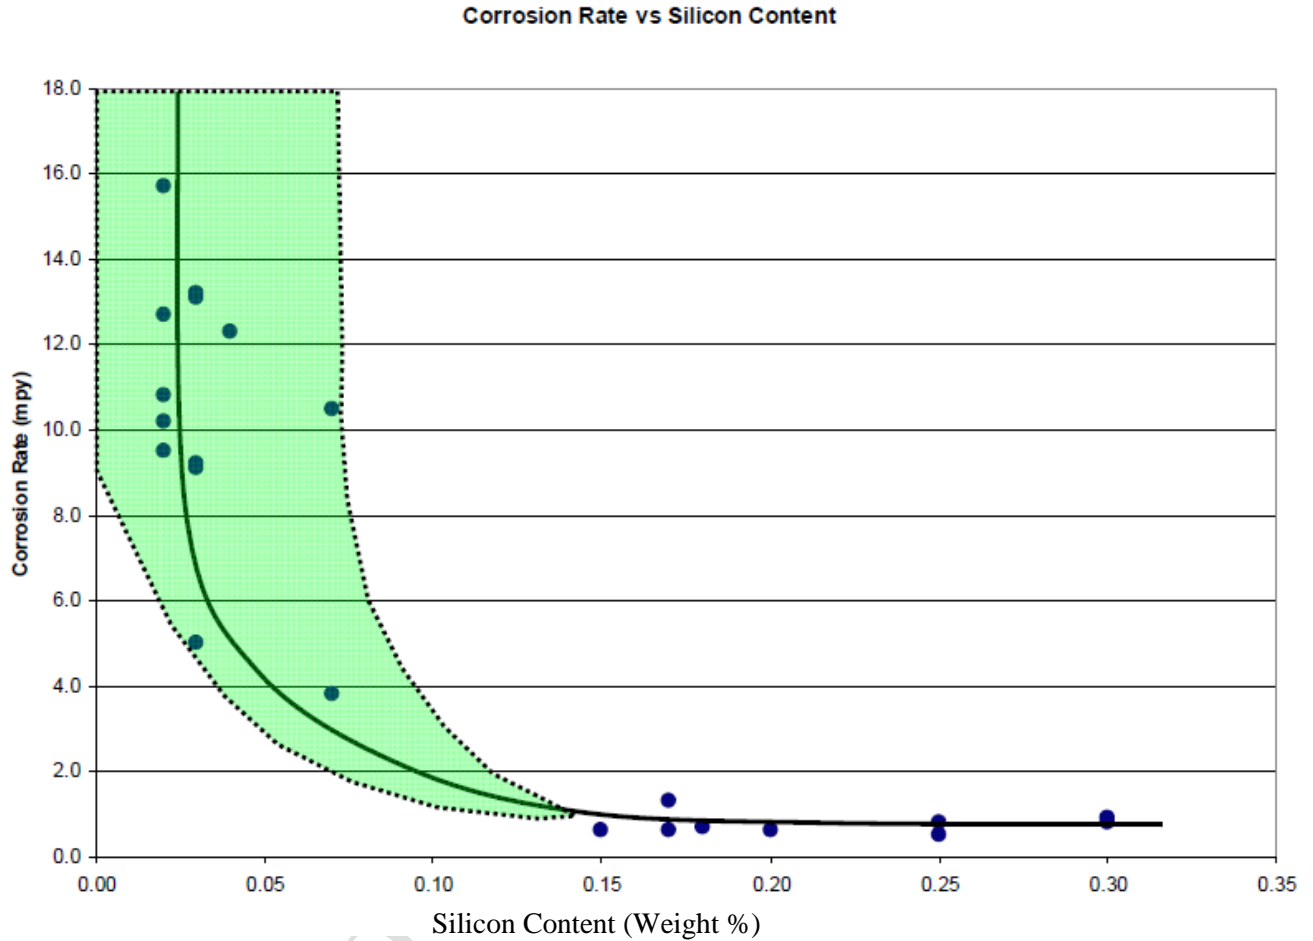
Figure 8. This graph shows how corrosion rates increase in carbon steel containing decreasing percentages of silicon. This information can be found in Annex C of API RP 939-C.ⁱ

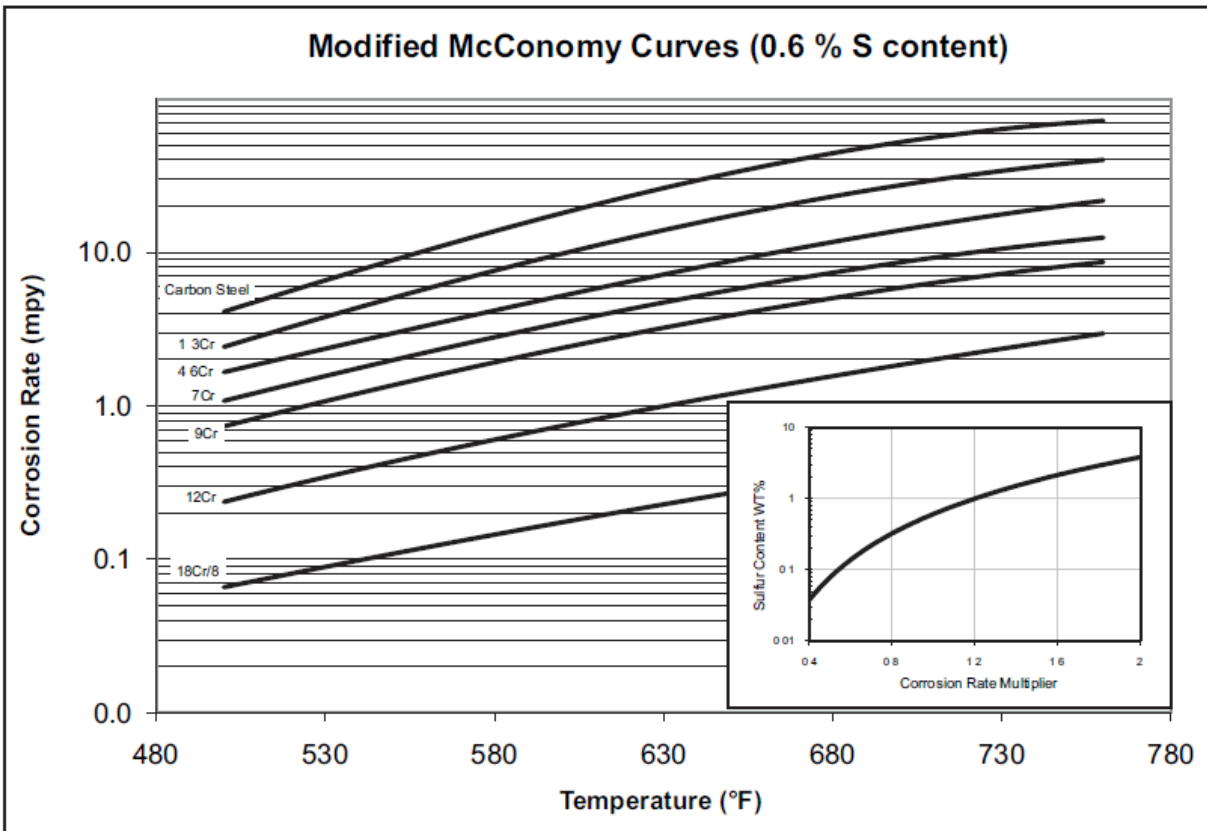
This makes alloys with higher chromium content an inherently safer choice in high temperature sulfidation corrosion environments.ⁱ As shown in the Modified McCconomy Curvesⁱⁱ (Figure 10) from API RP 939-C, 9-Chromeⁱⁱⁱ corrodes 15 times faster than stainless steel,^{iv} and carbon steel^v corrodes 125 times faster than stainless steel.²⁷

Figure 10. Modified McCconomy Curves from API RP 939-C.

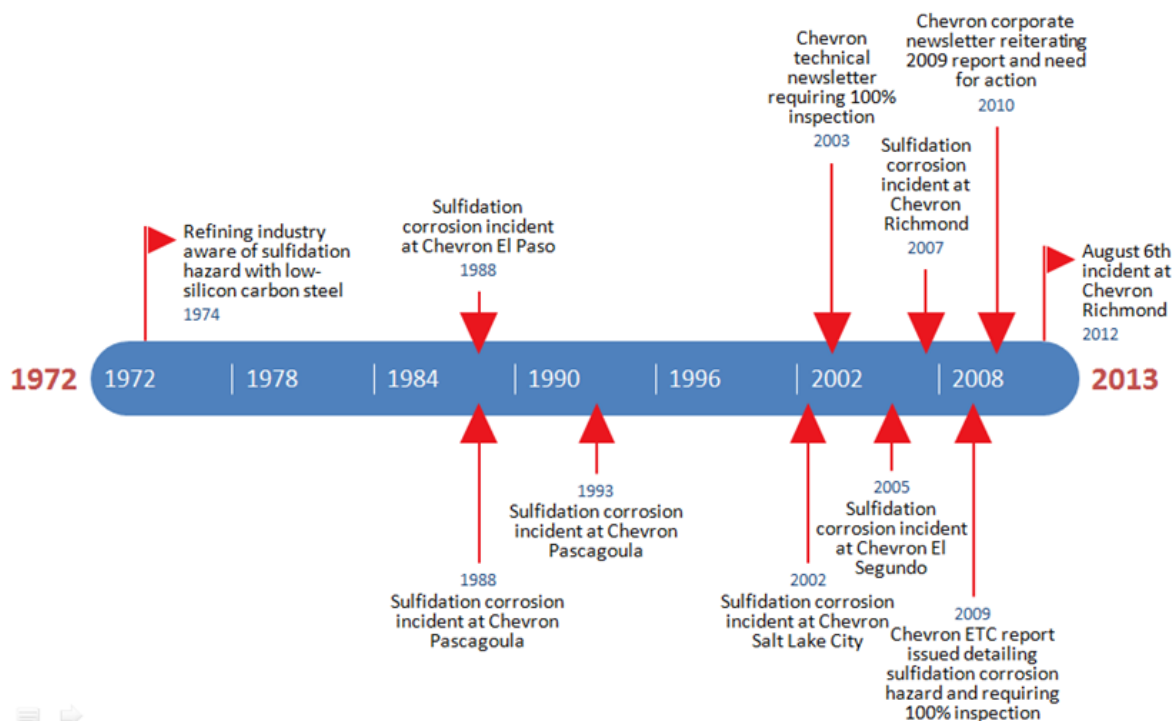
21. Figure 11 shows a timeline of Chevron's key sulfidation events. Chevron technical staff has considerable knowledge and expertise regarding sulfidation corrosion, specifically with respect to corrosion rate variations caused by differing silicon concentration in carbon steel piping. Chevron employees have authored industry papers on sulfidation corrosion and had significant influence in the development of the industry sulfidation corrosion recommended practice, API RP 939-C. This recommended practice, first published in 2009, was developed under Chevron leadership. At the approximate time of publication of API RP 939-C, Chevron Energy Technology Company (Chevron ETC)ⁱ created an internal document on the subject of sulfidation corrosion. Chevron ETC metallurgists released a formal report dated September 30, 2009 (nearly 3 years prior to the incident) to Chevron refinery-based reliability managers and chief inspectors titled *Updated Inspection Strategies for Preventing Sulfidation Corrosion Failures in Chevron Refineries*. In the Chevron ETC report, sulfidation experts acknowledged that, "Until now, Chevron has not directly addressed the risk of low Si[licon] carbon steel..."ⁱⁱ This report specifically recommends that inspectors perform 100 percent component inspection on high temperature carbon steel piping susceptible to sulfidation corrosion. However, this recommendation was not implemented at the Richmond refinery prior to the August 6, 2012, incident.

Figure 11. Chevron's key sulfidation events between 1974 and 2013.

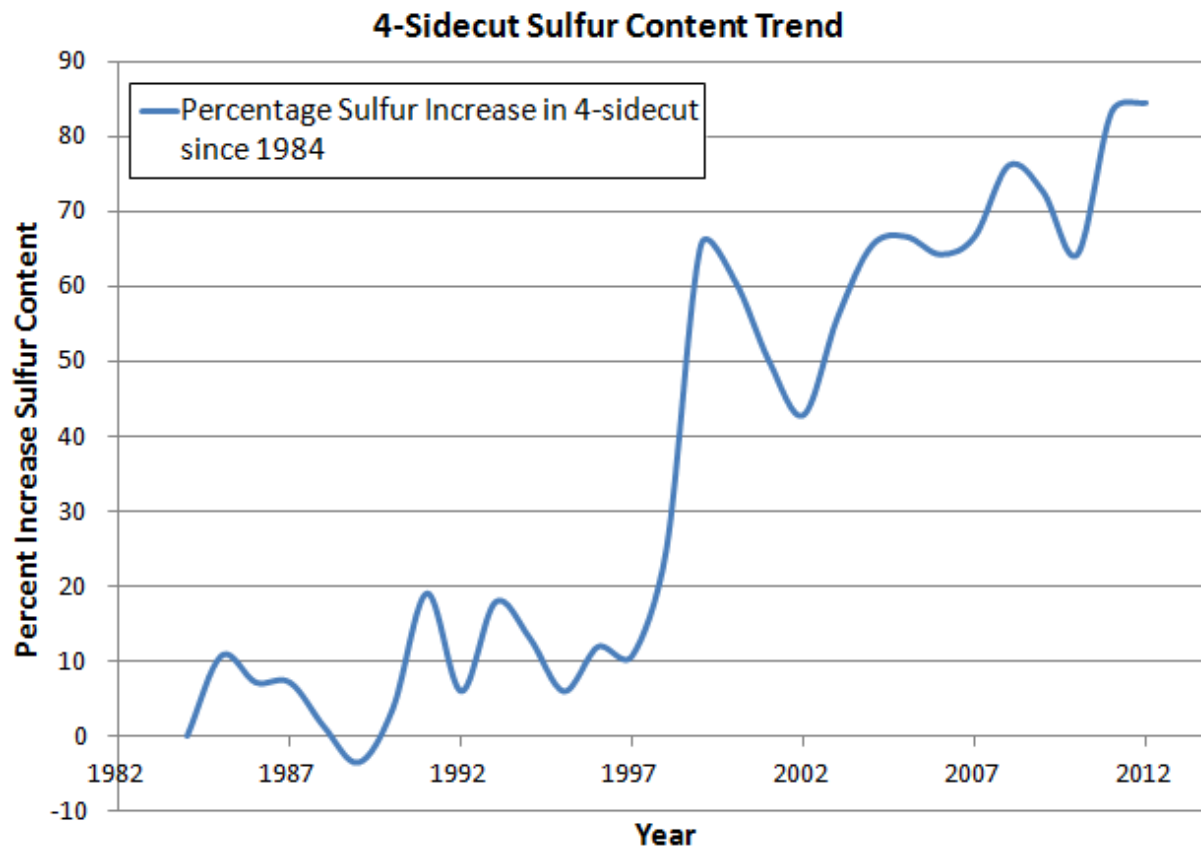
running more high-sulfur content crudes, the sulfur content in the 4-sidecut line steadily increased (Figure 14), as discussed below.

Figure 14. Graph shows the percentage increase from 1984 values of the sulfur content in the 4-sidecut.

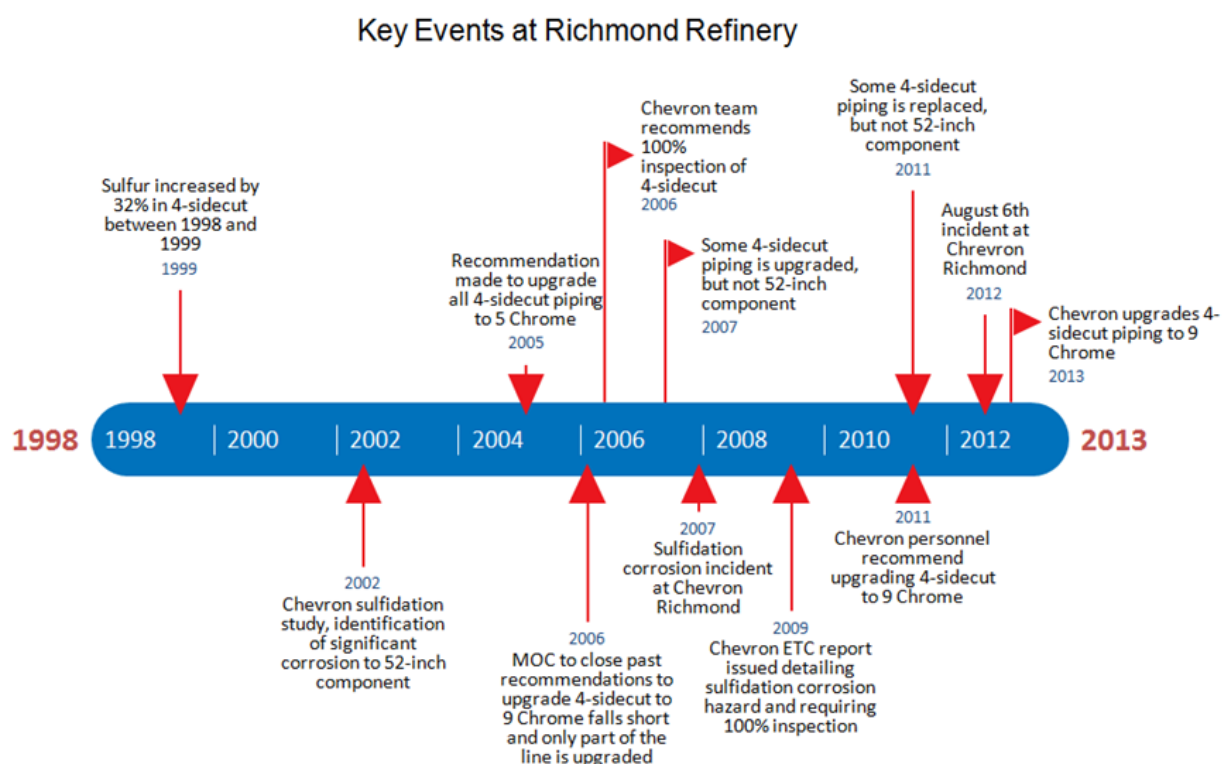
44. In the ten years prior to the incident, a small number of Chevron personnel with knowledge and understanding of sulfidation corrosion made at least six recommendations (listed in the following six paragraphs and included in Figure 15) to increase inspection or upgrade the metallurgy in the 4-sidecut piping. The recommendations made by these personnel were not implemented by Chevron management.

Figure 15. Key events at the Richmond refinery between 1998 and 2013.

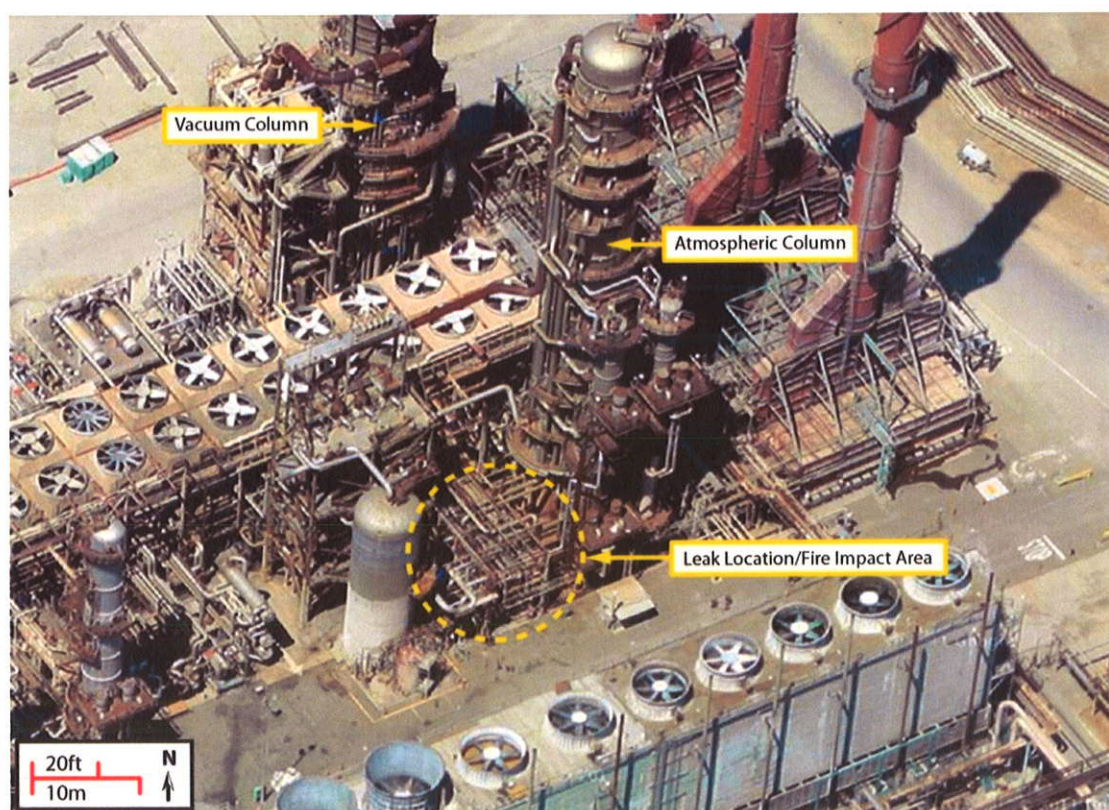
Figure 1. Overhead view of the 4CU prior to the Incident with the location of the rupture circled in yellow (image from Google Maps®).

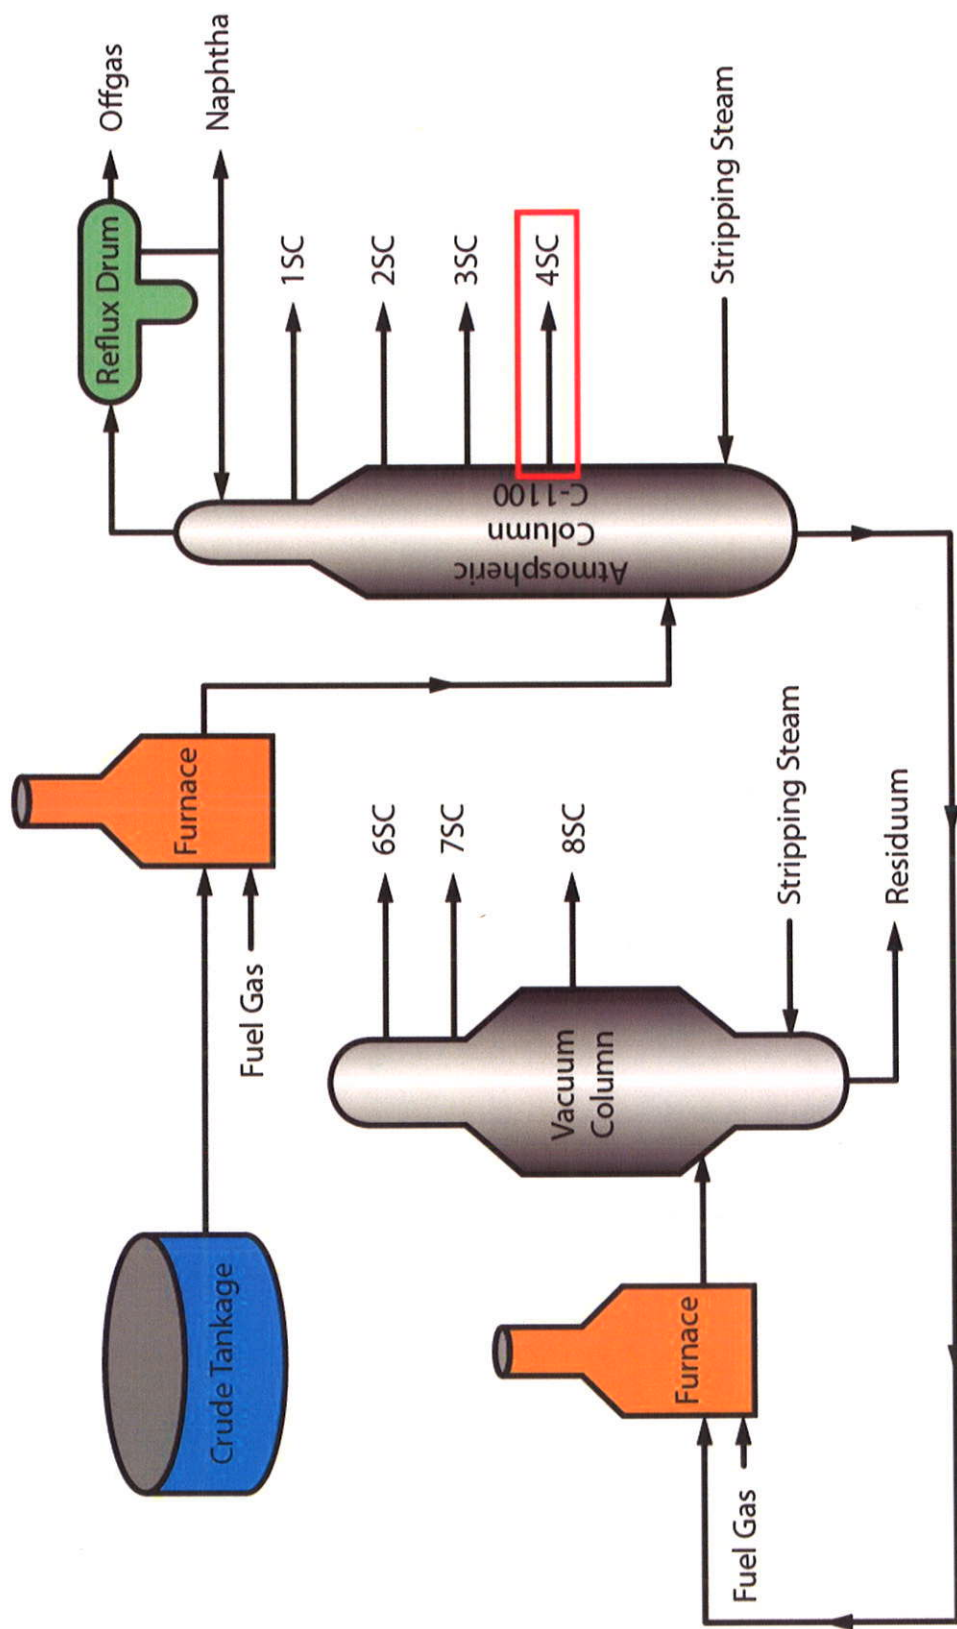
Figure 2. Simplified 4CU flow diagram. The failure occurred in the 4SC piping of the C-1100 (marked in red).

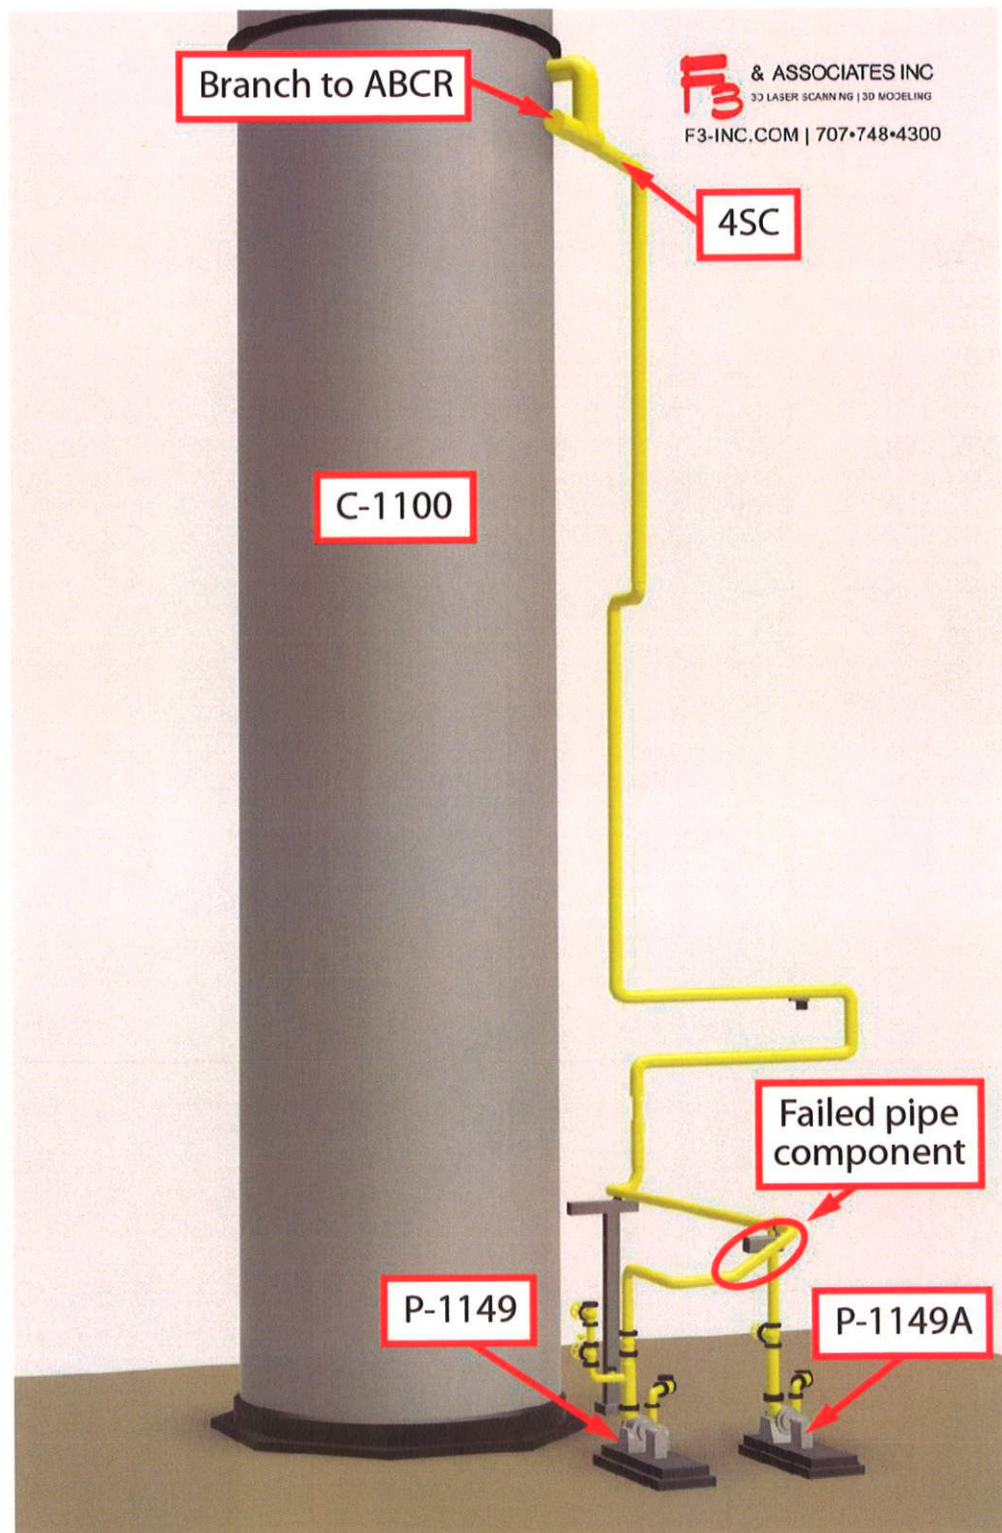
The 4SC and the Atmospheric Bottom Circulating Reflux (ABCR) are drawn via a 20-inch nozzle from the C-1100 (Figure 3). The piping branches to a 12-inch ABCR pipe and a separate 8-inch 4SC pipe. Post-Incident inspection showed that there were 67 components, including straight pipe and fittings (elbows, tees, flanges, etc.) in the 4SC piping between the piping branch and the 4SC stripper pumps.

Figure 3. Three-dimensional model showing the 4SC and the ABCR drawn via a 20-inch nozzle from the C-1100. Note: the ABCR piping is not shown beyond the initial branch.

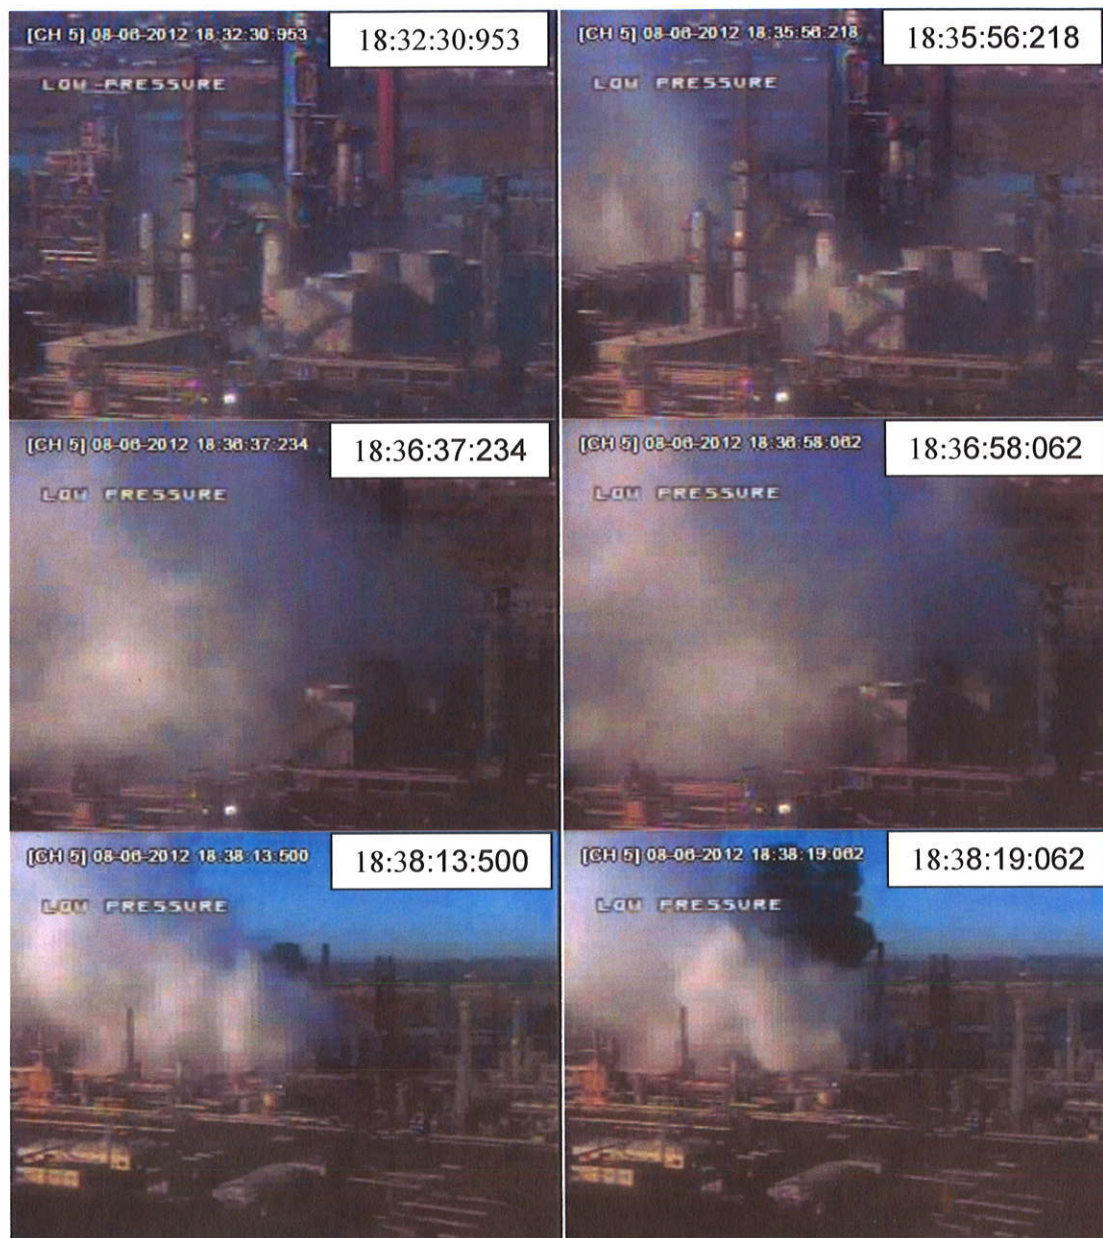
At approximately 1830 hours, the leak rapidly worsened, as confirmed by a radio transmission and video footage (Figure 6). As a result, a large white cloud formed and quickly enveloped the 4CU and downwind processing plants. Consequently, the CFD hose teams shut off the hose nozzles and withdrew from the area. Water application via the portable Blitz monitor continued and water flow from Engine Foam 60’s deck monitor was activated and directed toward the general area of the leak.

Figure 6. CUSA surveillance camera showing the 4CU (top left). A white cloud is shown forming (top-right and middle-right/left) for approximately 2 minutes and 30 seconds after the leak escalated and before the fire ignited (bottom, camera had been zoomed out). (The clock in these images is approximately 5-7 minutes ahead of actual time.)

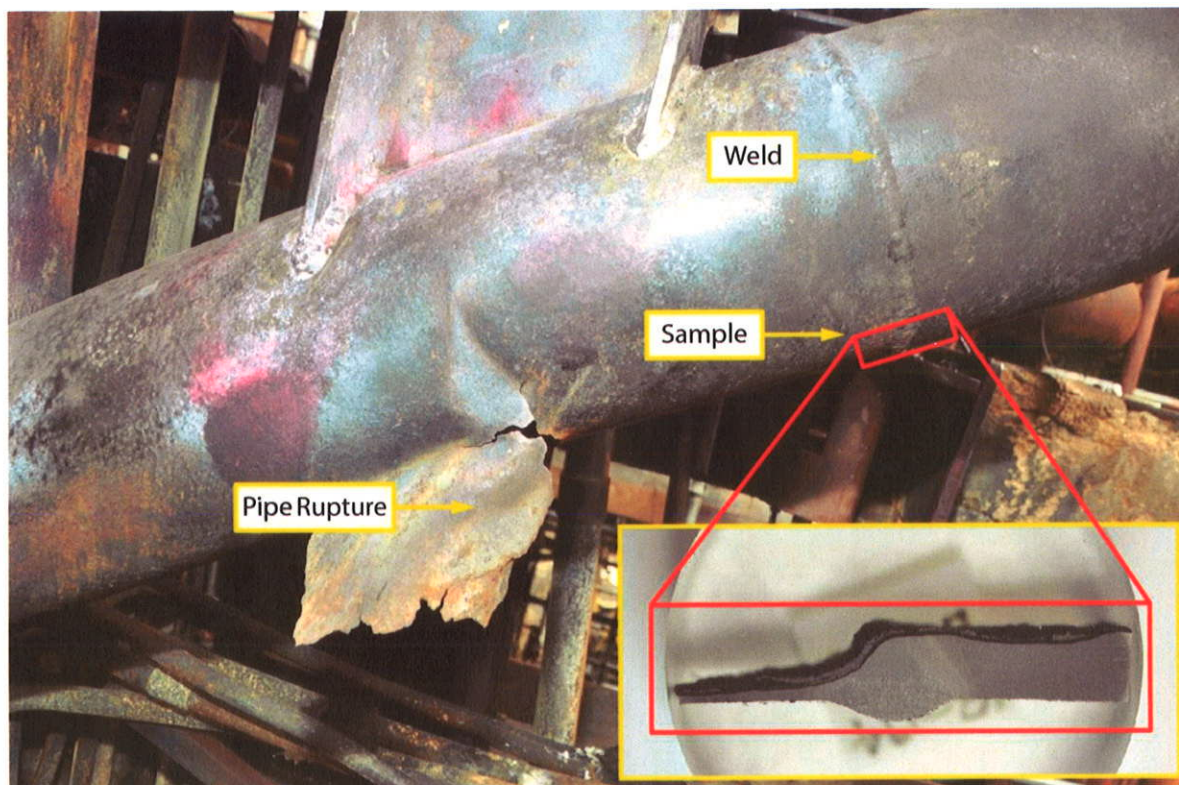
Figure 12. Image showing the location where the sectioned sample was removed from the ruptured pipe component.

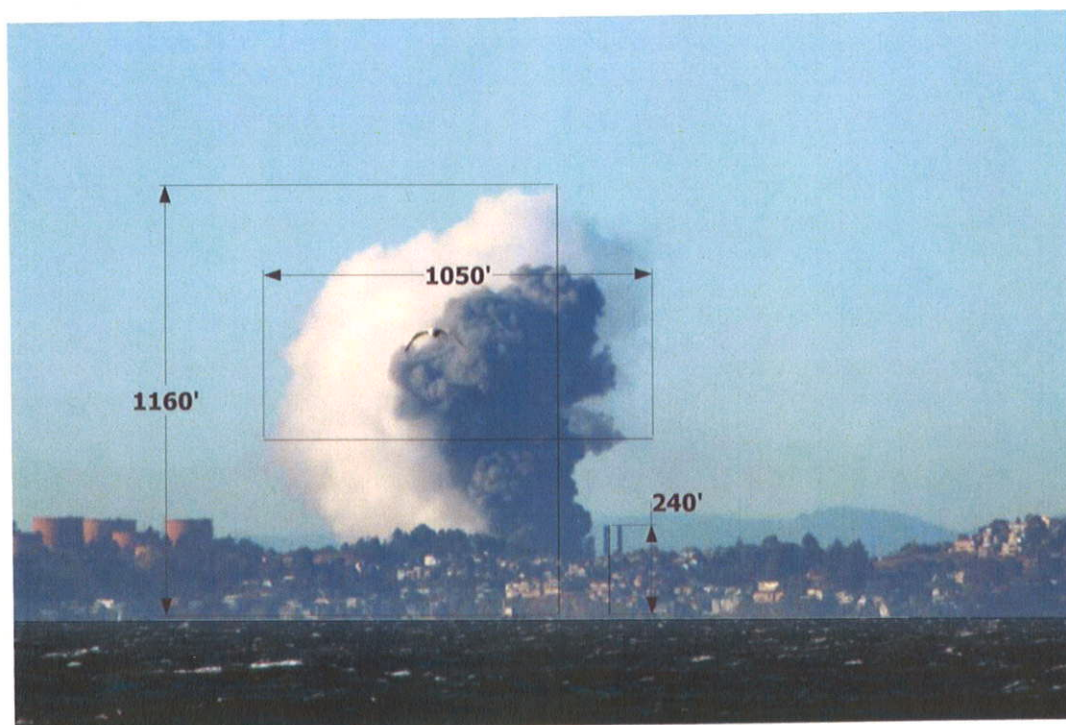
Just after ignition, a freelance photographer at Pier 39 in San Francisco and video footage shot from Marine View Avenue in Point Richmond captured the white cloud. Analysis was performed to estimate the size of the white cloud at the time witnesses reported the fire started. The largest dimensions of the white cloud were approximately 1,100 feet wide (in the east-west direction) and approximately 1,200 feet high, as shown in Figure 13.

Figure 13. Estimated size of the white cloud utilizing a photograph taken at Pier 39 in San Francisco. The 240 foot dimension shows the height of the 4CU furnace stacks.

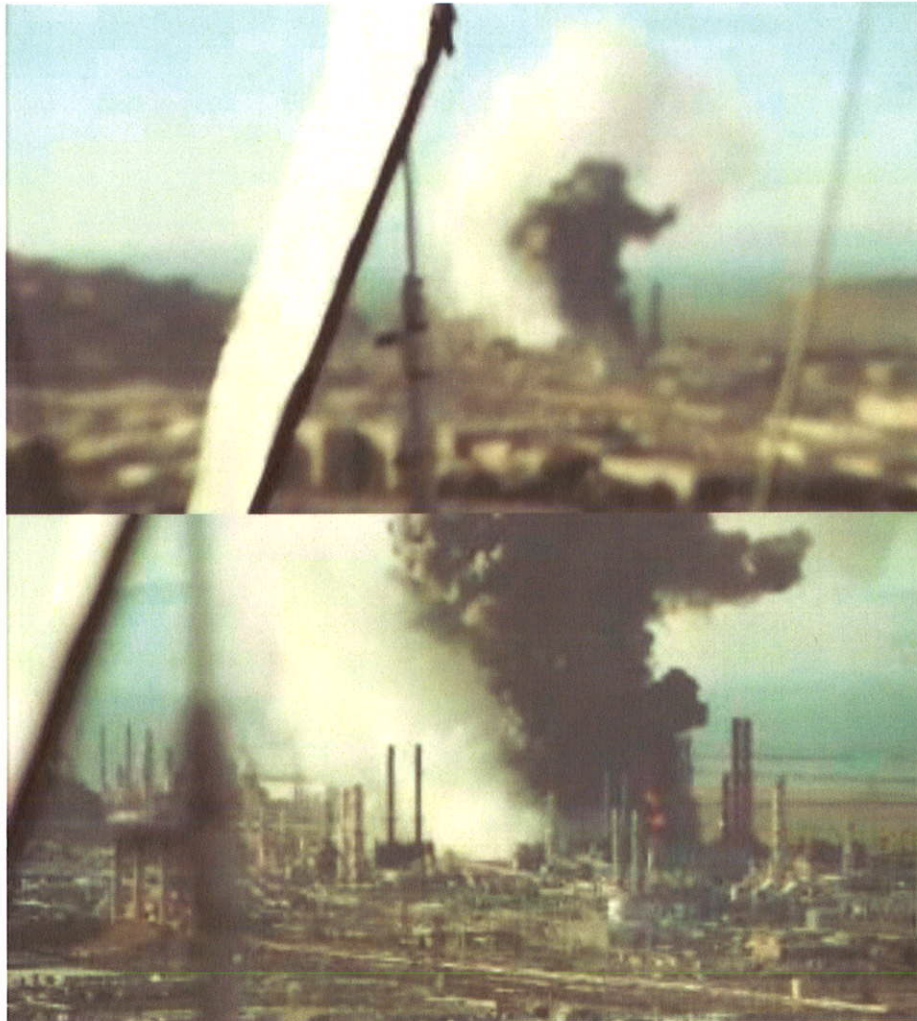
Incident site inspections, witness observations, and video footage show that the vast majority of the white cloud did not ignite. According to witnesses, ignition occurred near the pipe rupture, resulting in a black smoke plume. A clear demarcation was observed between the black smoke plume and the white cloud, as shown in Figure 14. Flames were visible in the video footage, providing a competent ignition source for the white cloud. However, the white cloud persisted for several minutes in the immediate vicinity of the black smoke plume even after the ignition. No flames were observed propagating through the white cloud and no signs of overpressure were observed.

Figure 14. Stills from video footage taken from Marine View Avenue in Point Richmond that shows the formation of the black plume shortly after ignition of the fire (top), and after continued burning (bottom).
